## Technical Service Bulletin

| Topic | 00 Combined software update ID.S 5.6.3 for Audi Q4 - V7B |
| Transaction No. | 2082958/1 |

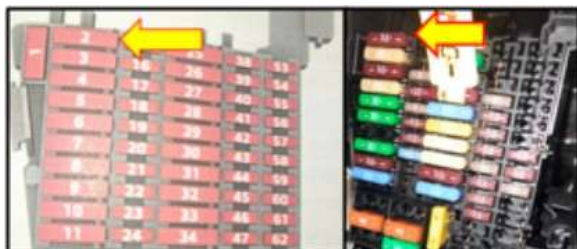
- Insert the USB stick specified by the diagnostic tester.
  - If the instructions to remove the fuse (7.5 A, brown) for airbag control unit J234 are shown, follow the instructions on the tester. Refer to the image to see the fuse location (-2-).
