## Condition

| Model(s) | Year(s) | VIN Range | Vehicle Specific Equipment |
|---|---|---|---|
| Q4 e-tron, and Q4 Sportback e-tron | 2024 – 2026 | All | PR Code:<br>V7E |

The following complaints (TSB) are resolved with this software update:

- Moving images are not played while the vehicle is moving.

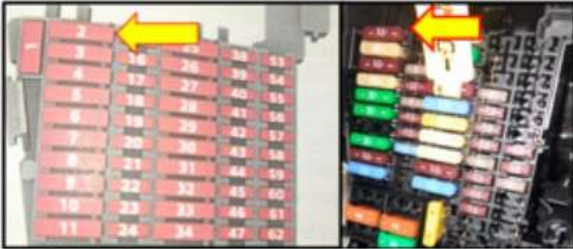
- Insert the USB stick specified by the diagnostic tester.
  - If the instructions to remove the fuse (7.5 A, brown) for airbag control unit J234 are shown, follow the instructions on the tester. Refer to the image to see the fuse location (-2-).
