## Condition

| Model(s) | Year(s) | VIN Range | Vehicle Specific Equipment |
| Q4 e-tron, and Q4 Sportback e-tron | 2024 – 2026 | All | With PR Code:<br>V7T<br><b>AND</b><br>Without PR Code:S7E |

The following TSB describes the specific flashing procedure that must be used on the vehicle.

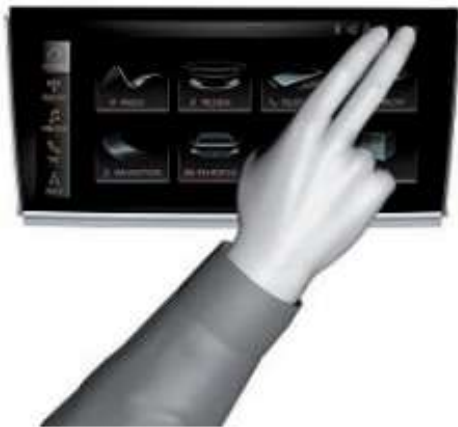
Select "Update" and the source in which you have inserted the update medium (USB connection). Use the volume control to do this. All control units to be updated are shown; scroll all the way down and start the update. Once the manual update has been successfully completed, leave the red menu entirely before starting a diagnostic session. The MMI will now restart.
