## Condition

| Model(s) | Year(s) | VIN Range | Vehicle Specific Equipment |
|---|---|---|---|
| Q4 e-tron, and Q4 Sportback e-tron | 2026 | All | Not applicable |

This TSB replaces Pending Service Solution (PSS) TSB 2079656, *91 PSS Audi connect: Charging Targets cannot be adjusted*.

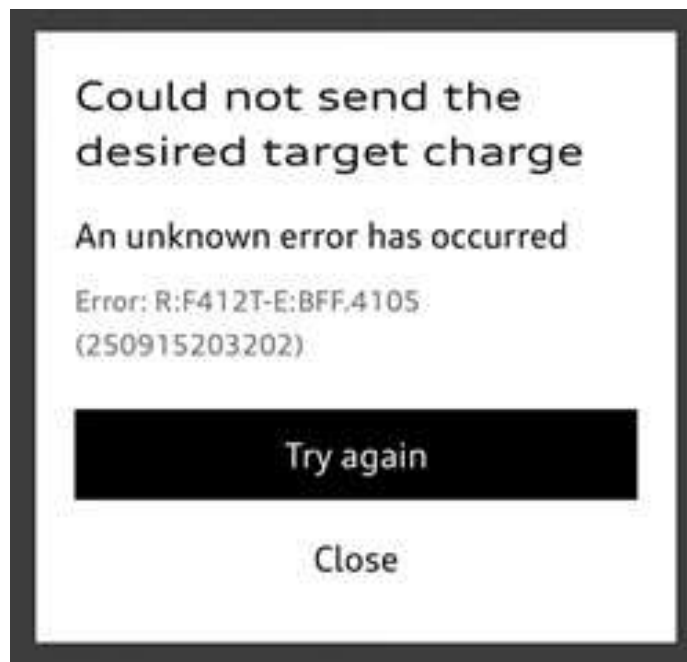
In the context of the issue that the charging target cannot be set, an error message appears in the myAudi app indicating that the set charging target cannot be sent.

Screenshot from app: "The desired charging target could not be sent. An unknown error has occurred."

Software issue in diagnostic interface control unit (DA0019)

The functional issue can be remedied via a software update to **IDS 5.6.3**.

Provided that the requirements are fulfilled, the vehicle must be updated to software version **IDS 5.6.3** in accordance with the TSB referred to in the service info.

After the update has been performed successfully, the function for adjusting the charging target must be checked again to verify its effectiveness.
