## Condition

| Model(s) | Year(s) | VIN Range | Vehicle Specific Equipment |
|---|---|---|---|
| Q4 e-tron, and Q4 Sportback e-tron | 2024 – 2026 | All | With PR code:<br>VG7<br><b>And</b><br>S7E |

The following TSB describes the specific flashing procedure that must be used on the vehicle.

- Moving images not played while vehicle is moving.

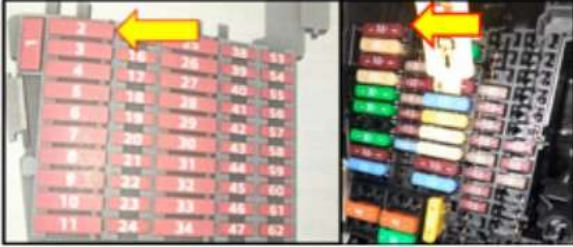
- Insert the USB stick specified by the diagnostic tester.
- If the instructions to remove the fuse (7.5 A, brown) for airbag control unit J234 are shown, follow the instructions on the tester. Refer to the image to see the fuse location (-2-).
