Technical Service Bulletin: TSB260110

Improper Lubricating Oil Fill Practices Observed in Transit Applications

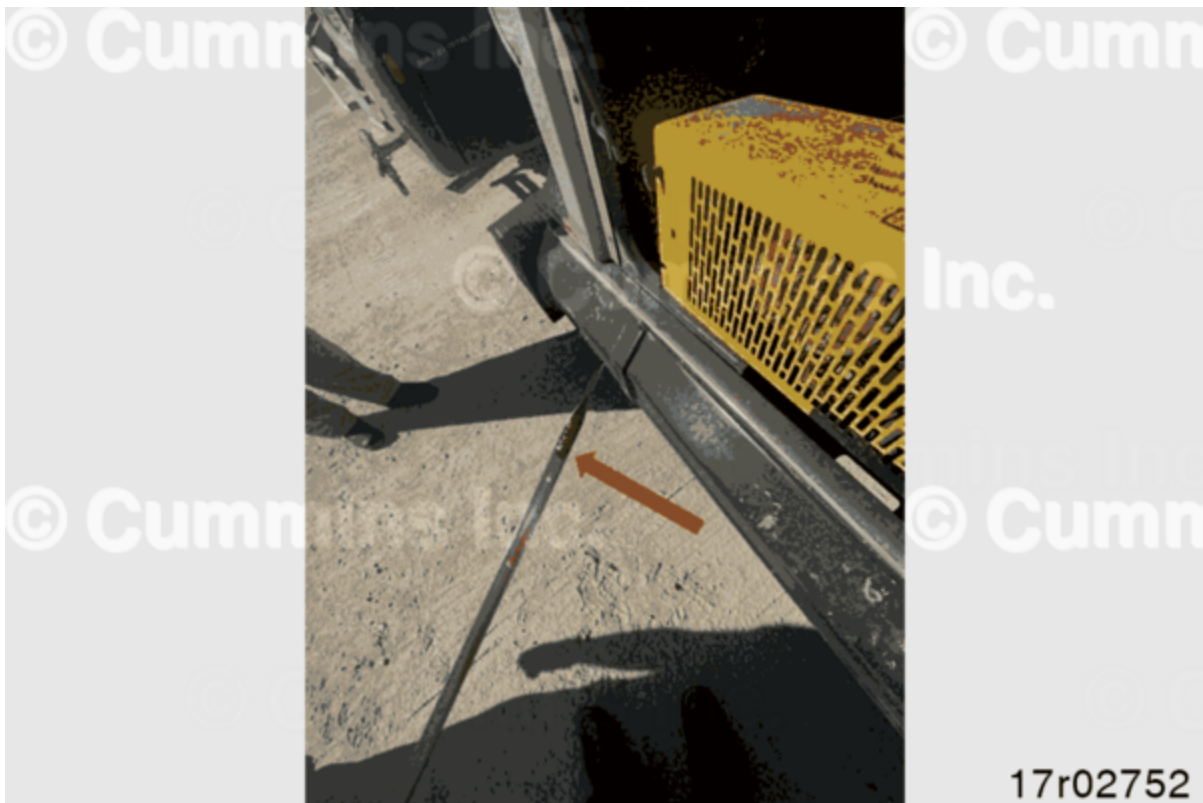
Figure 1, Lubricating Oil Level at 0 Minutes Drainback.

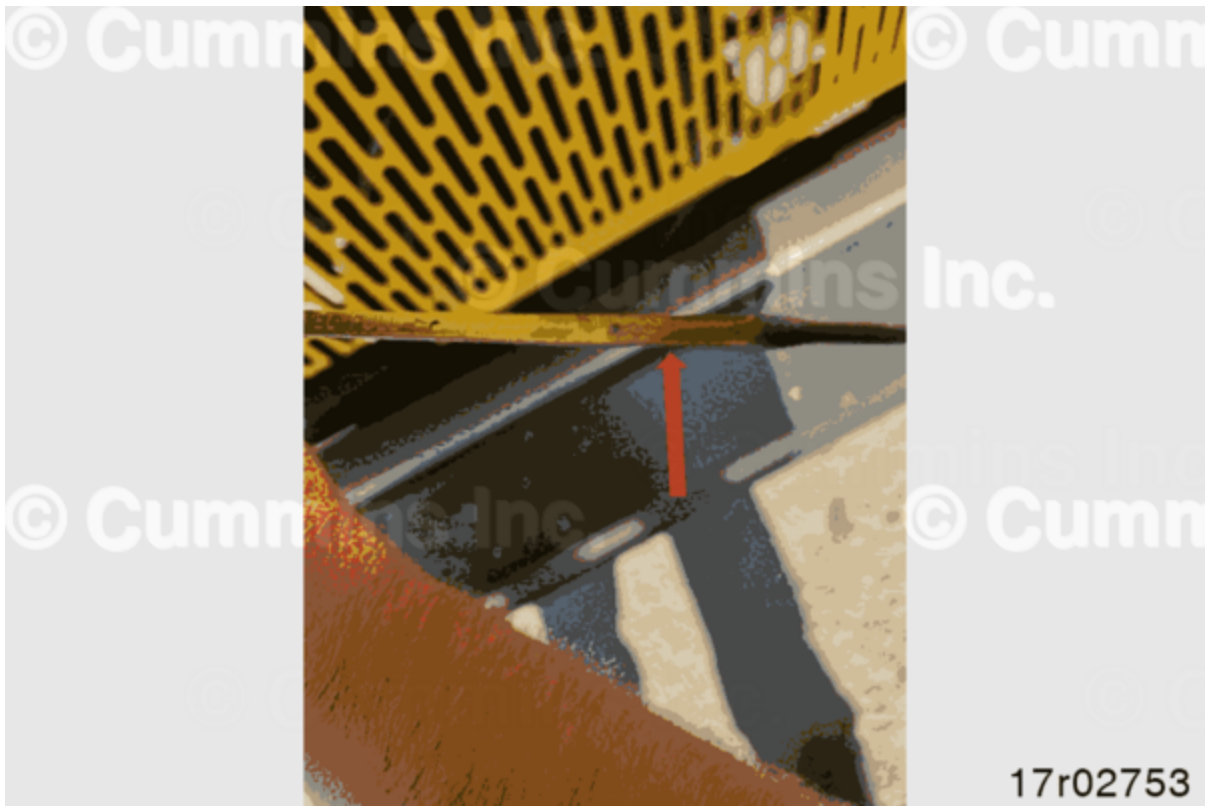
Figure 2, Lubricating Oil Level at 5 Minutes Drainback.

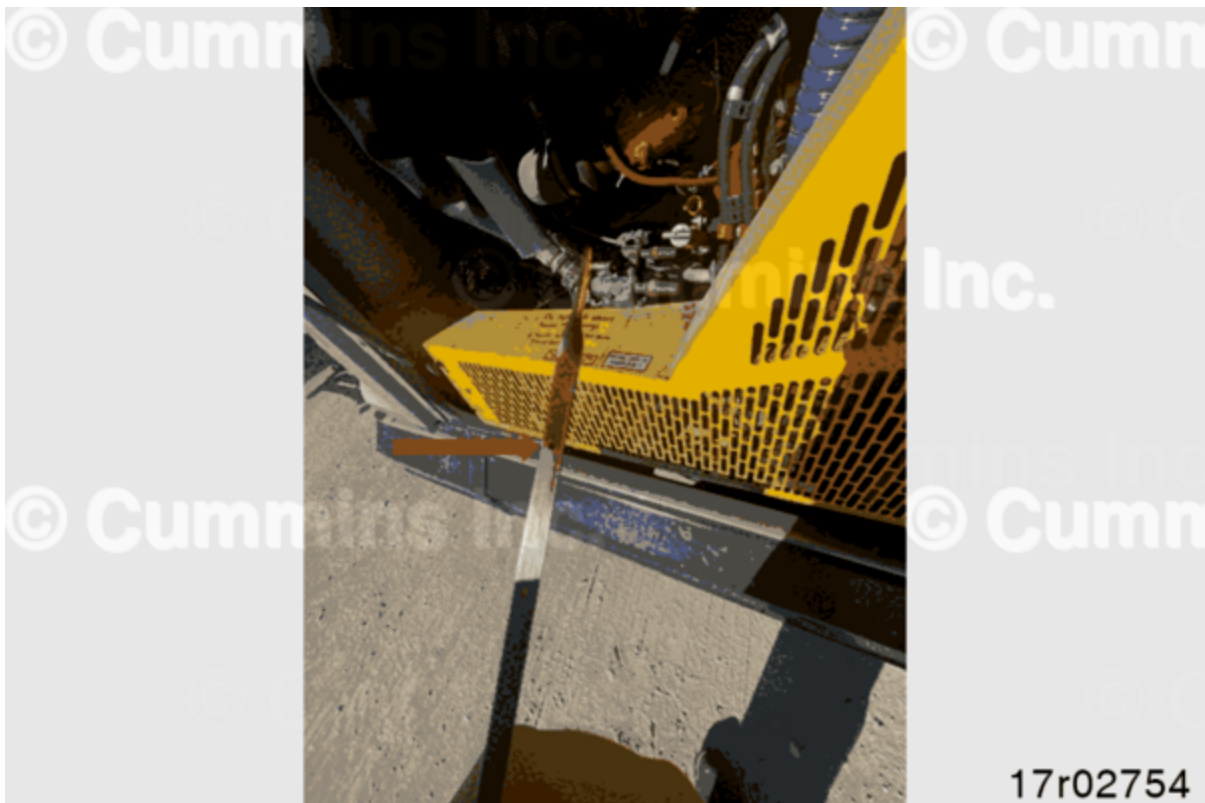
- Due to how some Applications are operated, the Lubricating Oil Level procedures specified in the corresponding Operation and Maintenance Manuals are **not** followed, resulting in an overfill.
  - Failure to allow sufficient time for the lubricating oil to drainback before checking or refilling can result in the engine being overfilled with lubricating oil.

Figure 3, Lubricating Oil Level at 30 Minutes Drainback.

- Review the lubricating oil fill and top off procedures that are being used, see corresponding Operation and Maintenance Manual. Reference Procedure 007-043 in Section 2.

- To determine the lubricating oil pan capacity, see corresponding Operation and Maintenance Manual. Reference Procedure 018-017 in Section V.
- Confirm dipstick calibration and adjust, if necessary. Reference Procedure 007-009 Lubricating Oil Dipstick in Section 7 of the corresponding Service Manual.
- Verify if there are any related open field actions.

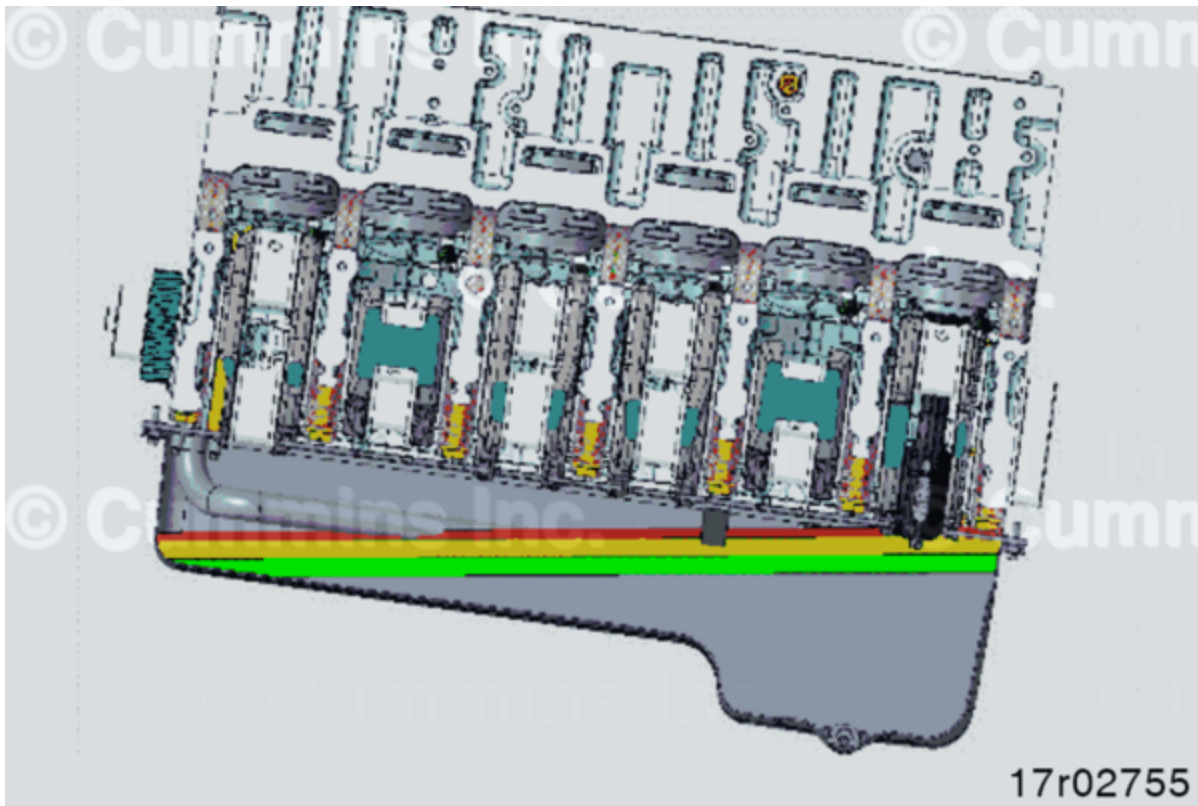
- Transit Application power angles increases the sensitivity of the engine to elevated oil levels, which can lead to the connecting rod dipping into the lubrication oil.

Figure 4, Cross-sectional view showing rear connecting rod interaction with the oil sump when the lubricating oil level exceeds specification.

- This can create additional lubricating oil splash, leading to excess lubricating oil on the liners and potential impact on components.
- This can also lead to an increase in external lubricating oil leaks (lubricating oil pan and rear main seal).
