Technical Service Bulletin: TSB260117

Ignition Coil Ground Wire Removal Procedure

- B6.70 CM3580 B193B

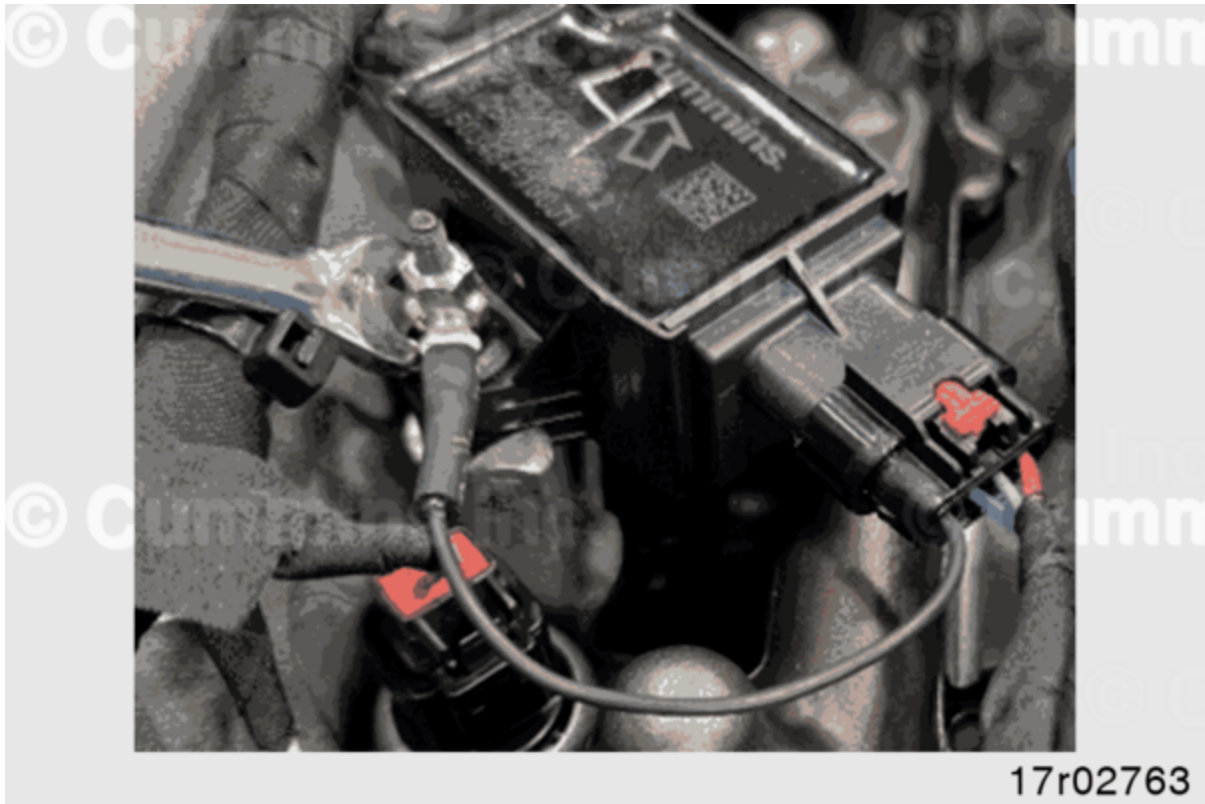
- The nut holding down the ignition coil grounding wire can cause the studded capscrew underneath it to rotate when trying to remove the nut. This can cause the ring terminal on the grounding wire connector to rotate against the side of the ignition coil and cause the ring terminal to break off from the grounding wire. This will only happen during the service event itself and will not occur during normal engine operation.

Figure 1, Hold the studded capscrew underneath the ignition coil grounding wire

Use a second tool to hold the studded capscrew underneath the ignition coil grounding wire to ensure the studded capscrew does not rotate while removing the nut as in Figure 1.
