# Technical Information

## Water Collection in the Rear Doors - Heavy Water Leak when Opening the Rear Doors (70/26)

Model Line: **Cayenne Electric (X1A/X1B)**

Model Year: **2026**

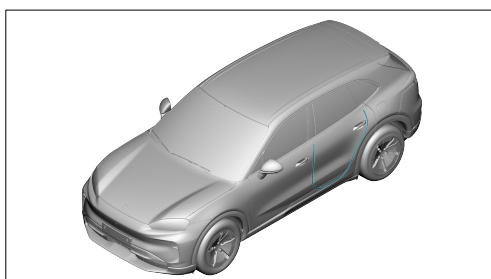
Cause: The water drain holes in the outer door seal at the rear may have been drilled incorrectly. As a result, water may collect in the sill area and drain out when the door is opened. Due to the design, no water can penetrate into the passenger compartment.

Installation position outer seal for rear door

Action: Replace the outer rear door seal at the affected rear door and then perform a water test.
