# RCA-78-26-001-1: Loose or Cross-Threaded Instrument Panel Ground Nut

| Document Type | Customer Satisfaction Campaign Bulletin |
| Affected Model(s) | R1T, R1S |
| Vehicle System | 78 - Low Voltage Electrical |

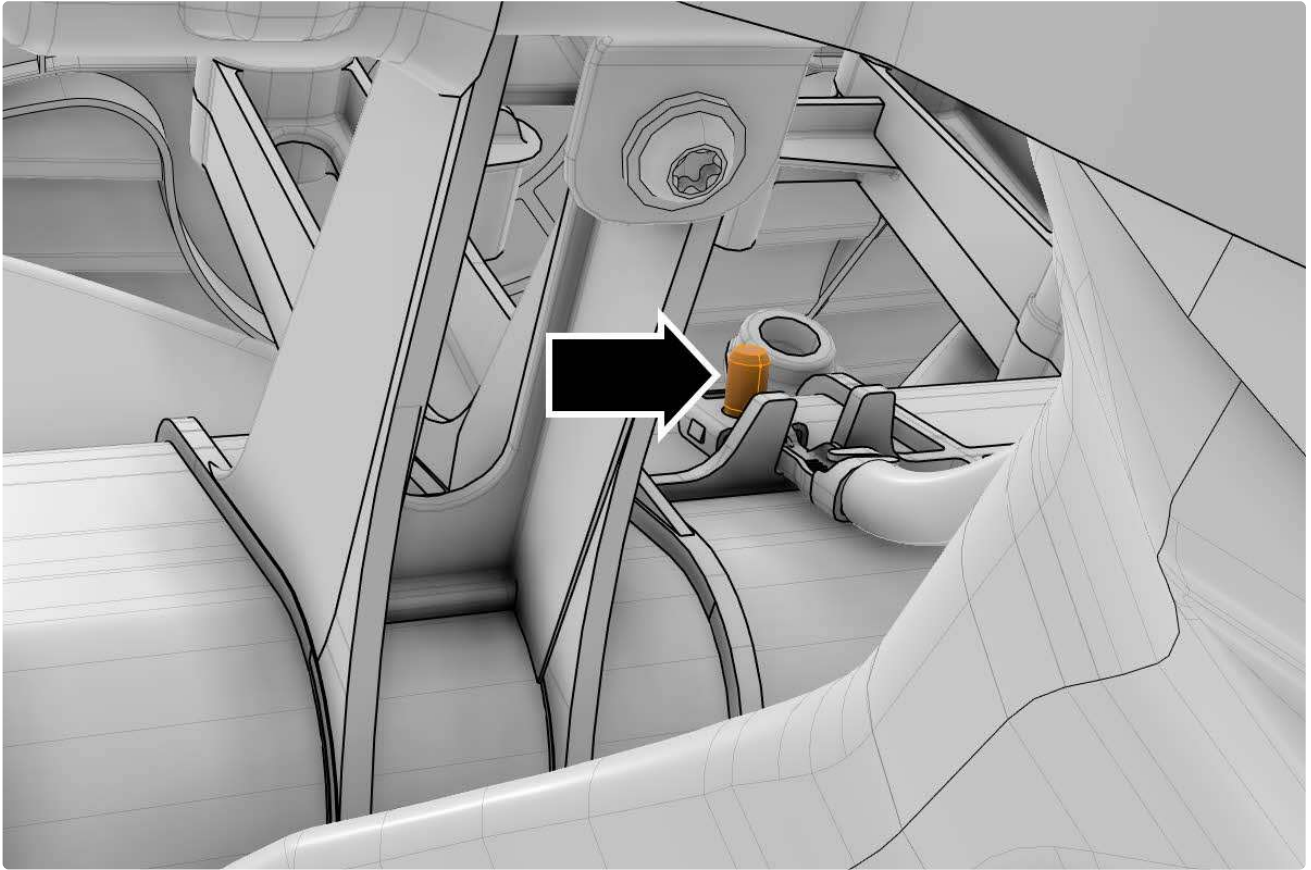
5. Inspect the threads on the stud for damage.

- 6.
- If there is no thread damage: Continue to the next step.
  - If the threads are damaged and appear to be repairable: Skip to the [Repair Threads](#) section.
  - If the threads are damaged and do not appear to be repairable: Skip to the [Replace Stud](#) section.

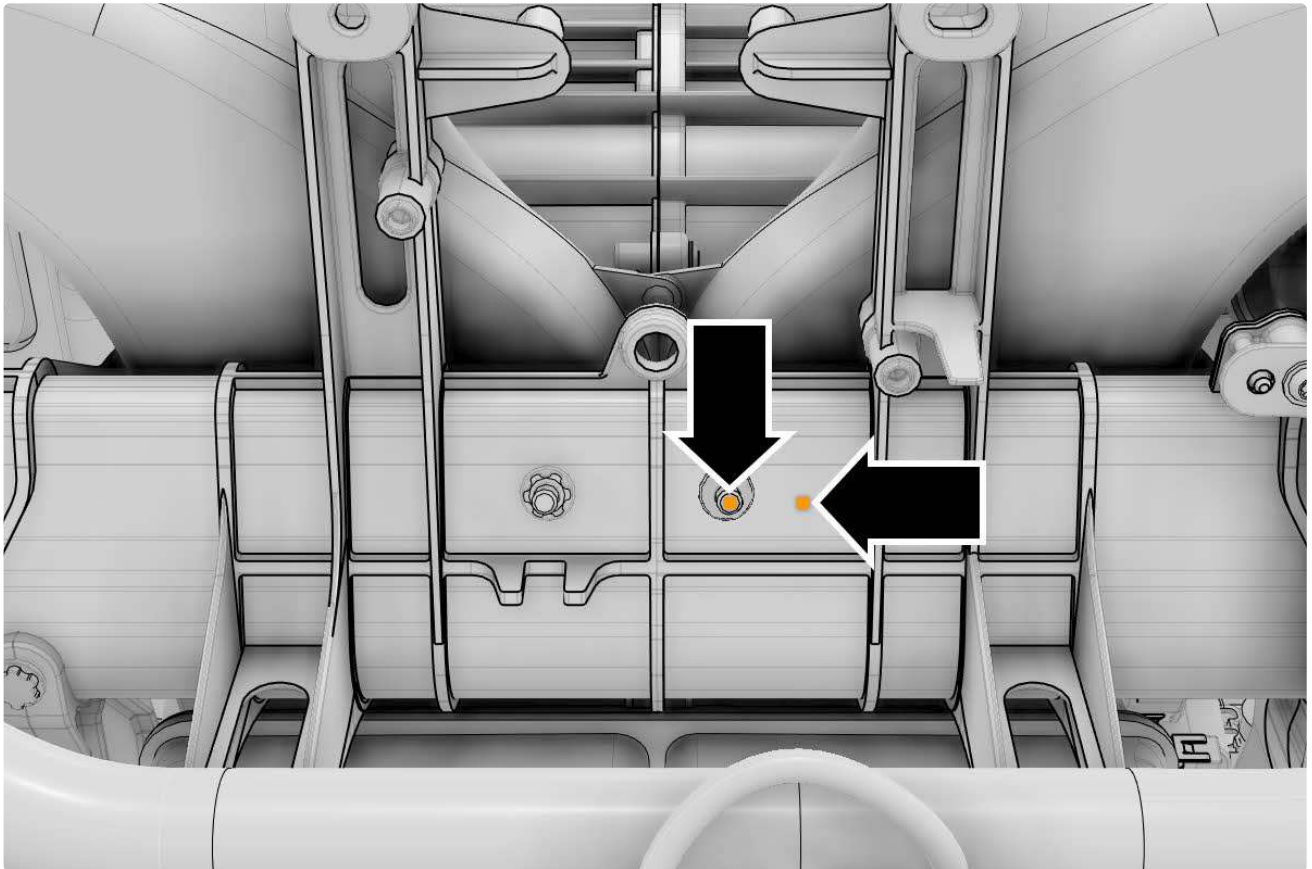
7. Check resistance. Measure between the points shown.

- 8.
- If resistance is 0  $\Omega$ : Continue to the next step.
  - If resistance is more than 0  $\Omega$ : Skip to the [Replace Beam](#) section.
