# Whine or Grind Noise From the Transaxle

**Service Category** Drivetrain

**Section** CVT

## Introduction

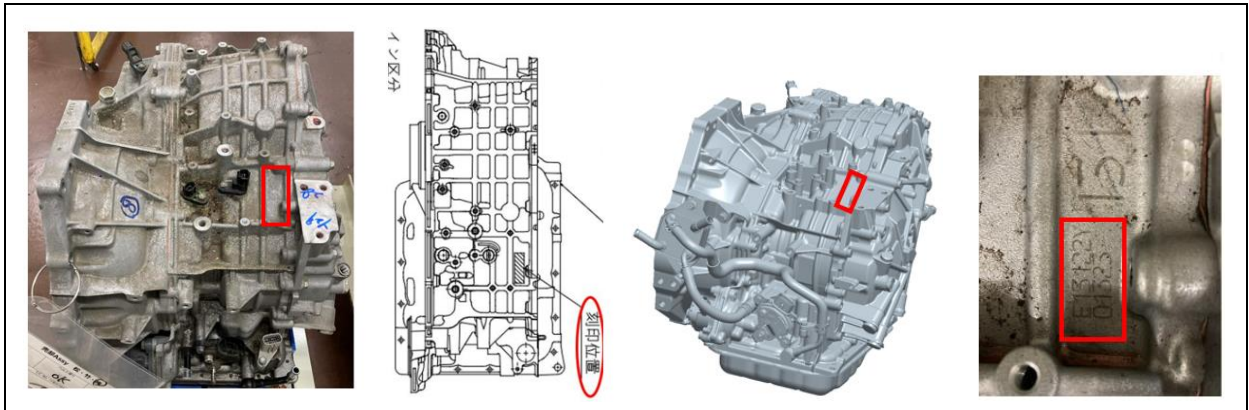
1. Locate the transaxle serial number, found on the top of the housing as shown in Figure 1.
