# Head Unit Software Update Version 8612G42397 via OTA and USB (Panasonic)

| YEAR(S) | MODEL(S) | ADDITIONAL INFORMATION |
|---|---|---|
| 2026 | RAV4 HV, RAV4 PHV | |

A head unit software update (version 8612G42397) is now available for 2026 model year RAV4 Hybrid, and RAV4 Plug-in Hybrid vehicles via OTA or USB.

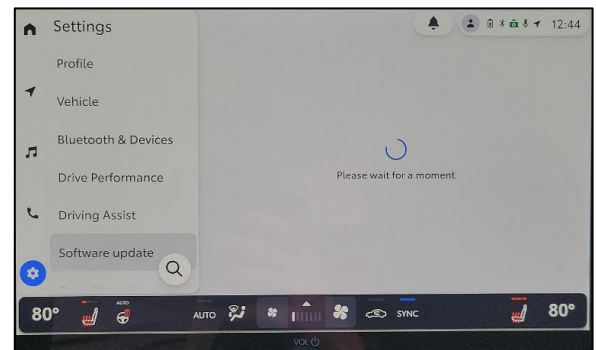
**Figure 4.**

2. If the Software update menu displays the message "Please wait for a moment" as seen in Figure 4, go to the Software Update Menu Repair Procedure section on page [6](#).

1. Prepare a USB flash drive with the menu repair file from Table 1.
2. Turn the vehicle OFF.
3. Is the vehicle equipped with JBL audio?
  - **YES** — Continue to step 4.
  - **NO** — Go to step 5.
4. Remove the 30A amplifier fuse from the power distribution box assembly.  
Refer to TIS, applicable model and model year Repair Manual:
  - [2026](#) RAV4 HV and RAV4 PHV:  
*Power Source / Network – Power Distribution – Power Integration System – Parts Location*
5. Insert the USB drive.
6. Turn the vehicle Ready ON.
