# CUSTOMER SATISFACTION NOTIFICATION

## Powertrain Modules Software Update

Reference: 74D

2024 – 2026 (LB) Dodge Charger

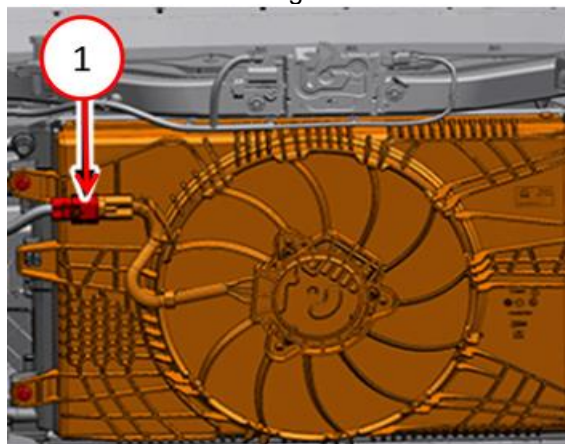
**Fig 1. Cooling Fan Assembly**

**NOTE:** The cooling fan must be disconnected to prevent it from powering on, which may interrupt/ abort the flash process.

3. Disconnect the cooling fan wire harness connector Fig. 1

69. Position the rear carpet in place.
70. Connect the cooling fan wire harness connector Fig. 1.
71. Install the front storage bin. Refer to the detailed service procedures available in DealerCONNECT/ServiceLibrary under: Service Info> 23 - Body / Exterior / Bin, Storage / Installation
72. Click "**View DTCs**", select "**Clear All DTCs**", click "**Continue**" and then click "**Close**".
73. Place the ignition in the "**OFF**" position and then remove the wiTECH MicroPod II or MDP device from the vehicle.
74. Return the vehicle to the customer.

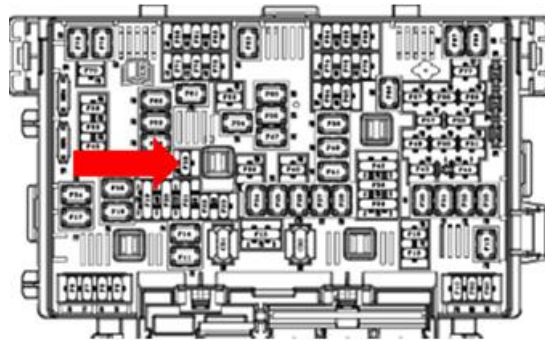
**Fig 3. #38 AGSM Fuse Location LB Model**

**CAUTION:** Failure to remove the #38 or the #32 AGSM fuse will result in damage to the shifter.

5. **LB Model:** Remove the PDC cover, locate and remove the #38 AGSM fuse Fig. 3,

**NOTE: If the Wheel End Disconnect Position Learn routine is not successful, roll the vehicle slightly forward so that the wheel end disconnect actuators can align on the spline before attempting to perform the routine again.**
68. Install the #38 AGSM fuse Fig. 3 for LB model and install the PDC cover or fuse # 32 for KM model and install the PDC cover and right side cowl cover Fig. 4.
