**Technical Service Bulletin (TSB)**  
**Rear Cradle Weld Missing**

| REFERENCE: | TSB: 17-003-26<br>GROUP: 17 - Rear Suspension | Date: | September 1, 2026 | REVISION: | — |
| VEHICLES AFFECTED: | 2026 (WD) Dodge Durango<br>This bulletin applies to vehicles built on or after January 29, 2026 (MDH 0129XX) and on or before January 30, 2026 (MDH 0130XX) equipped with a 3.6L V6 24V VVT Engine Upg I w/ESS (Sales Code ERC) or 5.7L V8 Hemi MDS VVT Engine (Sales Code EZH). | | | MARKET APPLICABILITY:<br><div><input checked="" type="checkbox"/> NA<input type="checkbox"/> CH</div> <div><input type="checkbox"/> EE<input type="checkbox"/> IAP</div> <div><input type="checkbox"/> SA<input type="checkbox"/> MEA</div><br><b>NOTE:</b> This bulletin applies to the North American market. | |

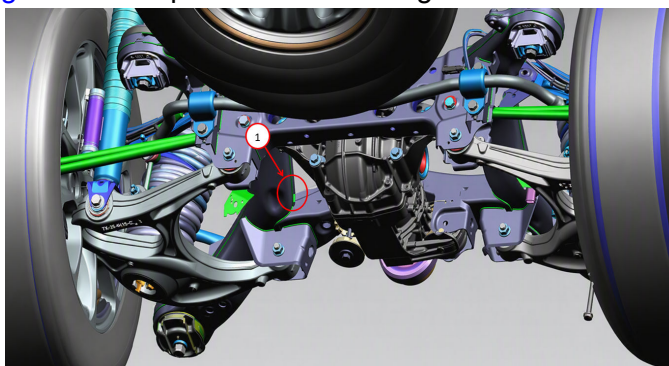
**Fig. 1**  
Rear Cradle LH Crossmember Upper Weld

1- Rear Cradle LH Crossmember Upper Weld Location

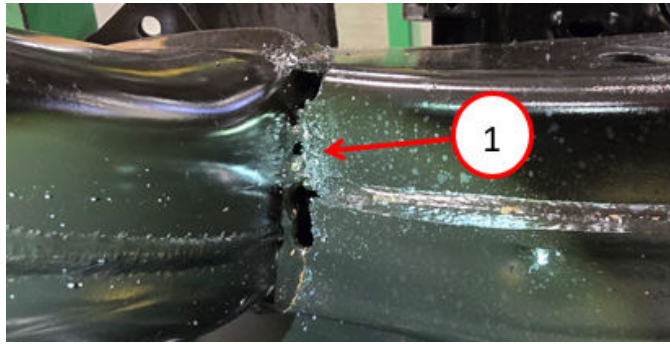
1 - Weld With Porosity And Burn Through

5. Based on the measurement and visual comparison, was the weld acceptable, undersized, bad, or missing?
  - YES >>> Document the bad weld with the clear photo. Add the photo to the claim file; and then proceed to [Step 6](#).
  - NO >>> This bulletin is complete. Use Inspect LOP (13-30-01-9G) to close this active RSU.
6. Remove the rear crossmember. Refer to the detailed service procedures available in DealerCONNECT/Service Library under: 13 - Frame and Bumpers / Frame / Crossmember, Rear / Removal.
7. Install the **NEW** rear crossmember and listed parts. Refer to the detailed service procedures available in DealerCONNECT/Service Library under: 13 - Frame and Bumpers / Frame / Crossmember, Rear / Installation.

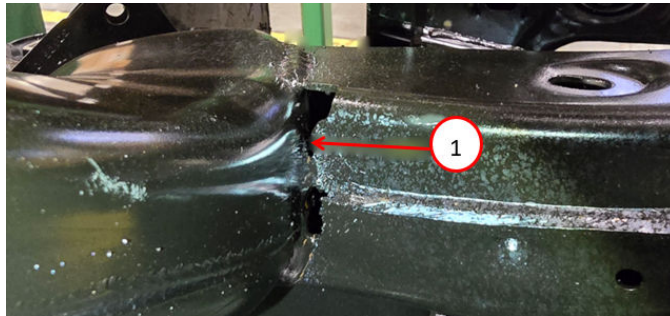
1 - Partial Weld With Burn Through

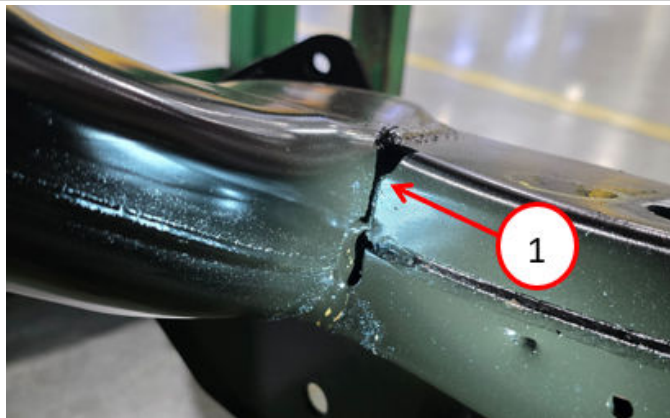
1 - Lack Of Weld Due To Burn Through

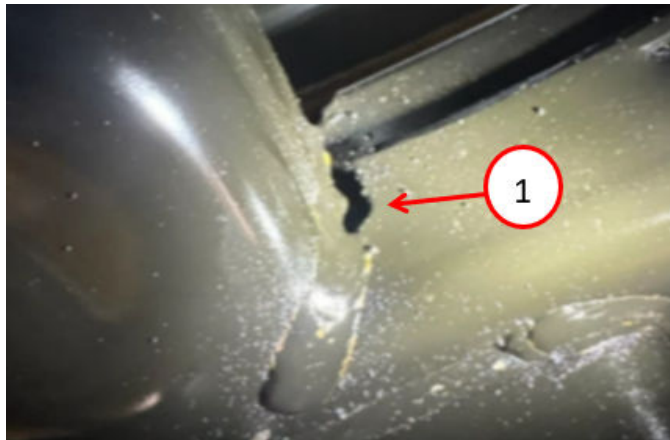
1 - Lack Of Weld With Burn Through And Large Gap
