## Technical Service Bulletin (TSB)

### Oil Leak Through The Rear Crankshaft Oil Seal (Flywheel Side)

| REFERENCE: | TSB: 09-010-26 REV. B<br>GROUP: 09 - Engine | Date: | September 5, 2026 | REVISION: | 09-010-26 REV. A |
| VEHICLES AFFECTED: | 2025 - 2027 (B1) Jeep Renegade<br>2025 - 2027 (H1) Jeep Commander<br>2025 - 2027 (M1) Jeep Compass<br>This bulletin applies to vehicles built on or after July 07, 2025 (MDH 0707XX) and on or before February 20, 2026 (MDH 0220XX). | | | MARKET APPLICABILITY:<br><div><input checked="" type="checkbox"/> NA<input type="checkbox"/> MEA</div> <div><input type="checkbox"/> EE<input type="checkbox"/> IAP</div> <div><input checked="" type="checkbox"/> SA<input type="checkbox"/> CH</div><br>NOTE: This bulletin applies to North and South America markets. | |

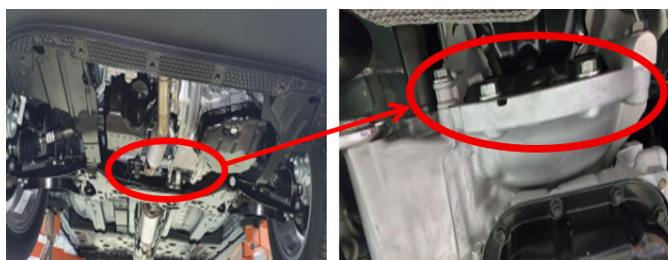
**Fig. 1**  
Area For Oil Leaks

1. Start the vehicle and after 20 seconds at idle, accelerate to 3500 rpm for three minutes then turn off the vehicle.
2. Raise and support the vehicle. Refer to the detailed service procedures available in DealerConnect> Service Library under: Service Info> 04 - Vehicle Quick Reference/Hoisting/Standard Procedure.
3. Check for the presence of oil in the engine area coupling between the engine and transmission, and the flywheel seal area [Fig. 1](#).

4. Is there presence of oil in the coupling area between the engine and transmission [Fig. 1](#)?
  - YES >>> Proceed to [Step 5](#).
  - NO >>> Lower the vehicle. This bulletin has been completed, use Inspect LOP (09-25-75-9A) to close the active RSU.
5. Replace the rear crankshaft oil seal (flywheel side). Refer to the detailed service procedures available in DealerCONNECT/Service Library under: 1020D39 - Retentor Traseiro - Lado Volante - Remoção/Recolocação e Substituição, para Veículos com Câmbio Automático. Incluso Procedimentos Necessários.
