**Technical Service Bulletin (TSB)**  
**Flash: Vehicle System Interface Module (VSIM) Updates**

| REFERENCE: | TSB: 08-331-26<br>GROUP: 08 - Electrical | Date: | September 11, 2026 | REVISION: | — |
| VEHICLES AFFECTED: | 2025 - 2026 (DJ) RAM 2500 Pickup<br>2025 - 2026 (DD) RAM 3500 Cab Chassis<br>2025 - 2026 (DP) RAM 4500/5500<br>2025 - 2026 (D2) RAM 3500 Pickup<br>This bulletin applies to vehicles built on or before January 10, 2026 (MDH 0110XX) equipped with Upfitter Electronic Module (VSIM) (Sales Code XXS). | | | MARKET APPLICABILITY:<br><div><input checked="" type="checkbox"/> NA<input checked="" type="checkbox"/> MEA<br/><input type="checkbox"/> SA<input type="checkbox"/> IAP<br/><input checked="" type="checkbox"/> EE<input type="checkbox"/> CH</div><br>NOTE: This bulletin applies to the North America, Enlarged Europe and Middle East & African markets. | |

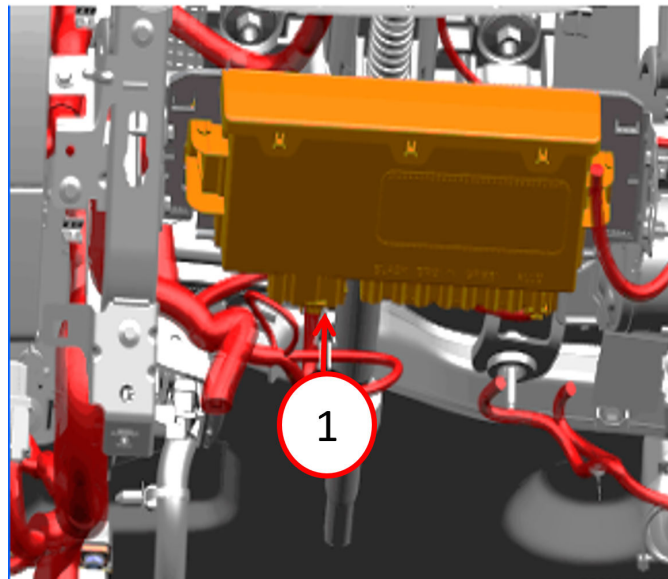
**Fig. 1**  
VSIM

1 - VSIM Connector To Disconnect

1. Is the VSIM communicating on BUS?
  - YES >>> Proceed to [Step 6](#).
  - NO >>> Proceed to [Step 2](#).
2. Disconnect and isolate the negative battery cable(s). Refer to the detailed service procedures available in DealerConnect> Service Library under: Service Info> 08 - Electrical / 8F - Engine Systems / Battery System / Battery / Removal.
3. Disconnect the VSIM connector [Fig 1](#) for 60 seconds and reconnect.
