**Technical Service Bulletin (TSB)**  
**Steel Hood Vent Gap**

| REFERENCE: | TSB: 23-039-26<br>GROUP: 23 - Body | Date: | September 9, 2026 | REVISION: | — |
| VEHICLES AFFECTED: | 2026 (JL) Jeep Wrangler<br>This bulletin applies to vehicles built on or after February 03, 2026 (MDH 0203XX) and on or before April 02, 2026 (MDH 0402XX) equipped with Steel Performance Hood Package (Sales Code ALZ). | | | MARKET APPLICABILITY:<br><div><input checked="" type="checkbox"/> NA<input type="checkbox"/> CH</div> <div><input checked="" type="checkbox"/> EE<input checked="" type="checkbox"/> IAP</div> <div><input checked="" type="checkbox"/> SA<input checked="" type="checkbox"/> MEA</div><br><b>NOTE:</b> This bulletin applies to the North and South America, Enlarged Europe, India & Asia Pacific and Middle East & Africa markets. | |

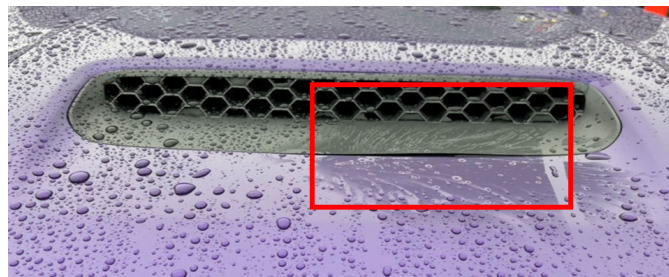
| CUSTOMER SYMPTOM: | Customers may comment on one or more of the following: <ul style="list-style-type: none"><li>● Gap between Steel Hood Vent and Performance Hood <a href="#">Fig. 1</a>.</li><li>● Buzz, squeak and rattle noise.</li><li>● Hood pad water soaked after rain.</li><li>● Water leak through into the engine compartment.</li></ul> | | | | |
| CAUSE: | Stamping Issue | | | | |

**Fig. 1**  
Hood Vent Unseseated

1. Inspect for a gap between plastic hood vent and steel Rubicon hood [Fig. 1](#).
2. Is there a gap between plastic hood vent and steel Rubicon hood?
  - YES>>> Proceed to [Step 3](#).
  - NO>>> This bulletin does not apply. Use Inspect LOP (23-09-57-90) to close this active RSU.
3. Open the hood of the vehicle.
4. Remove hood pad push pins [Fig. 2](#).
