| REFERENCE: | TSB: 23-043-26<br>GROUP: 23 - Body | Date: | September 11, 2026 | REVISION: | — |
| VEHICLES AFFECTED: | 2026 (JL) Jeep Wrangler<br>This bulletin applies to vehicles built on or after June 29, 2026 (MDH 0629XX) and on or before July 17, 2026 (MDH 0717XX) equipped with the 6.4L V8 SRT HEMI MDS Engine (Sales Code ESG). | | | MARKET APPLICABILITY:<br><div><input checked="" type="checkbox"/> NA<input type="checkbox"/> CH</div> <div><input type="checkbox"/> EE<input type="checkbox"/> IAP</div> <div><input type="checkbox"/> SA<input type="checkbox"/> MEA</div><br><b>NOTE:</b> This bulletin applies to the North America market. | |
| CAUSE: | PCM bracket not secure | | | | |

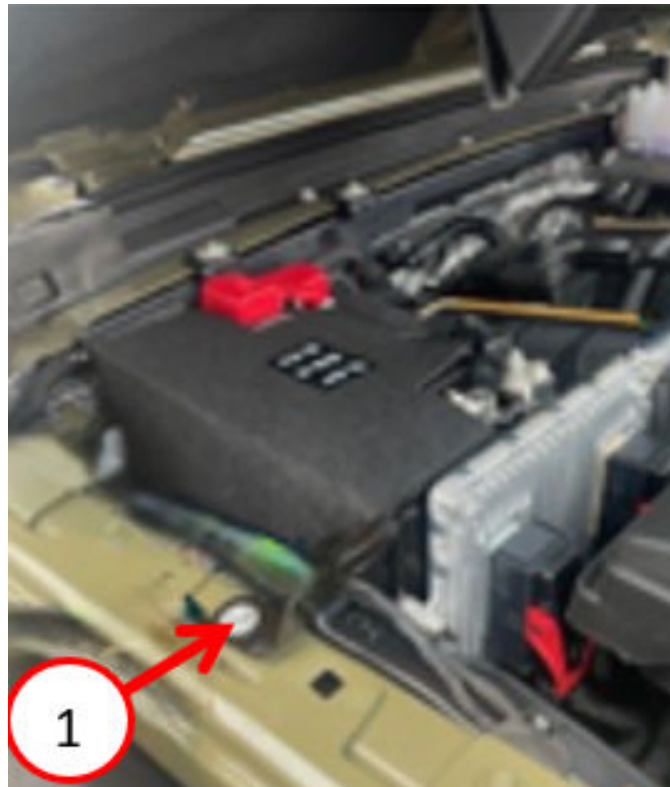
**Fig. 1**  
PCM Bracket Bolt

1. Raise the hood and locate the PCM bracket bolt (right front inner fender) [Fig. 1](#).

1 - PCM Bracket Bolt

6. Reposition the PCM bracket and reinstall the bolt [Fig. 1](#).

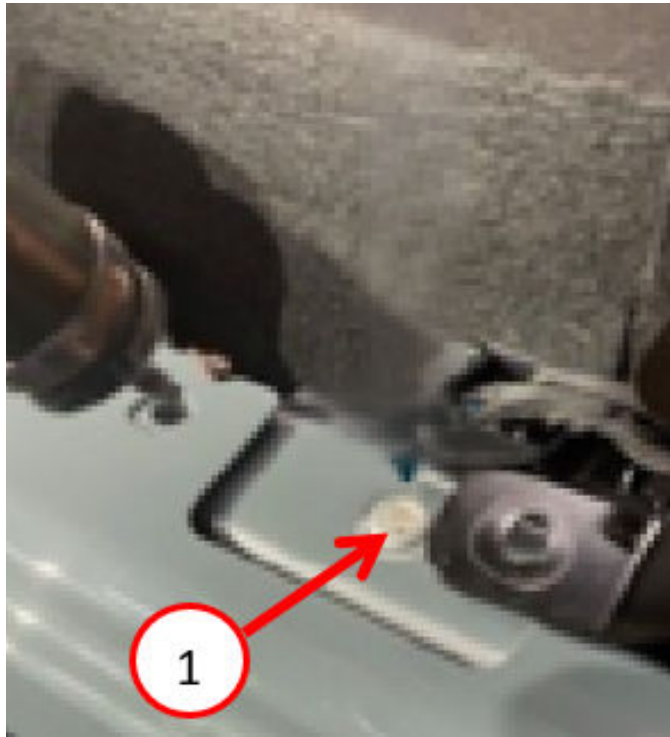
**Fig. 2**  
Riv-Nut

1 - Riv-Nut

4. Remove PCM bracket bolt and move the PCM bracket forward to access the riv-nut. [Fig. 2](#).
