Altec Industries, Inc. has issued a **customer satisfaction campaign** as described in the included Service Information Letter (SIL). According to our records, you own one or more units this applies to.

## Bolt Contacting Chassis U-Bolt Inspection

**Units Affected:** Certain AT37/41/48 units on small duty Ford and Dodge chassis, built from December 2017 to May 2025. Verify your unit is affected by reviewing the attached list or accessing Altec Connect.

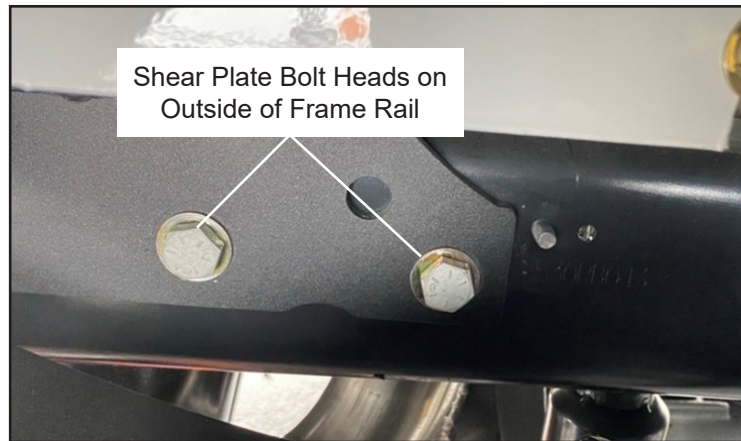
**Figure 3 — Shear Plate Bolts with Heads Outside**

4. Inspect the orientation of the bolts in the shear plate above the rear axle suspension (refer to Figures 3 and 4).
  - If all the shear plate bolts are installed with the heads on the outside of the frame rail, the clearance is adequate. Proceed to step 14.
  - If any of the bolts are installed with the heads on the inside, continue to the next step.

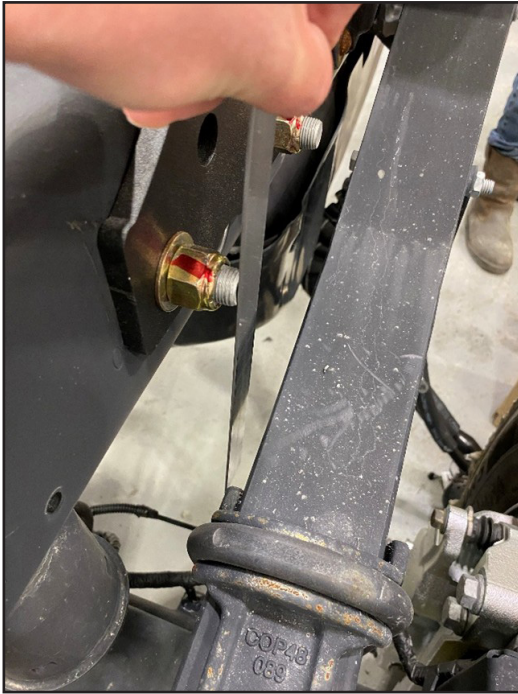
**Figure 5 — Adequate Clearance**

5. For each shear plate bolt with the head on the inside, use a flat edge to determine if there is horizontal clearance between the suspension components and the frame rail bolt so that if the suspension were to travel vertically, there would not be contact (refer to Figures 5 and 6).
  - a. Place the flat edge on the part of the fastener closest horizontally to the suspension components.
  - b. Move the flat edge directly and vertically down to the closest horizontal suspension component.

- c. Alternatively, place the flat edge on the suspension part that is closest horizontally to the frame rail and bolts, and move the edge directly up to the bolts.
- If the flat edge can move past the opposite horizontally-nearest component without touching, mark the clearance as adequate and proceed to step 14.
  - If the flat edge touches or cannot move past the opposite horizontally-nearest component for any tested bolt, continue to the next step.

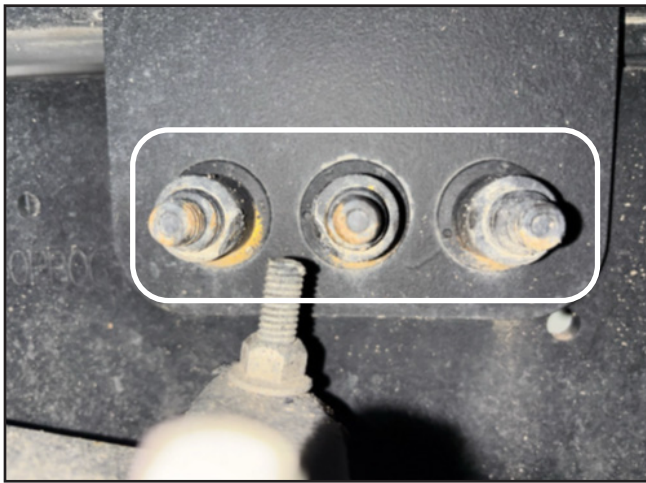
**Figure 9 — Huck Bolt Damage**

7. If a SuperSpring has been installed, check for damage to the SuperSpring and shear plate bolts (refer to Figures 9 to 11).

- a. To ensure that damage is visible, clean off any dirt or debris on the suspension components below the shear plate bolts using an appropriate method.
- b. Using a flashlight, look at the top of all the suspension components that could potentially contact a shear plate bolt end, collar, or hex nut.
- c. Inspect the suspension for damage due to contact with the shear plate bolt end, collar, or hex nut.
- d. Make note that the clearance is not adequate and repair will be needed. Bolts will need to be flipped and SuperSpring may need replaced depending on damage inspection. Proceed to step 14.

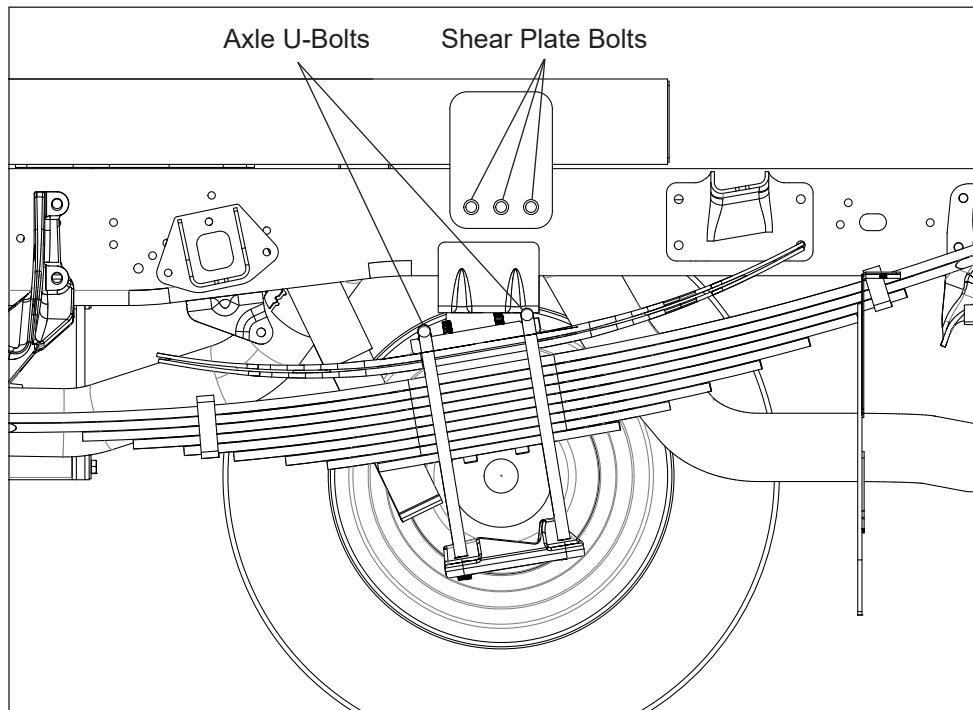
**Figure 12 — Shear Plate Bolts Located Above Axle U-Bolts**

8. If a SuperSpring has not been installed:
  - If the vehicle is an AT48 unit, proceed to step 9.
  - If the unit is an AT37 or AT41, continue to step 10.
9. Inspect the location of the shear plate bolts versus the rear axle U-bolts.
  - a. If any of the shear plate bolts are located in the region directly above the top of either axle U-bolt (refer to Figure 12), continue to the next step.

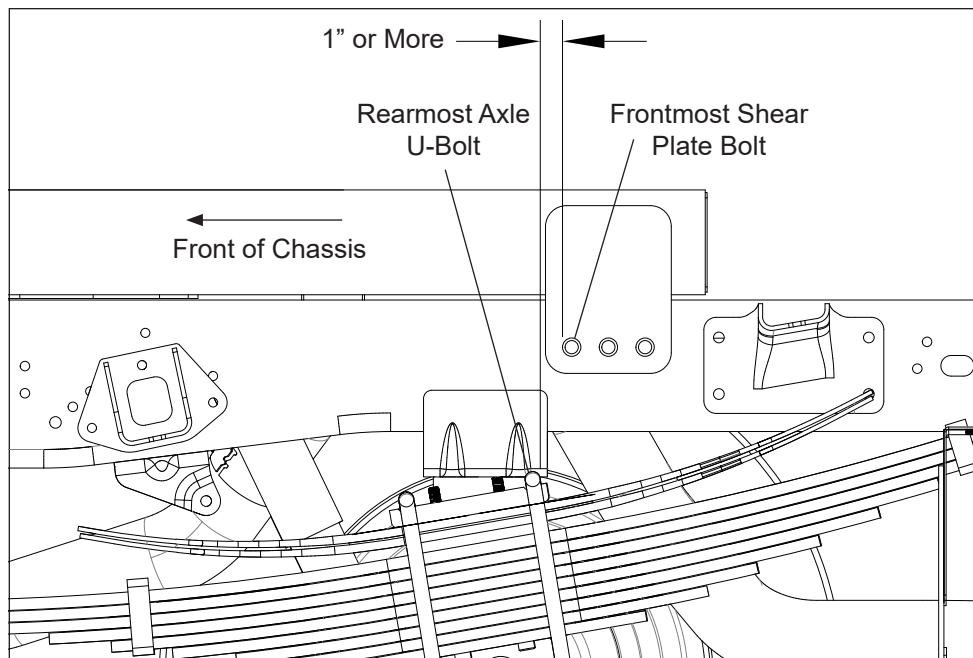
**Figure 13 — Shear Plate Bolts Located Behind Axle U-Bolts**

- b. If the frontmost shear plate bolt is located with a horizontal spacing of 1" or more behind the back or rear of the rearmost axle U-bolt (refer to Figure 13), mark them as having adequate clearance. If there is less than 1", continue to the next step.
    - c. If the rearmost shear plate bolt is located with a horizontal spacing of 2" or more in front of the back or rear of the frontmost axle U-bolt (refer to Figure 14), mark them as having adequate clearance. If there is less than 2", continue to the next step.
      - If **all** of the bolts are found to have adequate clearance, proceed to step 14.
      - If **any** of the bolts are found to have inadequate clearance, continue to step 10.

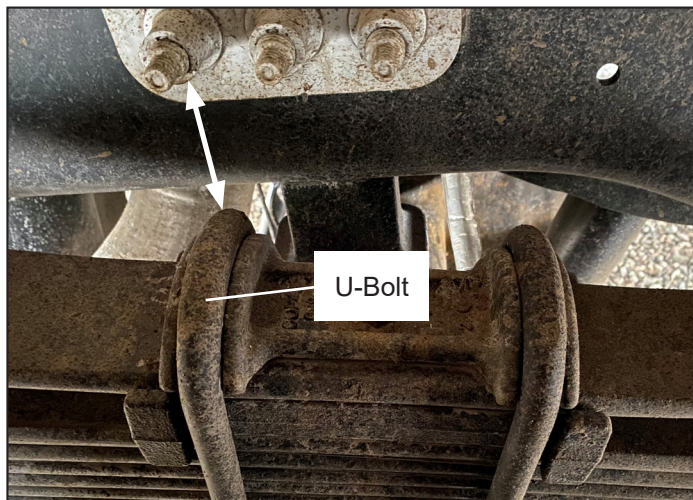
**Figure 19 — Measuring for U-Bolt Clearance Number**

12. Determine the contact clearance number by identifying the nearest part of the shear plate bolt (Huck bolt/collar or bolt/hex nut) located above the rear suspension that will make contact if the suspension goes through the full range of motion.

- Measure the vertical distance from the closest point of potential contact on the suspension to the bottom of the nearest part of the shear plate bolt (refer to Figure 19).

- Subtract  $\frac{1}{2}$ " from the measurement as a safety factor to determine the contact clearance number.
  - Enter this number in column B of the table in Figure 18 in the row of the chassis side currently being inspected.

- For AT48 units, if any damage is observed on shear plate bolts, try to turn the bolt/huck bolt by hand. If the bolt rotates, then it has lost clamp load, and the unit must be taken out of service. If the bolts cannot rotate, continue to inspect bolts at each daily preoperational inspection. If clamp load is lost, the unit must be taken out of service.
