## TECHNICAL SERVICE BULLETIN

### Stuck In Park, "Service Vehicle Soon" Message In The IPC, Illuminated Powertrain Malfunction (Wrench) Indicator With DTC P07E6:71 Stored In The SOBDMC

**26-2421**

17 September  
2026

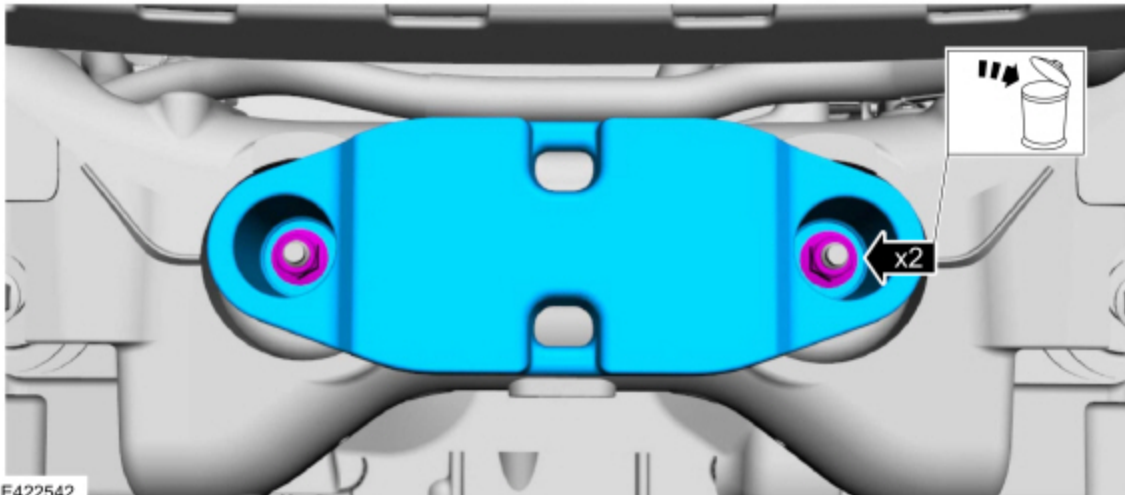
Figure 4

7. Is the vehicle equipped with a mass damper as shown in Figure 4?

(1). Yes - remove and discard the nuts, remove the mass damper.
