SUBJECT: **DEMONSTRATION / DELIVERY HOLD - Application Performance Upgrade 12A04
– Supplement #4**
Certain 2011-*2014* Model Year Vehicles Equipped with SYNC® and MyFord/MyLincoln Touch™
Application Performance Upgrade

DEMONSTRATION / DELIVERY HOLD –
Application Performance Upgrade 12A04 – Supplement #4
Certain 2011-2014 Model Year Vehicles Equipped with SYNC® with MyFord/MyLincoln Touch™
Application Performance Upgrade

CERTAIN 2011-2014 MODEL YEAR VEHICLES EQUIPPED WITH SYNC® AND MYFORD/MYLINCOLN TOUCH™ — APPLICATION PERFORMANCE UPGRADE

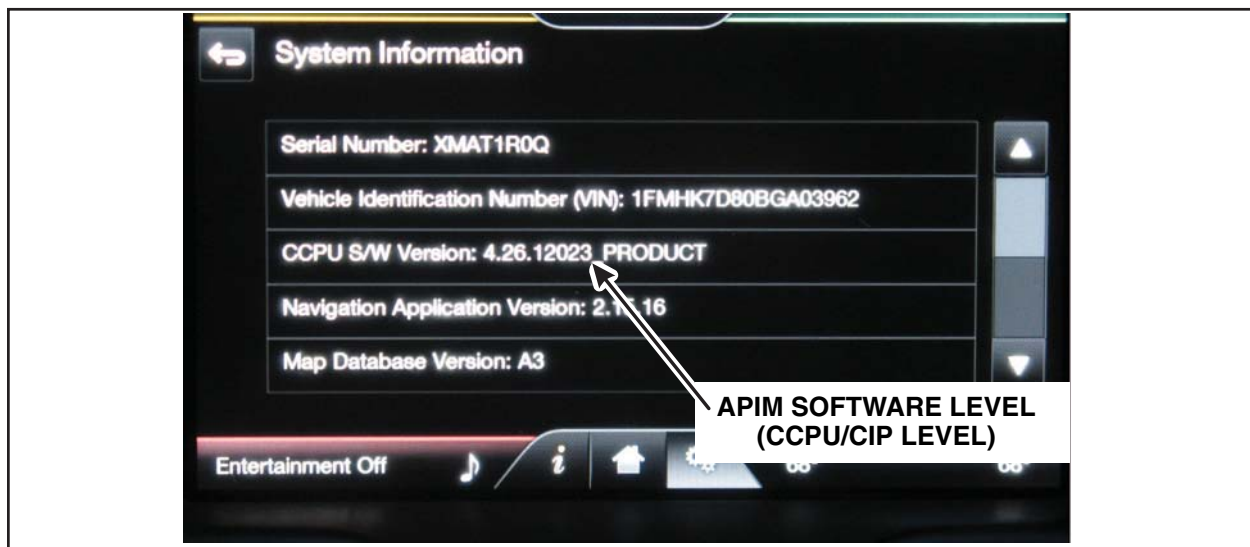
FIGURE 1

1. Determine the vehicle's current Accessory Protocol Interface Module (APIM) software level (CCPU/CIP level). See Figure 1.
 - a. On the Front Display Interface Module (FDIM), select "Menu" then select "Help".
 - b. Select "System Information".
 - c. Note the last five digits of the CCPU/CIP#. See Figure 1.
- If the last five digits **are "13171"** or higher, the APIM is at the latest level. Return the system to the home screen, and release the vehicle to the customer.
- If the last five digits **are less than "13171"** (e.g. 12023), proceed with the Service Procedure.

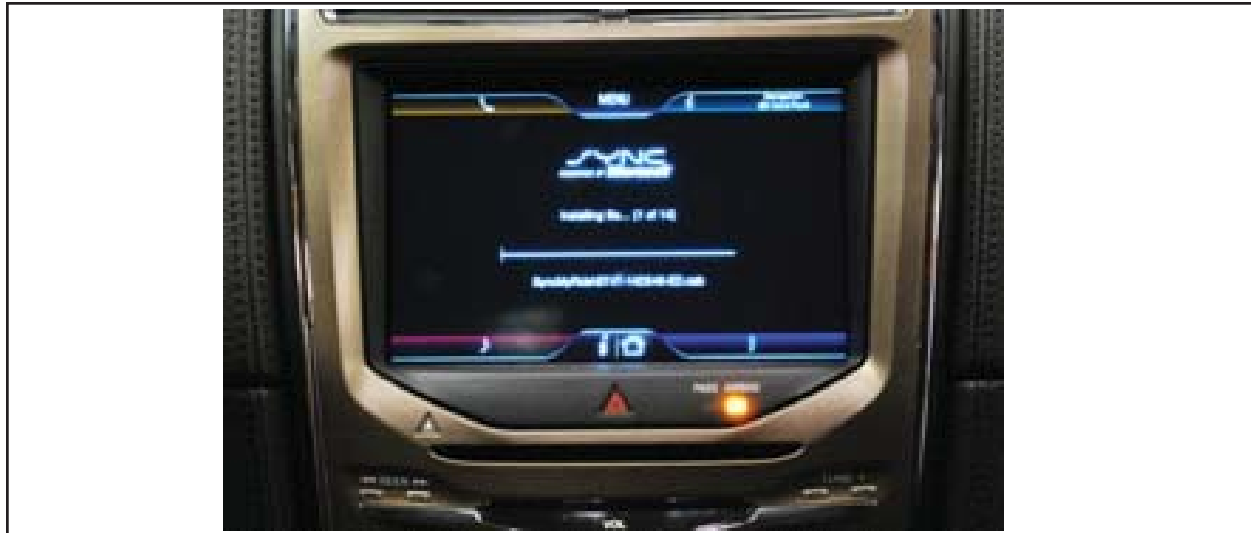
FIGURE 2

1. Start the vehicle so that the battery saver mode will not activate while performing the reprogramming procedure.
2. Wait for the system to boot up, remove any connected devices, and for the home screen to appear on the FDIM.
3. Install the USB drive containing *BD/13171/V3.6.2* software level into one of the vehicle's USB ports. The reprogramming procedure will start automatically. See Figure 2.

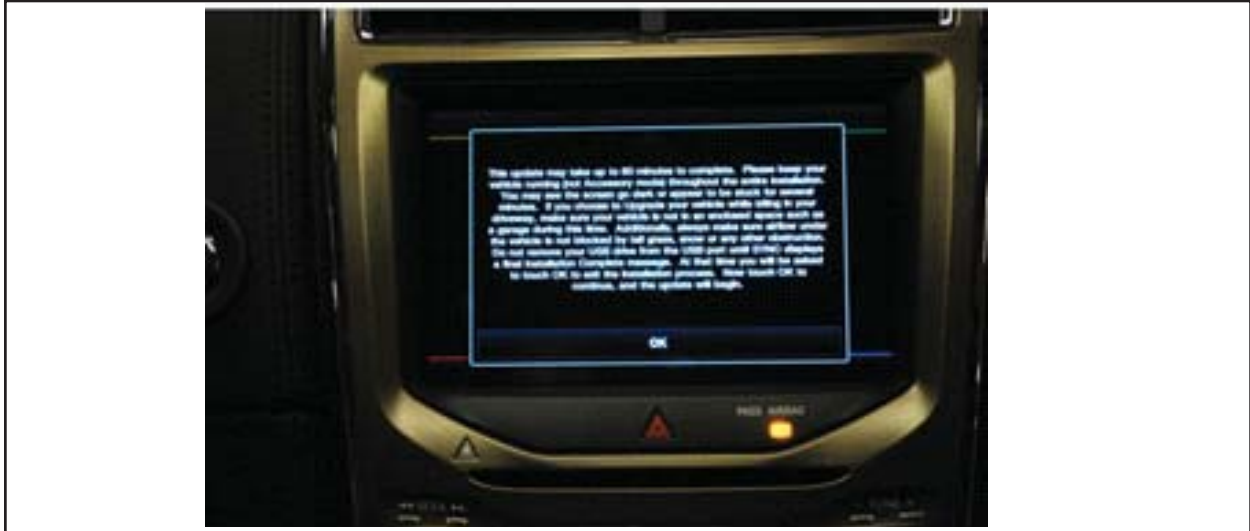
FIGURE 3

4. After the installation starts, a verbal and onscreen message will confirm that the installation is about to start, tap "OK". See Figure 3.

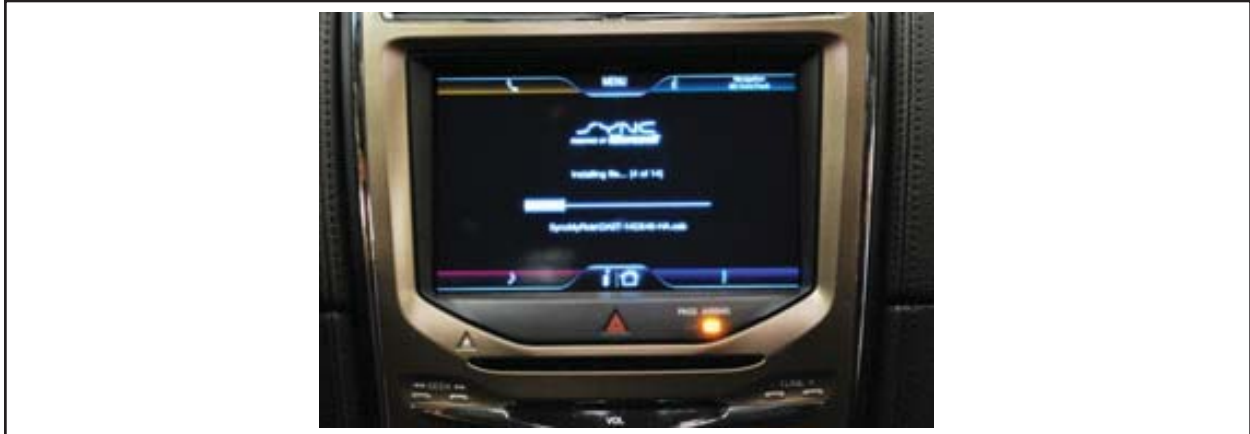
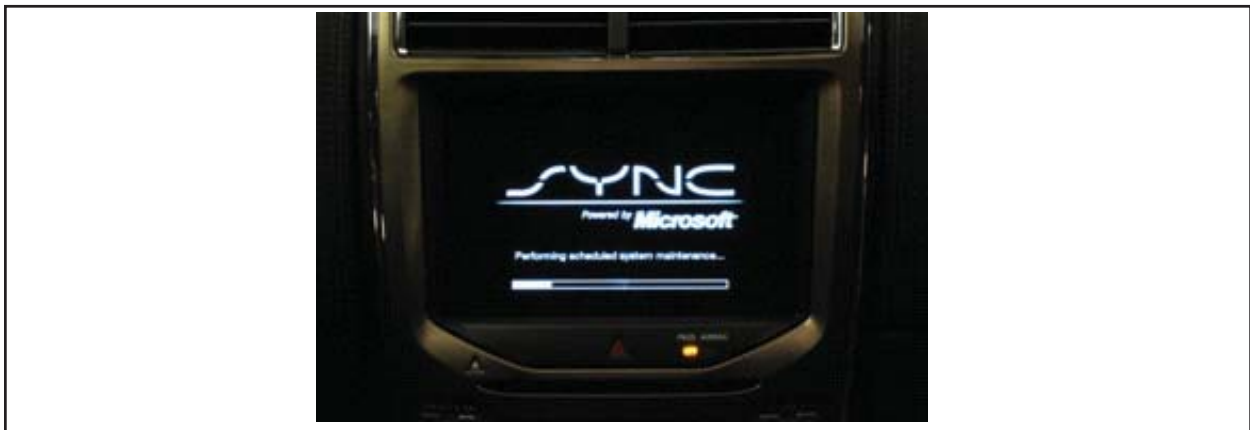
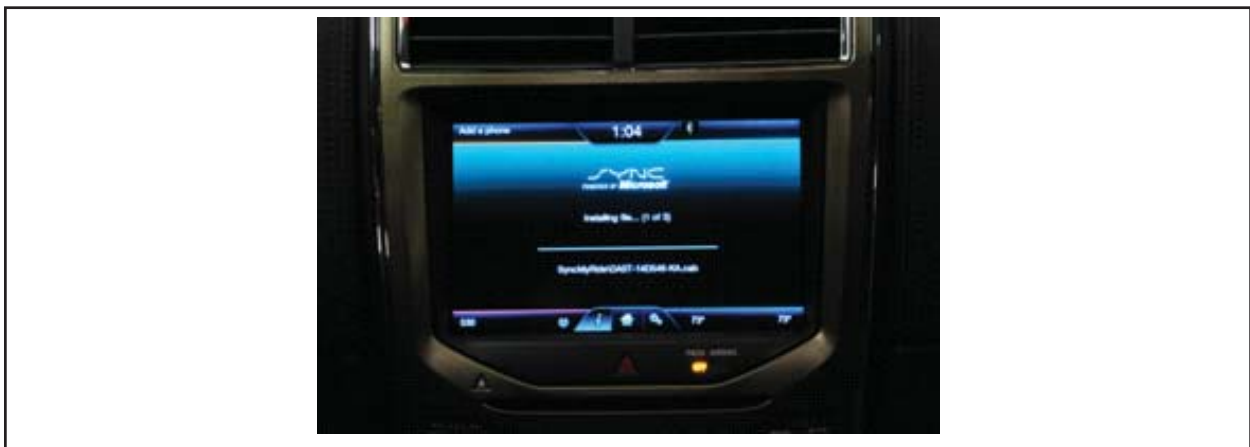
5. During the reprogramming process a series of screens may appear and/or the system will reboot with a blank screen. See Figures 4, 5, and 6.

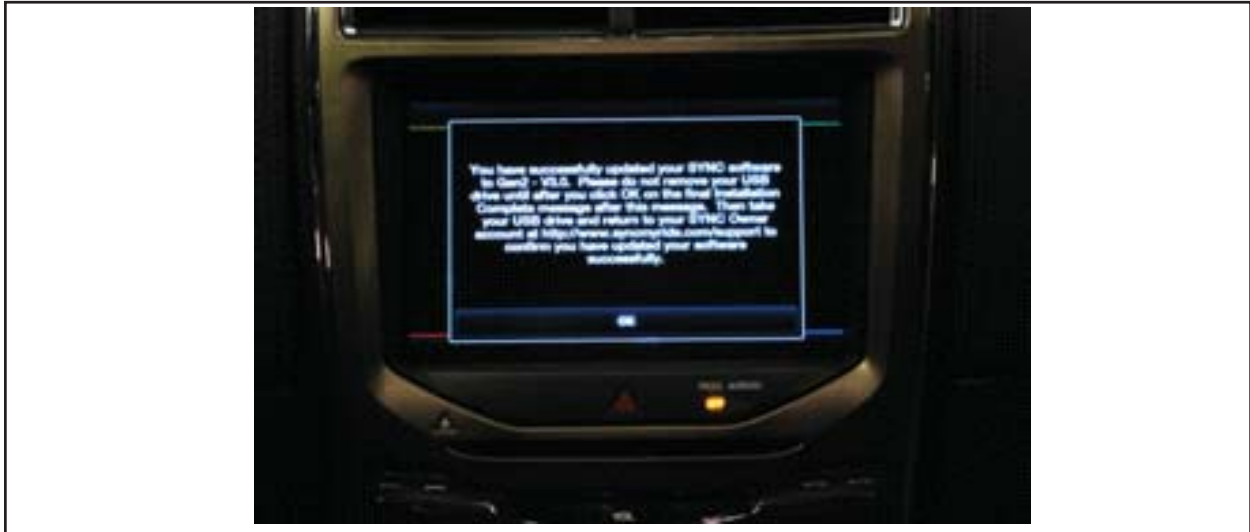
FIGURE 7

6. When the programming is completed, a screen stating the software update was successful will appear, tap "OK". See Figure 7.

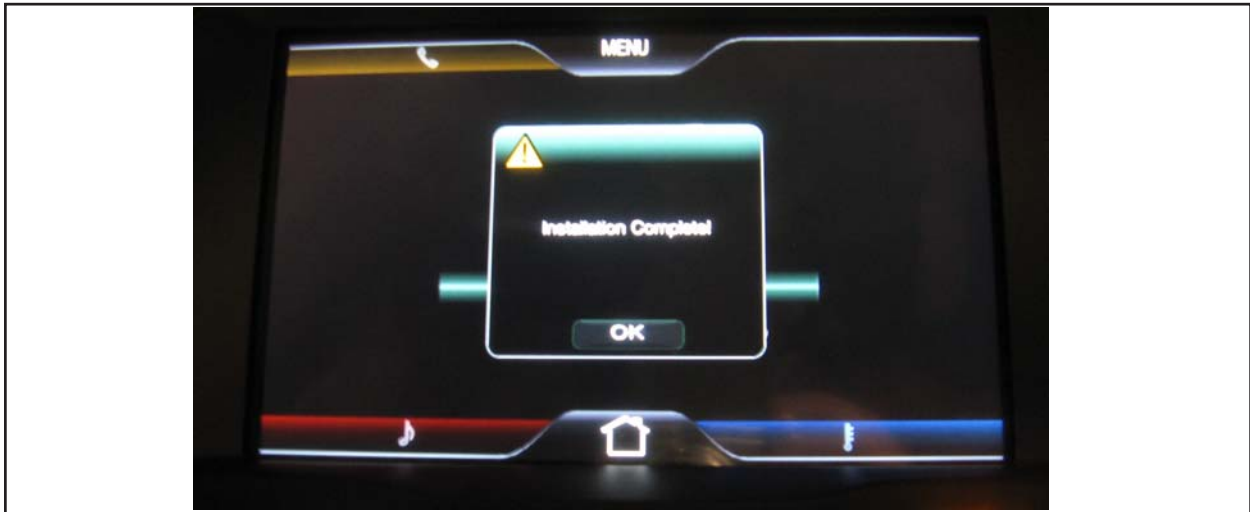
FIGURE 8

7. When the "Installation Complete!" screen appears tap "OK". See Figure 8.
