Michael A. Berardi
Director
Service Engineering Operations
Ford Customer Service Division

SUBJECT: **DEMONSTRATION / DELIVERY HOLD - Application Performance Upgrade 13A01
– Supplement #3**

Certain 2012-2013 Focus Electric, 2013 C-MAX Hybrid and C-MAX Energi, and 2013 Fusion Hybrid Vehicles Equipped with MyFord Touch®
Application Performance Upgrade

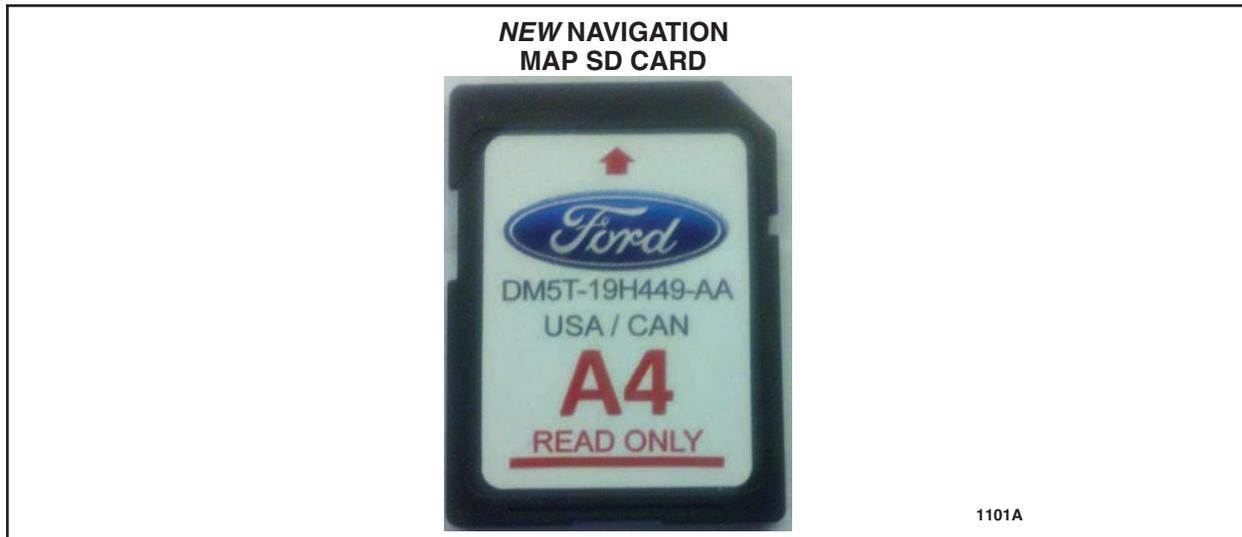
FIGURE 2

NOTE: After the reprogramming procedure completes, an SD card fault will appear on the screen. This is normal.

3. Remove the A3 level Navigation Map SD Card from the vehicle's map card slot.
4. Tap "SD Nav" on the touchscreen to clear the SD card fault.
5. Install the *new* A4 level Navigation Map SD Card into the vehicle's map card slot. See Figure 2. Wait for the *new* Navigation Map SD Card to be recognized and tap "OK" when the "SD Card Detected" screen appears on the touchscreen.

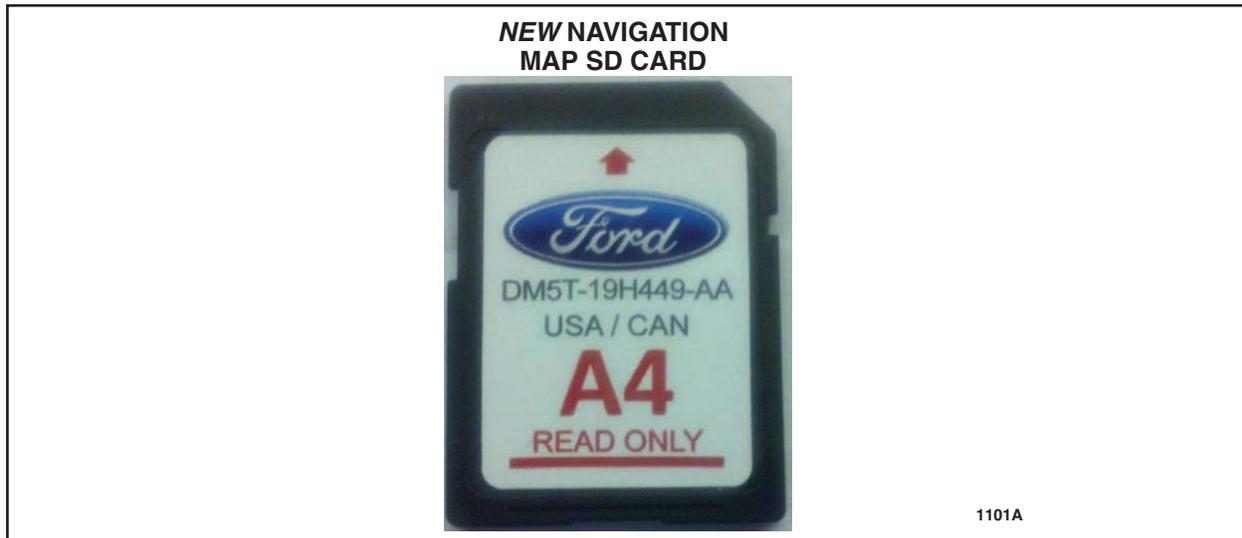
FIGURE 2

NOTE: After the reprogramming procedure completes, an SD card fault will appear on the screen.
This is normal.

5. Remove the A3 level Navigation Map SD Card from the vehicle's map card slot.
6. Tap "SD Nav" on the touchscreen to clear the SD card fault.
7. Install the *new* A4 level Navigation Map SD Card into the vehicle's map card slot. See Figure 2. Wait for the *new* Navigation Map SD Card to be recognized and tap "OK" when the "SD Card Detected" screen appears on the touchscreen.

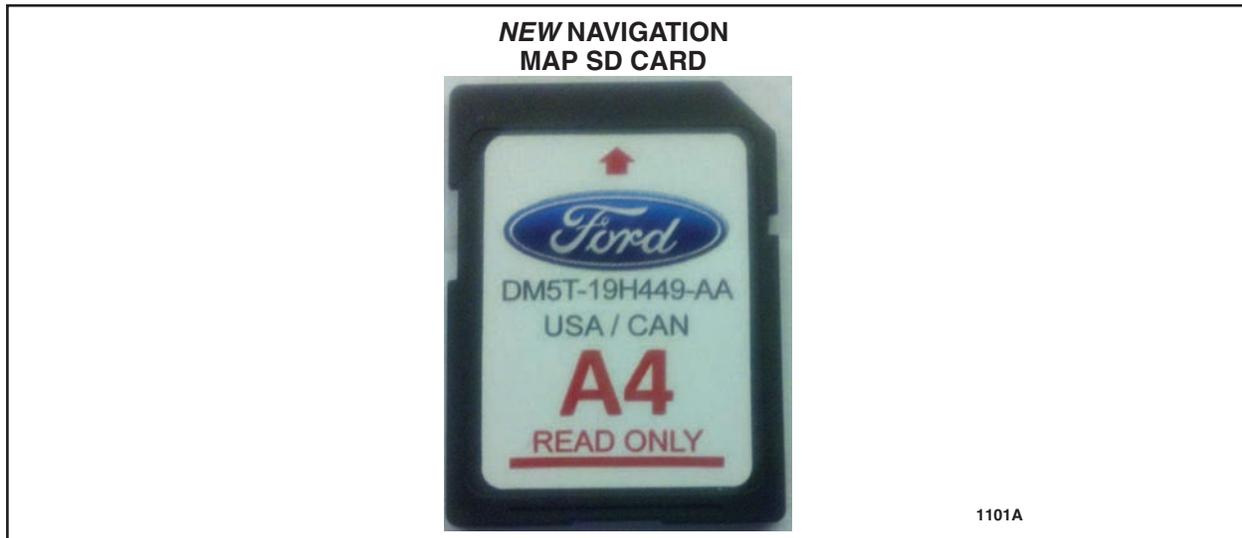
FIGURE 3

NOTE: After the reprogramming procedure completes, an SD card fault will appear on the screen. This is normal.

6. Remove the A3 level Navigation Map SD Card from the vehicle's map card slot.
7. Tap "SD Nav" on the touchscreen to clear the SD card fault.
8. Install the *new* A4 level Navigation Map SD Card into the vehicle's map card slot. See Figure 3. Wait for the *new* Navigation Map SD Card to be recognized and tap "OK" when the "SD Card Detected" screen appears on the touchscreen.
