Michael A. Berardi
Director
Service Engineering Operations
Ford Customer Service Division

SUBJECT: **DELIVERY HOLD - Customer Satisfaction Program 13B02 – Supplement #1**
Certain 2013 Model Year Fusion Vehicles Equipped with a Moon Roof
Headliner Wrinkles

Certain 2013 Model Year Fusion Vehicles Equipped with a Moon Roof
Headliner Wrinkles

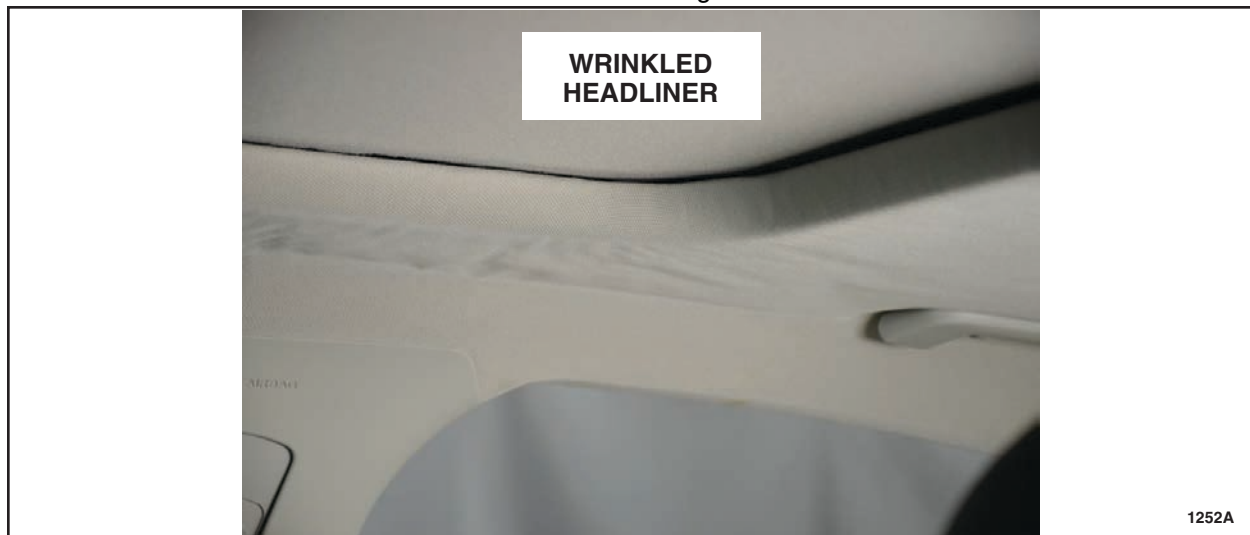
FIGURE 1

Differing rates of thermal expansion exist between the headliner substrate, glue, and other components bonded to the backside of the headliner, which can result in a wrinkle condition around the moon roof opening. Note that the wrinkle condition is accentuated by high and low ambient temperature cycles.

For vehicles built on or after October 11, 2012, dealers must inspect the headliner for the presence of wrinkles around the moon roof opening to determine if the headliner must be modified or replaced.

- If wrinkles are present, the headliner must be replaced.
- If wrinkles are not present, the headliner must be modified to prevent wrinkles from occurring in the future. The modification involves lowering the headliner and cutting reliefs into the blocks and supports glued to the backside of the headliner. The reliefs allow the components to expand and contract and at different rates without wrinkling the headliner material.

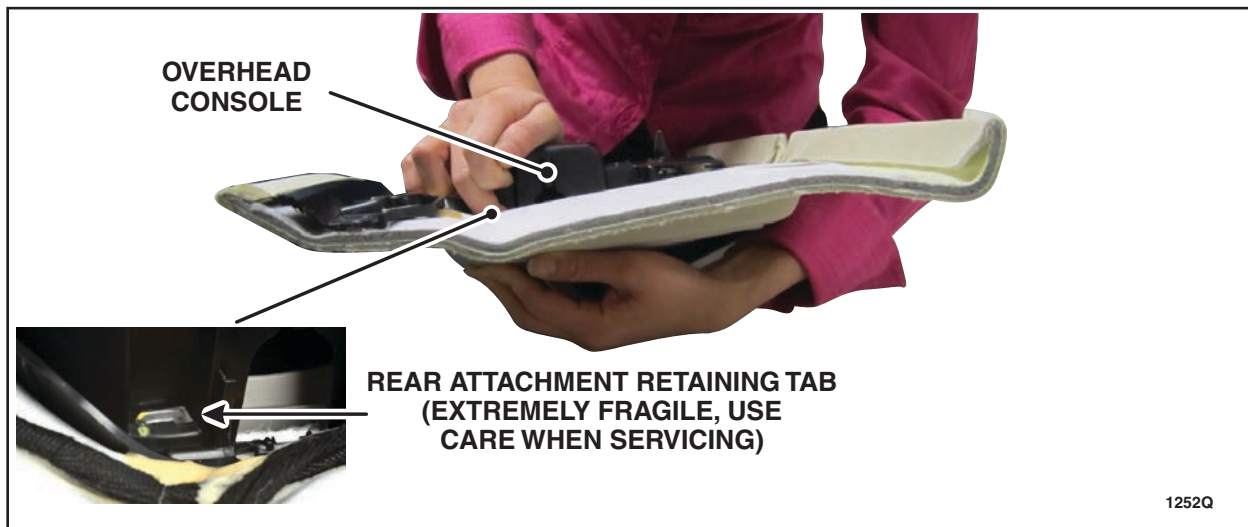
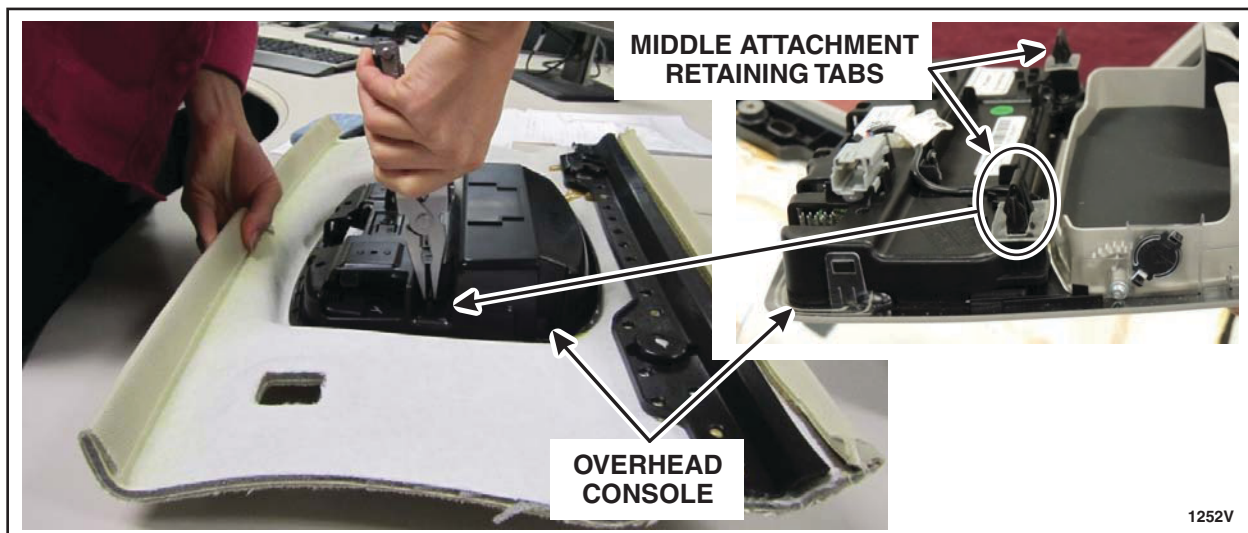
FIGURE 21a

2. **NOTICE:** Special care needs to be taken while removing the overhead console. The rear attachment retaining tabs are extremely fragile. See Figure 21a and 21b.

Remove the overhead console from the headliner. See Figure 21a and 21b (headliner cutaway view shown for clarity).

- Disengage the rear overhead console attachments by pushing up on the console from the interior side while holding the headliner bracket in place. Slowly press the retaining tab inboard to release.
- Support the overhead console from the interior side and use a set of pliers to release the middle retaining tabs.
- Pry down gently to free the overhead console. Rotate the rear of the console downward to access the electrical connectors.
- Disconnect and remove the overhead console.

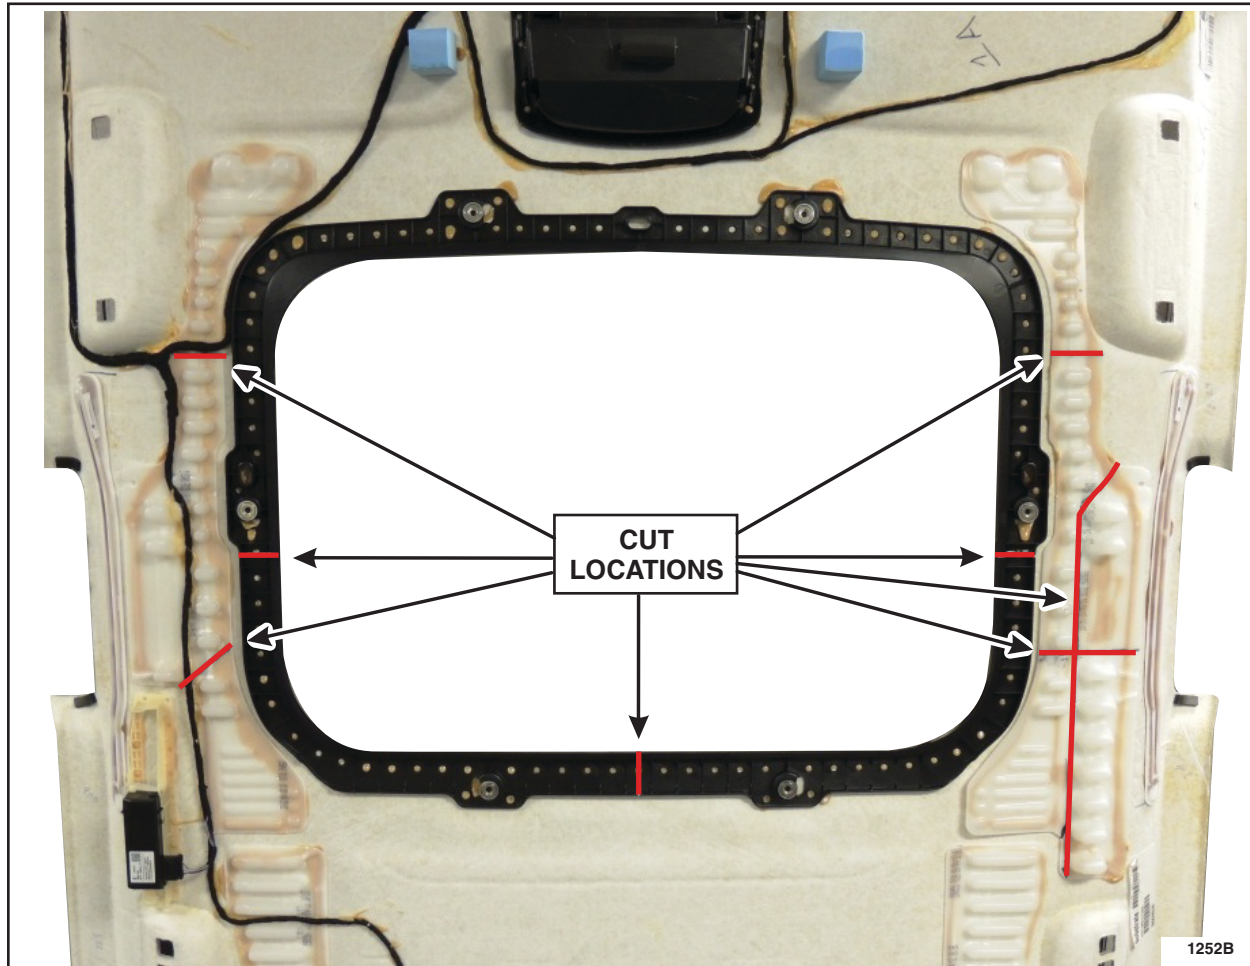
FIGURE 23

NOTE: Modification of the headliner reinforcements will prevent wrinkles by allowing greater flexibility of the substrate material.

1. Mark cut locations on the headliner reinforcement material. See Figure 23.

NOTICE: When cutting headliner reinforcements, care must be taken not to cut any deeper than the reinforcement material. Cutting deeper than the reinforcement material can result in damage to the headliner. Holding the DREMEL® cutting tool at a 45 degree angle will help ensure a smoother cut and reduce the risk of cutting deeper than necessary.
