**SUBJECT: Regional Program 14R01**

Certain 2010 through 2014 Model Year Taurus and 2013 through 2014 Model Year Police Interceptor Sedan Vehicles Not Covered Under Safety Recall 14S08 License Plate Lamp Assembly Replacement

**REF: Safety Recall 14S08 – Supplement #1**

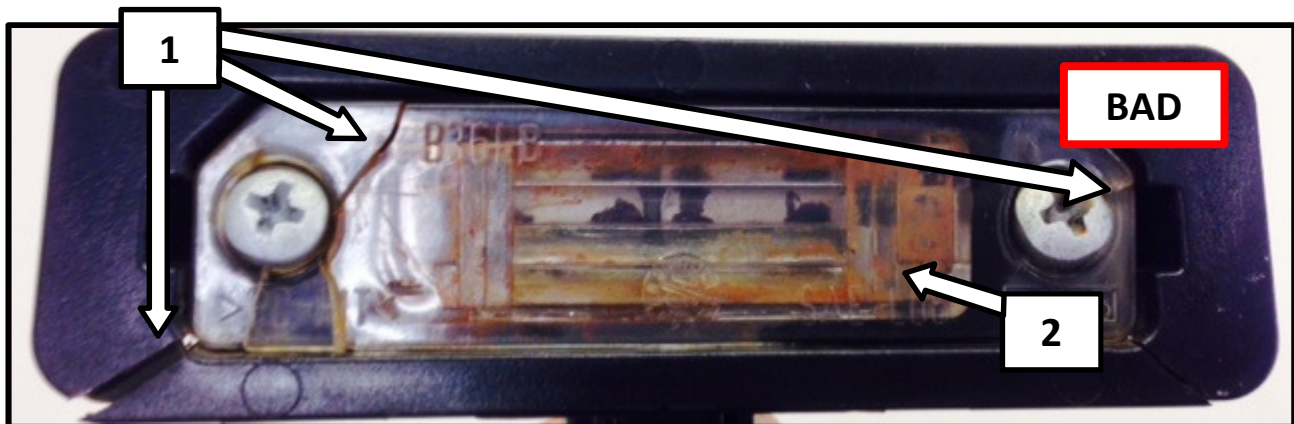
1. Visible cracks in exposed portions of the lens and housing
2. Visible corrosion behind the clear lens

If either cracks or corrosion are found during a visual inspection, contact your authorized Ford dealer for service.

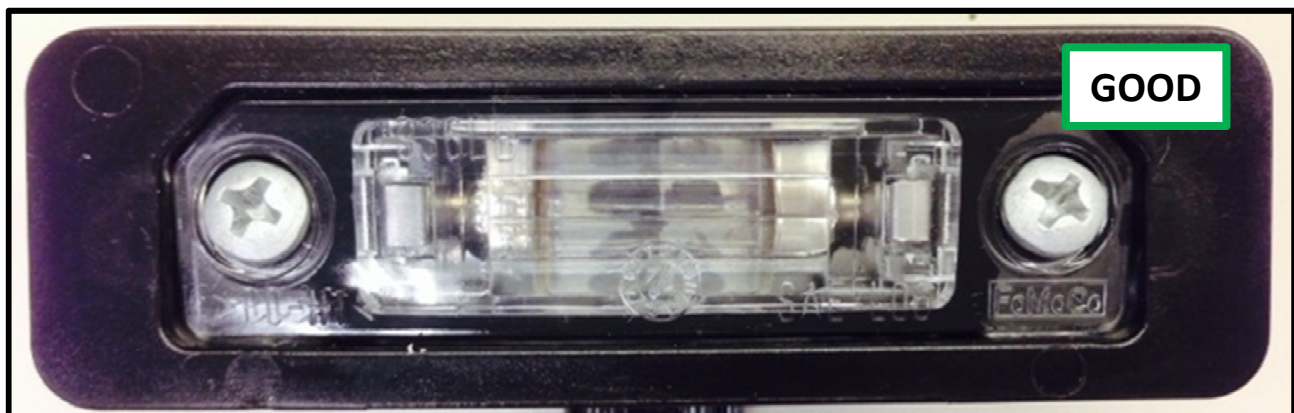
No visible cracks or corrosion
