**SUBJECT: DEMONSTRATION / DELIVERY HOLD - Safety Recall 14S08 - *Supplement #1***  
Certain 2010-2014 Model Year Taurus and 2013-2014 Model Year Police Interceptor  
Sedan Vehicles Operated in Corrosion States  
License Plate Lamp Assembly Replacement

**DEMONSTRATION / DELIVERY HOLD - Safety Recall 14S08 - Supplement #1**  
Certain 2010-2014 Model Year Taurus and  
2013-2014 Model Year Police Interceptor Sedan Vehicles Operated in Corrosion States  
License Plate Lamp Assembly Replacement

## CERTAIN 2010-2014 MODEL YEAR TAURUS AND 2013-2014 MODEL YEAR POLICE INTERCEPTOR SEDAN VEHICLES OPERATED IN CORROSION STATES — LICENSE PLATE LAMP ASSEMBLY REPLACEMENT

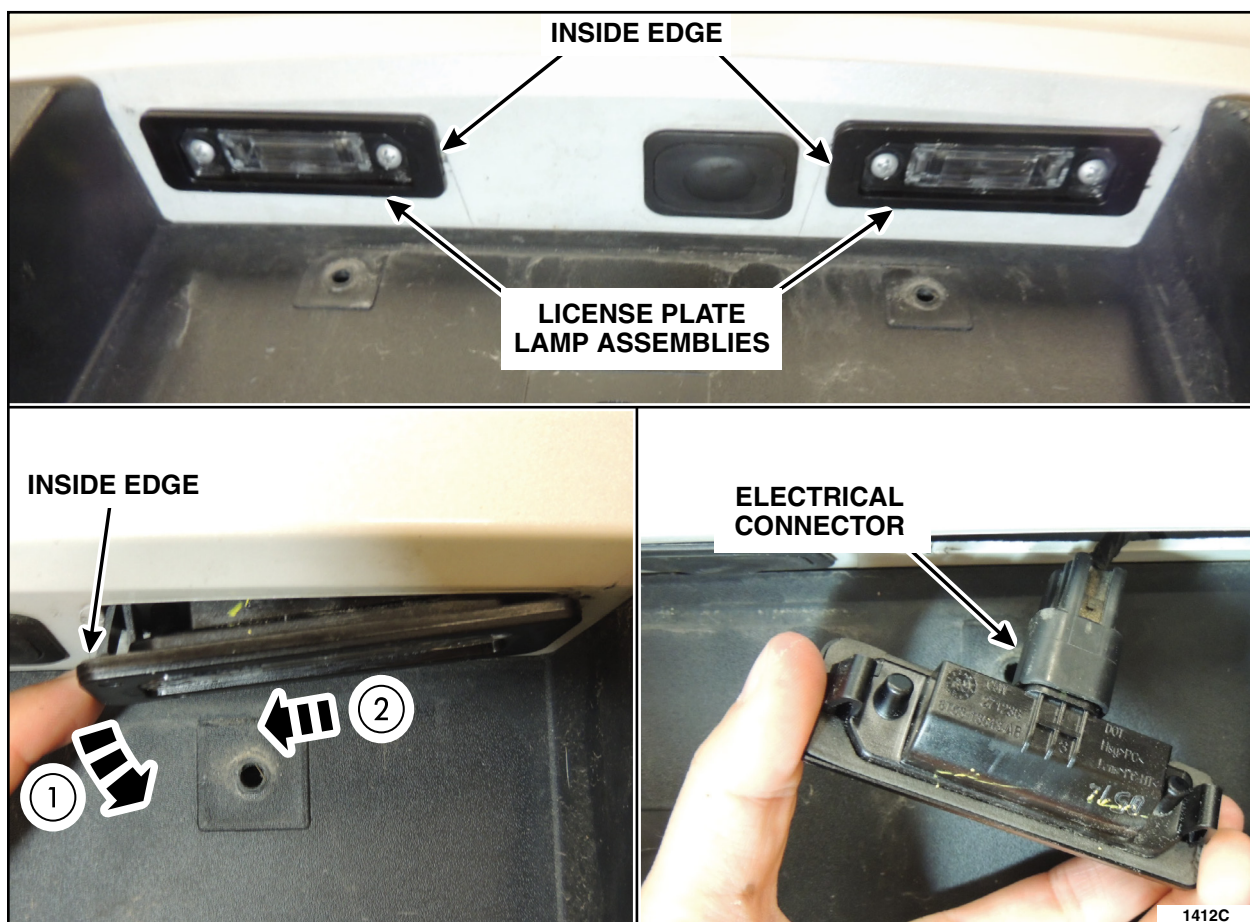
FIGURE 1

In some of the affected vehicles that are operated in high-corrosion environments associated with road salt use, moisture in the license plate lamp assemblies can lead to corrosion. The corrosion can bridge the positive and negative terminal plates creating a short circuit in the license plate lamp assemblies that causes high current draw, excessive heat and potentially a fire.

1. Remove and discard the RH and LH license plate lamp assemblies. See Figure 1.
  - a. Pull downward on inside edge of the RH and LH license plate lamp assemblies to release the inside edge clip.
  - b. Disconnect the electrical connector. Remove and discard the RH and LH license plate lamp assemblies.

3. Install the *new* RH and LH license plate lamp assemblies. See Figure 1.
- a. Connect the electrical connectors to the *new* RH and LH license plate lamp assemblies.
  - b. Install the *new* RH and LH license plate lamp assemblies into the bumper cover.

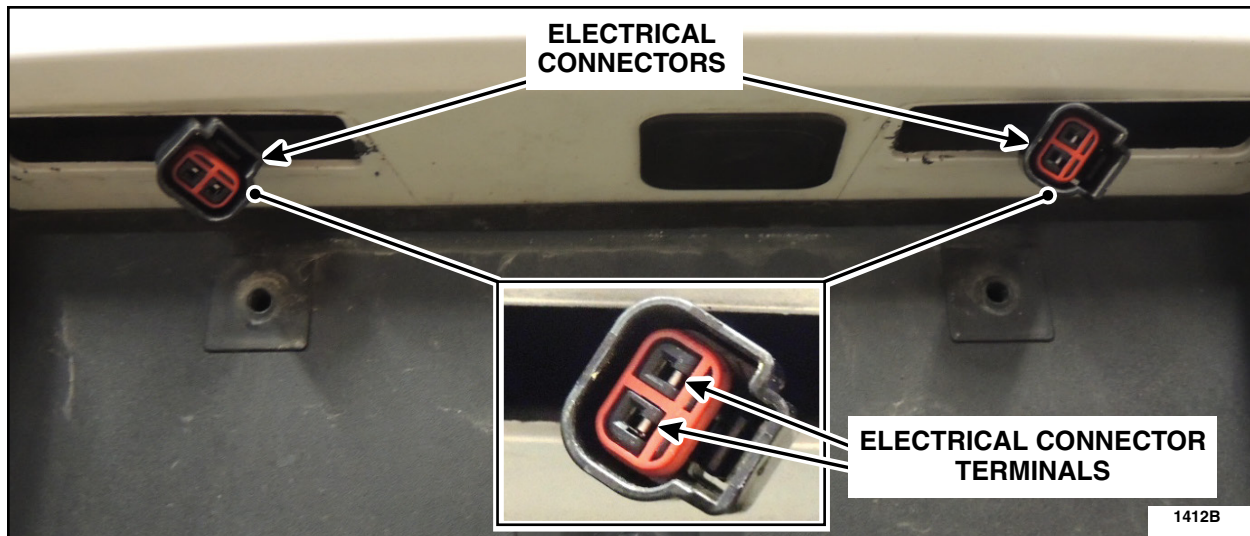
**FIGURE 2**

2. Inspect the license plate lamp electrical connector terminals for related damage. See Figure 2. If corrosion is found in the license plate lamp electrical connector terminals, replace the harness. (15K868).

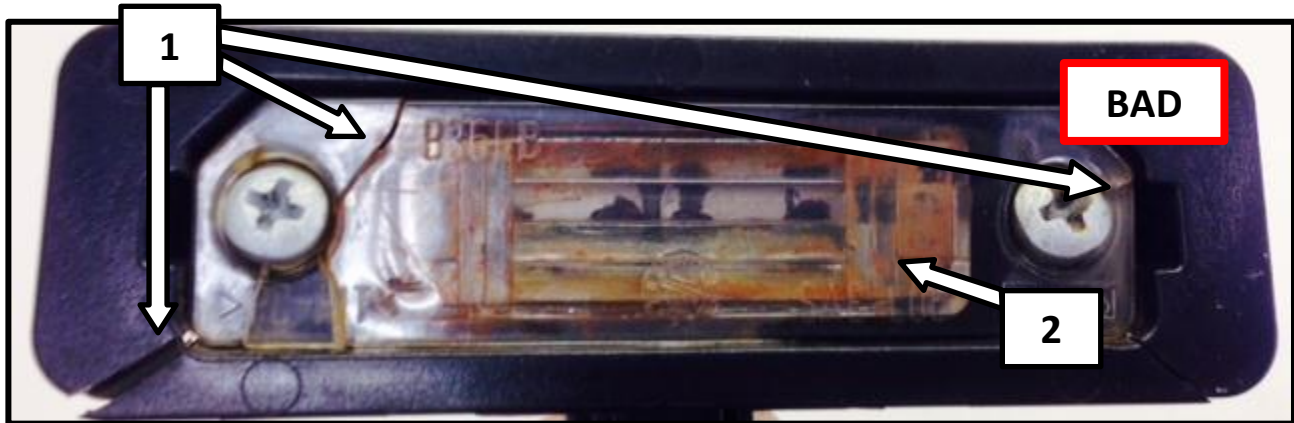
1. Visible cracks in exposed portions of the lens and housing
2. Visible corrosion behind the clear lens

If cracks or corrosion are evident, please contact your dealer and request a service appointment without delay.

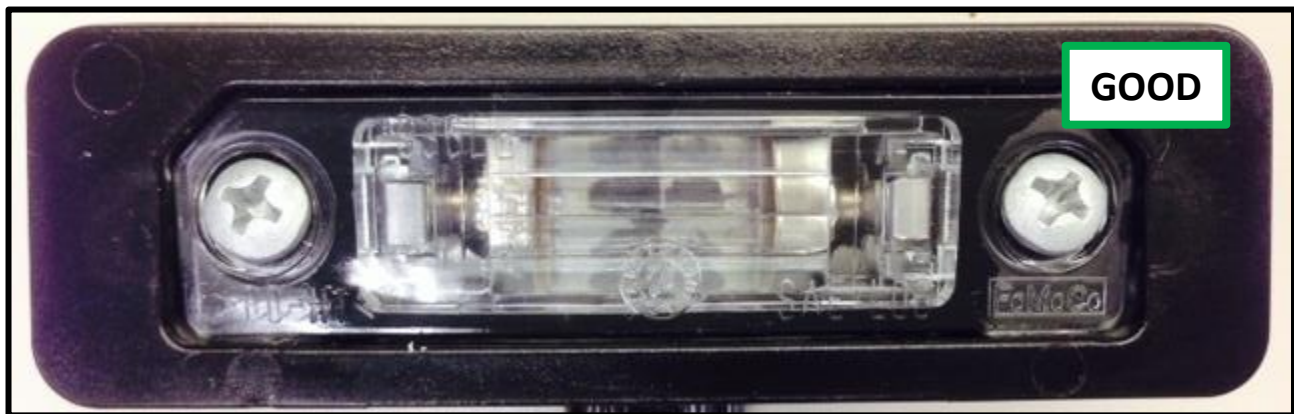
No visible cracks or corrosion

If neither cracks nor corrosion are evident, contact your dealer to schedule a service appointment for the end of September, 2014 when parts are anticipated to be available.

**Note:** *Vehicles with license plate lamp assemblies free of cracks or corrosion should be reinspected weekly until the repair is completed.*
