Recall Bulletin

PRODUCT SAFETY RECALL

SUBJECT: Transmission Oil Cooler Connection

MODELS: 2014 Chevrolet Silverado Light Duty Regular Cab, Double Cab, Crew Cab 1500 Series
2015 Chevrolet Suburban, Tahoe
2014 GMC Sierra Light Duty Regular Cab, Double Cab, Crew Cab 1500 Series
2015 GMC Yukon, Yukon XL
Equipped with 6-Speed Automatic Transmission (MYC)

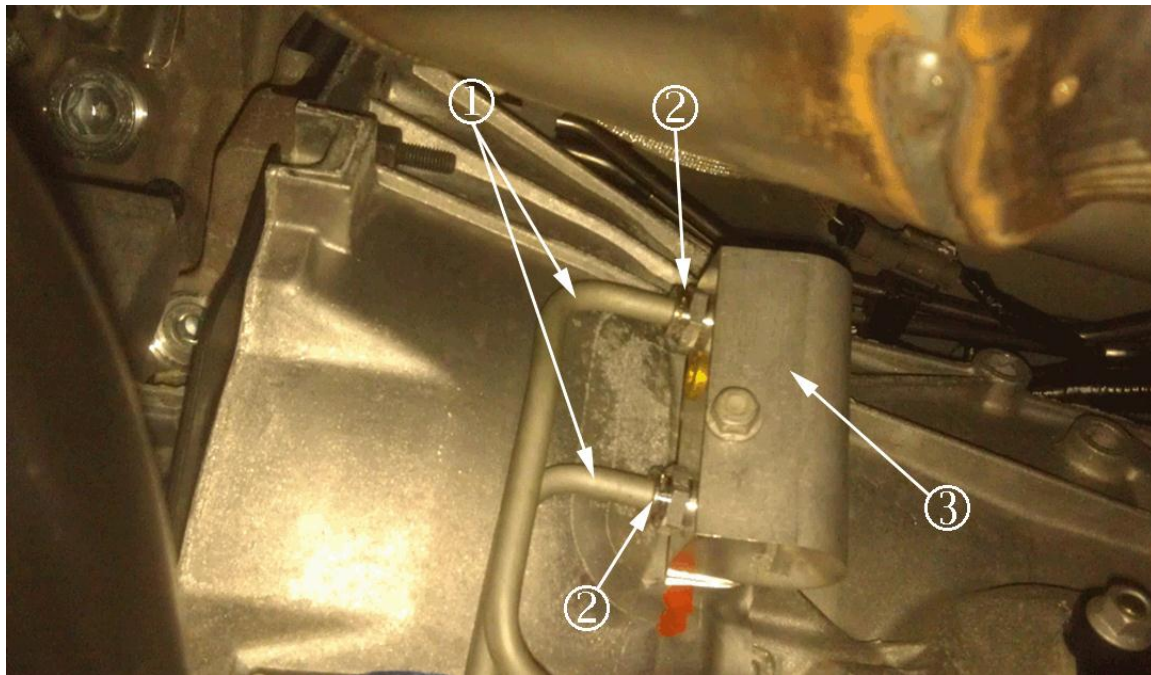
3792999

(1) Transmission Cooler Lines (2) Quick Connect Fittings (3) Thermal Bypass Valve

2. Inspect the transmission cooler lines where they connect to the thermal bypass valve.

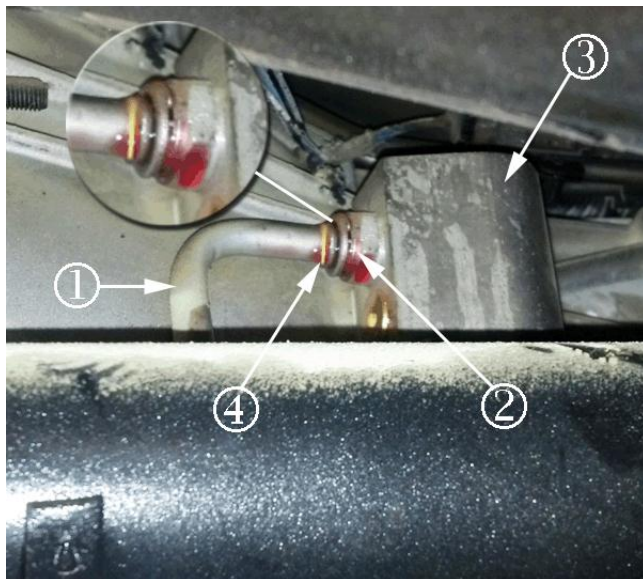
3793000

Photograph shows a fluid leak at the quick connect fitting (2) of the transmission cooler line (1) and thermal bypass valve (3).

2.2. Inspect the area around the thermal bypass valve (3) and the end of the transmission cooler line (1) for evidence of a fluid leak.
