Recall Bulletin

PRODUCT SAFETY RECALL

SUBJECT: Transmission Shift Cable Fracture

MODELS: 2004-2007 Chevrolet Malibu Maxx
2004-2008 Chevrolet Malibu
2005-2008 Pontiac G6
2007-2008 Saturn AURA
Equipped with 4-Speed Automatic Transmission (ME7/MN5)

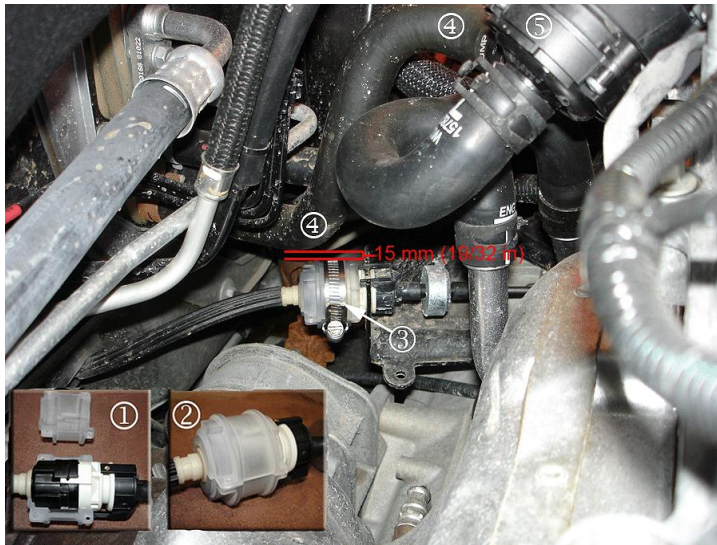
2269484

Hybrid vehicle shown. Combustion engine vehicle is similar.

- (1) Clam Shell in Two Pieces
- (2) Clam Shell Around Shifter Cable Locking Tabs
- (3) Clamp on Clam Shell
- (4) Inlet Coolant Hose and
- (5) Heater Cooler Pump.

4. Install the clam shell (1) (2) over the shifter cable locking tabs.
5. Install the service clamp over the clam shell (3). Position the clamp fastener head away from the inlet coolant hose (4). **Tighten the clamp to 4 N·m (35 lb-in).**
6. Ensure that there is 15 mm (19/32 in) of clearance between the inlet coolant hose (4) and the clam shell (3). On hybrid equipped vehicles, it may be necessary to reposition the inlet coolant hose (4) to achieve the required 15 mm (19/32 in) of clearance. **To reposition the inlet coolant hose (4) on hybrid equipped vehicles, locate the heater cooler pump (5) and perform Steps 6.1-6.5.**

Caution: Do not kink or damage the inlet coolant hose (4) when repositioning the hose to obtain the 15 mm (19/32 in) clearance. To avoid damaging the hose clamp, use J-38185 or equivalent hose clamp pliers to loosen the hose clamp.
