Recall Bulletin

PRODUCT SAFETY RECALL

SUBJECT: Transmission Shift Cable Fracture

MODELS: 2004-2007 Chevrolet Malibu Maxx
2004-2008 Chevrolet Malibu
2005-2008 Pontiac G6
2007-2008 Saturn AURA
Equipped with 4-Speed Automatic Transmission (ME7/MN5)

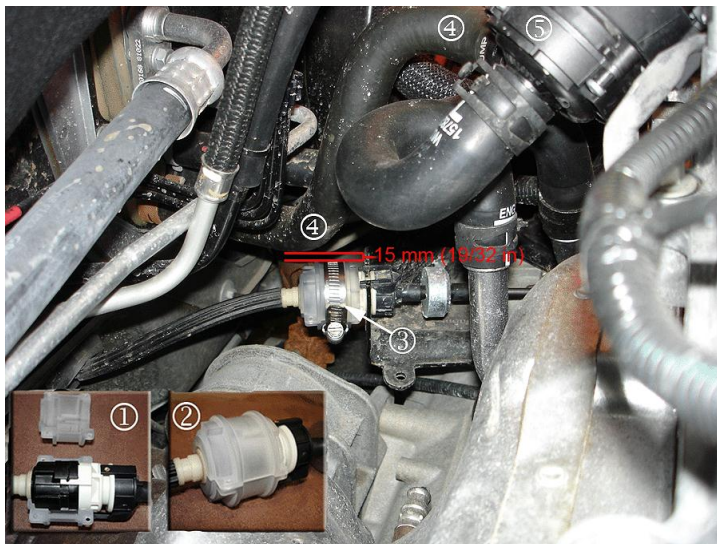
2269484

- (1) Clam Shell in Two Pieces
- (2) Clam Shell Around Shift Cable Locking Tabs
- (3) Clamp on Clam Shell
- (4) Inlet Coolant Hose and
- (5) Heater Cooler Pump.

5. Install the clam shell (1) (2) over the shifter cable locking tabs.
6. Install the service clamp over the clam shell (3). Position the clamp fastener head away from the inlet coolant hose (4). **Tighten the clamp to 4 N·m (35 lb-in).**
7. Ensure that there is 15 mm (19/32 in) of clearance between the inlet coolant hose (4) and the clam shell (3). On hybrid equipped vehicles, it may be necessary to reposition the inlet coolant hose (4) to achieve the required 15 mm (19/32 in) of clearance. **To reposition the inlet coolant hose (4) on hybrid equipped vehicles, locate the heater cooler pump (5) and perform Steps 7.1-7.5.**

Caution: Do not kink or damage the inlet coolant hose (4) when repositioning the hose to obtain the 15 mm (19/32 in) clearance. To avoid damaging the hose clamp, use J-38185 or equivalent hose clamp pliers to loosen the hose clamp.
