PRODUCT SAFETY RECALL

SUBJECT: Daytime Running Lamp (DRL) Inoperative – DRL Module Overheating

MODELS: 2004-2008 Chevrolet Aveo
2004-2006 Chevrolet Epica (Canada Only)
2004-2007 Chevrolet Optra (Canada Only)
2005-2008 Pontiac Wave / G3 (Canada Only)

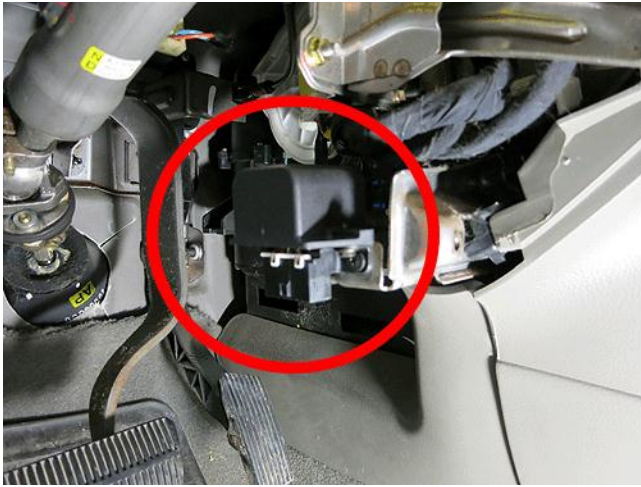
Epica Location A

Vehicle	Location	Epica Location With Auto Climate Control
Chevrolet Epica	Under the instrument panel to the left of the center console. Module secured to the top of the DLC (ALDL) connector. (A)	Mounted to a cross brace behind the radio/ashtray assy. (B)
Chevrolet Aveo Pontiac Wave/G3	Mounted under instrument panel on left side of center at HVAC control height. Remove the Lower IP Cover and steel knee bolster to access	NA
Chevrolet Optra	Behind the fuse panel located at the left hand side of the instrument panel. Remove the Lower IP Cover and steel knee bolster to access.	NA

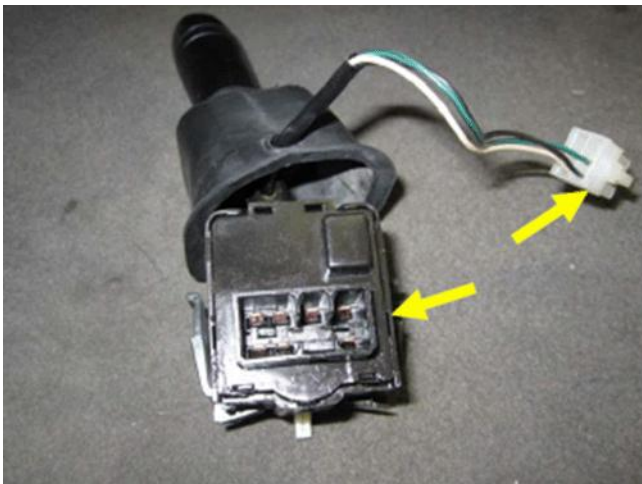
4053497

Inspect the larger connector for heat damage. If heat damage is detected, replace the connector on the vehicle harness. Refer to the “*DRL and Multifunction Switch Wiring/Connector Repair and Ground Check*” section at the end of this procedure.

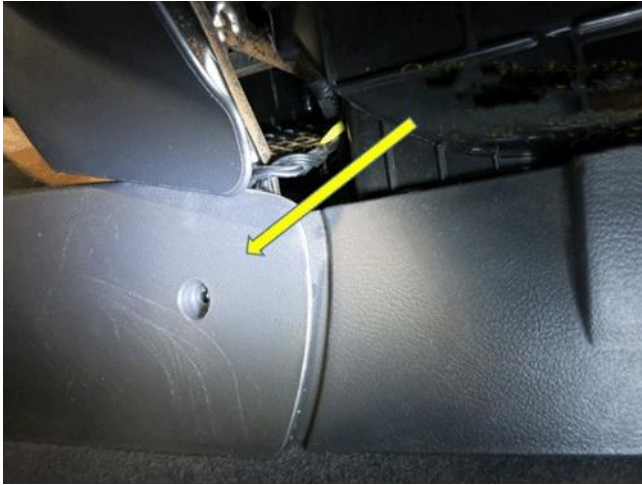
4053512

The G203 ground is located behind right hand floor console extension panel.

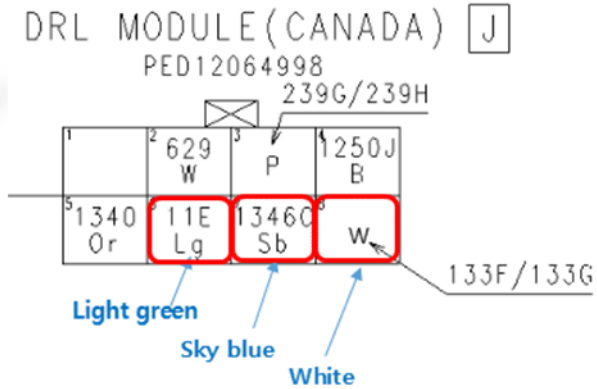
4053515

EPICA - DRL Connector End View Wire color and circuit numbers. Use Pigtail P/N 42364044.

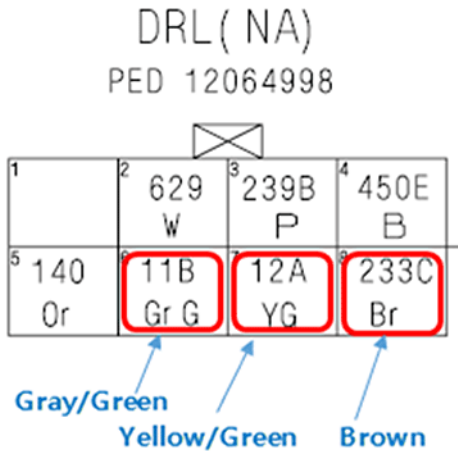
4053516

AVEO – DRL Connector End View Wire color and circuit numbers. Use Pigtail P/N 42364044.
