# Recall Bulletin

## PRODUCT SAFETY RECALL

**SUBJECT:** Transmission Shift Cable

**MODELS:** 2013-2014 Cadillac ATS  
2014 Cadillac CTS  
Equipped with Automatic Transmission (RPO MYA or MGG)

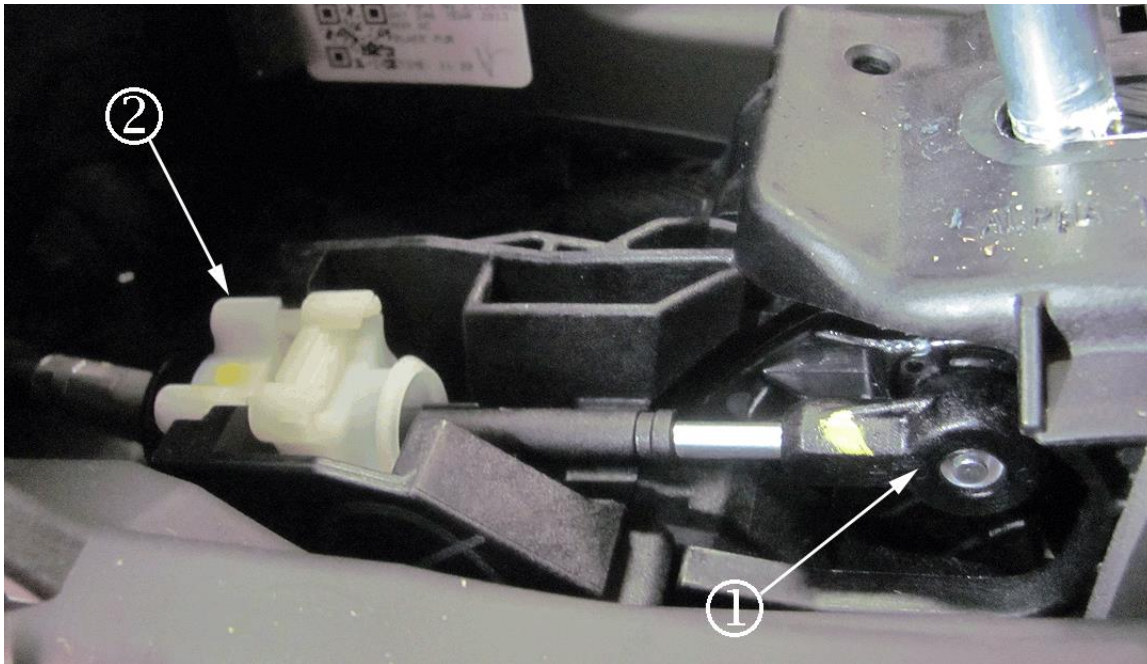
3940456

**Note:** Inspect the range selector lever cable at the terminal rod end (1) and bracket end fitting (2). Review steps 3.1-3.2.

3. Inspect the range selector lever cable inside the vehicle.

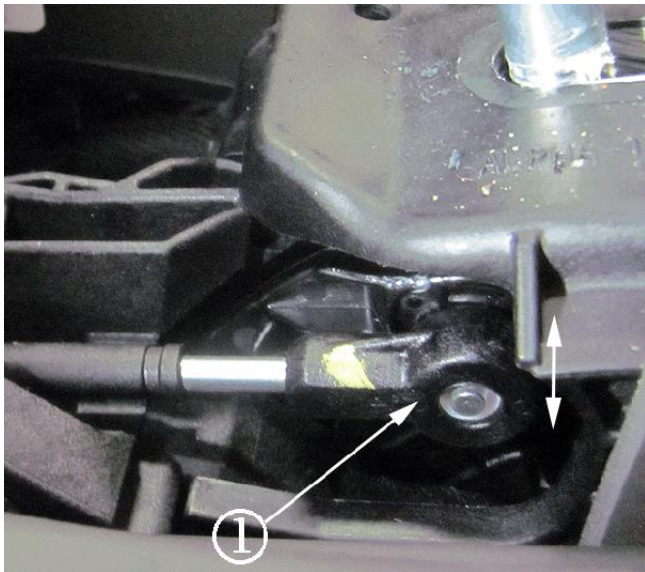
3940460

3.1 Ensure the transmission range selector lever cable terminal rod end (1) is connected to the shift lever pin correctly.

- Push and pull on the terminal rod end (1) to determine if the terminal rod end is connected to the shift lever pin. Push and pull direction is indicated in the photograph with a two way arrow.
- If the terminal rod end (1) is NOT connected to the shift lever pin, push the terminal rod end onto the shift lever pin. An audible click is present when the terminal rod end is installed onto the shift lever pin correctly.

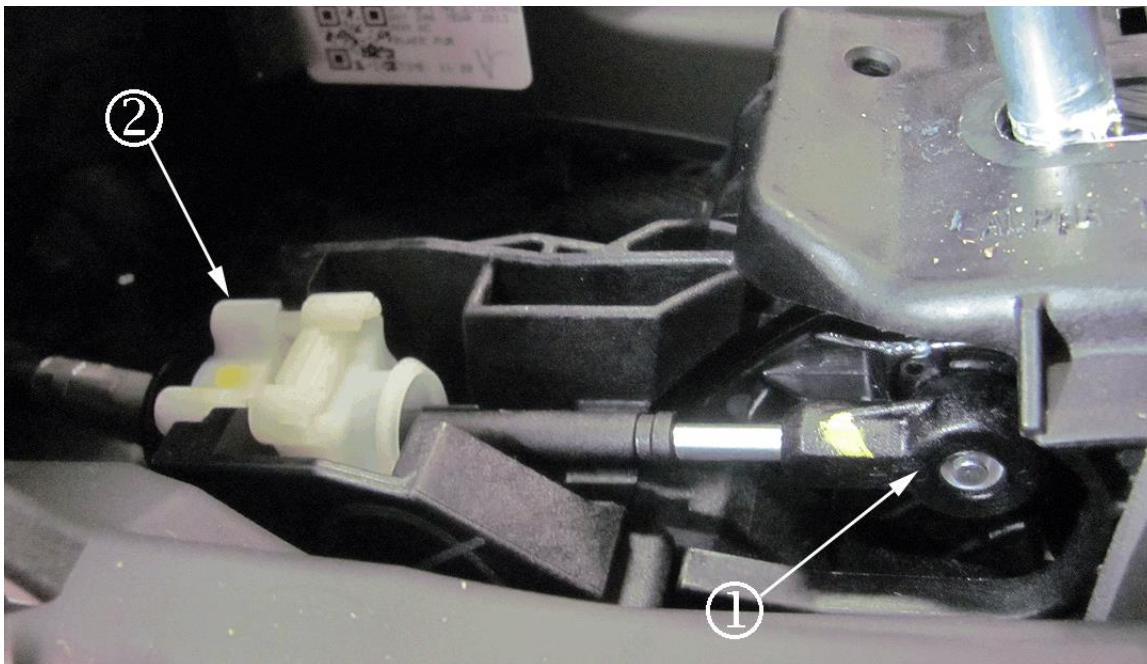
3940456

**Note:** Inspect the range selector lever cable at the terminal rod end (1) and bracket end fitting (2). Review steps 3.1-3.2.

3.2 Ensure the transmission range selector lever cable bracket end fitting (2) is seated into the bracket housing correctly.

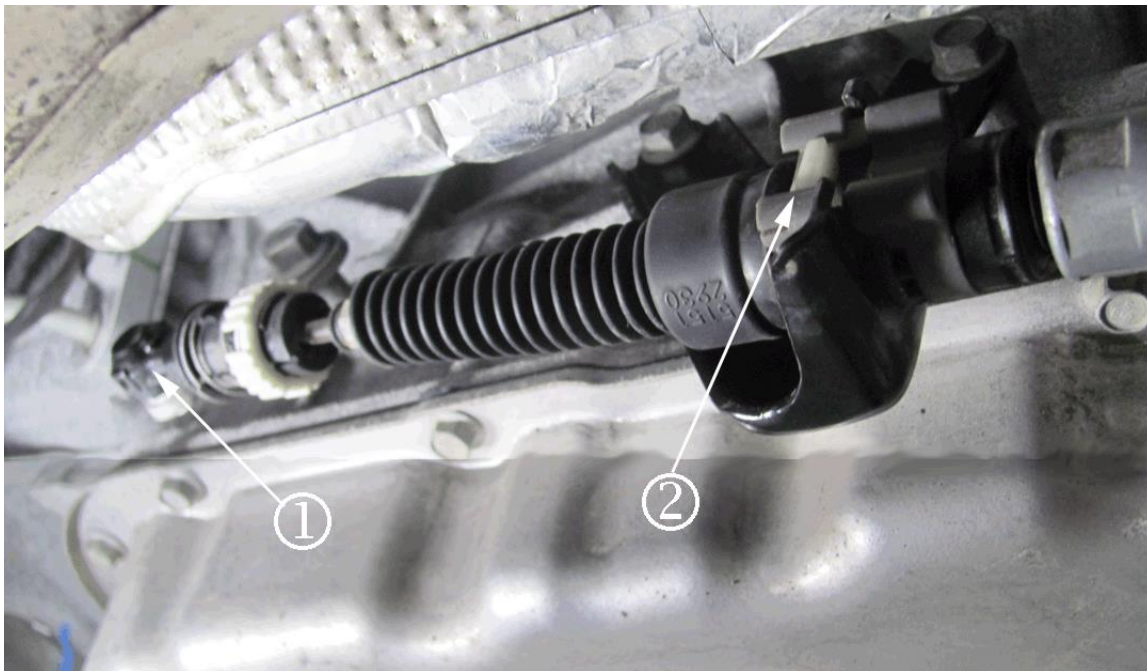
3940468

**Note:** Inspect the range selector lever cable at the terminal rod end (1) and bracket end fitting (2). Review steps 5.1-5.2.

5. Inspect the range selector lever cable at the transmission.

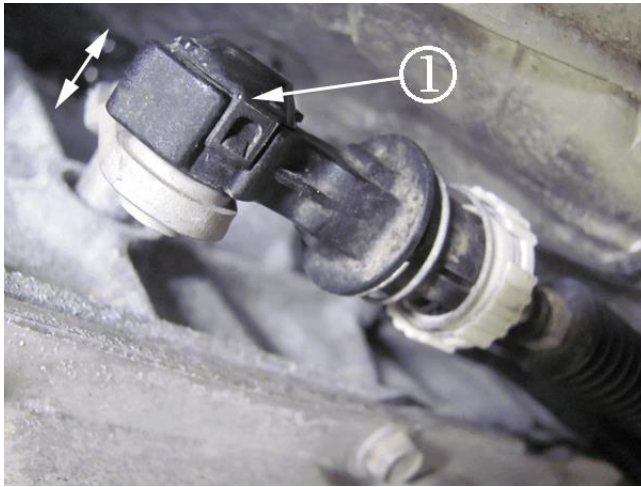
3940474

5.1 Ensure the transmission range selector lever cable terminal rod end (1) is connected to the shift lever pin correctly.

- Push and pull on the terminal rod end (1) to determine if the terminal rod end connected to the shift lever pin. Push and pull direction is indicated in the photograph with a two way arrow.
- If the terminal rod end (1) is NOT connected to the shift lever pin, push the terminal rod end onto the shift lever pin. An audible click is present when the terminal rod end (1) is installed onto the shift lever pin correctly.

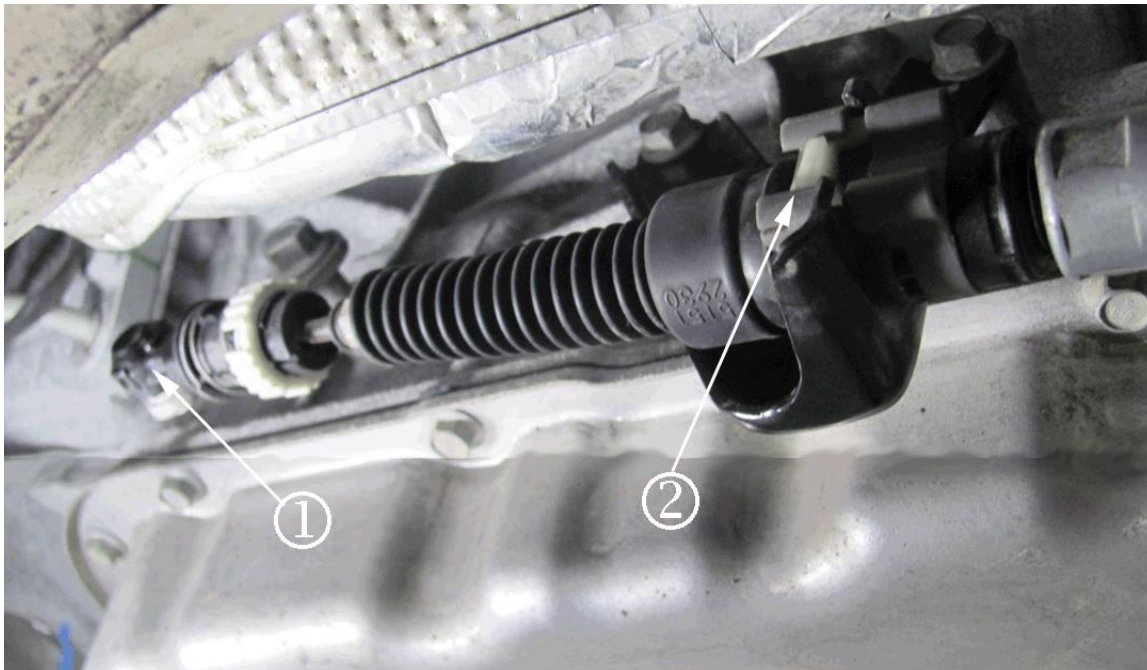
3940468

**Note:** Inspect the range selector lever cable at the terminal rod end (1) and bracket end fitting (2). Review steps 5.1-5.2.

5.2 Ensure the transmission range selector lever cable bracket end fitting is seated into the bracket housing correctly.
