Recall Bulletin

PRODUCT SAFETY RECALL

SUBJECT: Transmission Shift Cable

MODELS: 2013-2014 Cadillac ATS
2014 Cadillac CTS
Equipped with Automatic Transmission (RPO MYA or MGG)

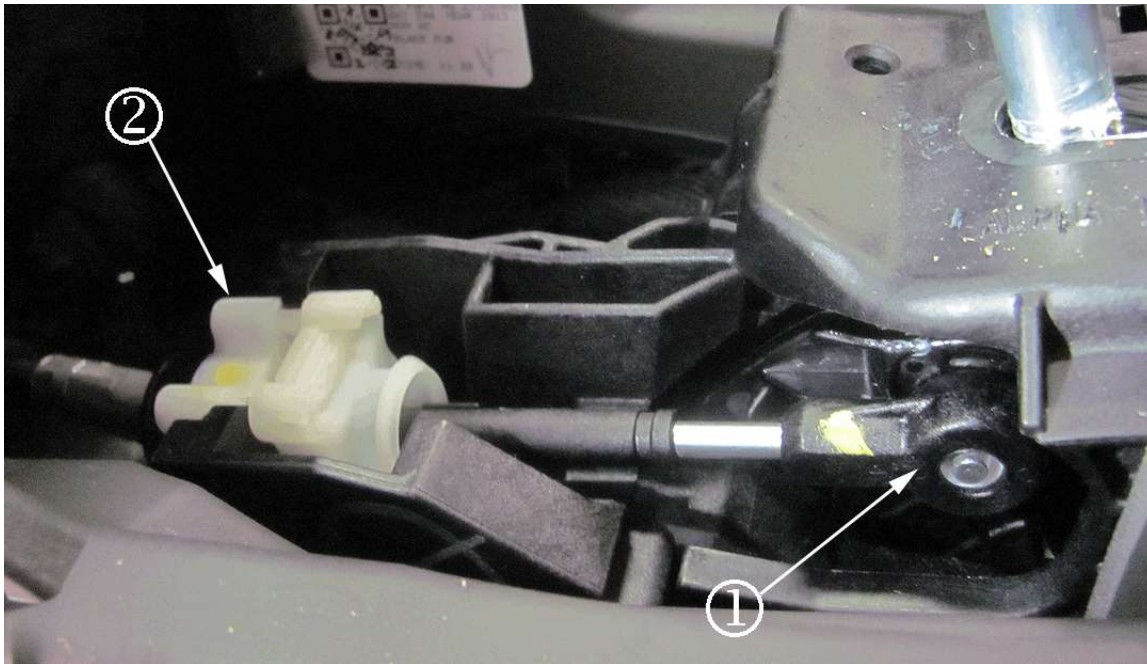
3940456

Note: Inspect the range selector lever cable at the terminal rod end (1) and bracket end fitting (2). Review steps 3.1-3.2.
