# Recall Bulletin

## PRODUCT SAFETY RECALL

**SUBJECT:** Unintended Ignition Key Rotation

**MODELS:** 2005-2009 Buick Allure (Canada)  
2005-2009 Buick LaCrosse  
2006-2011 Buick Lucerne  
2000-2005 Cadillac DeVille  
2006-2011 Cadillac DTS  
2006-2007 Chevrolet Monte Carlo  
2006-2013 Chevrolet Impala  
2014 Chevrolet Impala Limited (U.S. Fleet Only)

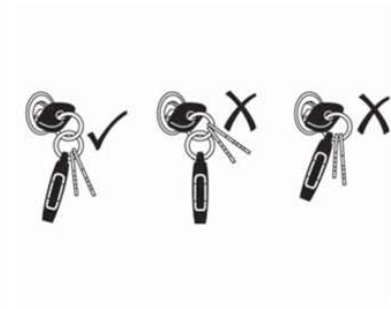
3973594

If the key is unintentionally rotated while the vehicle is running, the ignition could be moved out of the RUN position. This could be caused by heavy items hanging from the key ring, or by large or long items attached to the key ring that could be contacted by the driver or steering wheel. If the ignition moves out of the RUN position,

the engine will shut off, braking and steering power assist may be impacted, and airbags may not deploy. To reduce the risk of unintentional rotation of the ignition key, do not change the way the ignition key and Remote Keyless Entry (RKE) transmitter, if equipped, are connected to the provided key rings.

The ignition key and key rings, and RKE transmitter, if equipped, are designed to work together as a system to reduce the risk of unintentionally moving the key out of the RUN position. The ignition key has a small hole to allow attachment of the provided key ring. It is important that any replacement ignition keys have a small hole. See your dealer if a replacement key is required.

The combination and size of the rings that came with your keys were specifically selected for your vehicle. The rings are connected to the key like two links of a chain to reduce the risk of unintentionally moving the key out of the RUN position. Do not add any additional items to the ring attached to the ignition key. Attach additional items only to the second ring, and limit added items to a few essential keys or small, light items no larger than an RKE transmitter.
