PRODUCT CAMPAIGN BULLETIN

APPLICABILITY: 2003-2005 Subaru Legacy and Outback
 2003-2005 Subaru Baja
 2004-2005 Subaru Impreza
 (including WRX and STI)

NUMBER: WQP-51R
DATE: January 2015
NHTSA ID: 14V-763
REVISED: November 2, 2016

SUBJECT: Regional Front Passenger Air Bag Inflator Replacement

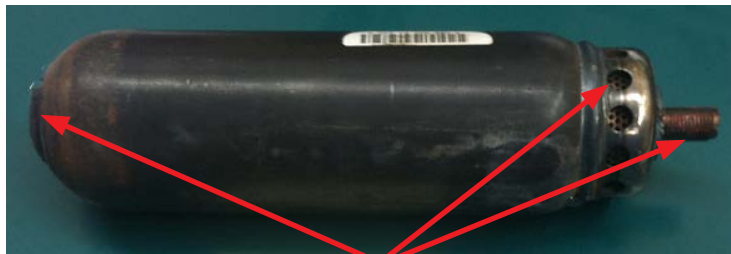
The shape, holes, and copper-colored stud indicate this not a Genuine Subaru inflator.

- **Do not proceed with this repair if your inspection reveals a non-Genuine Subaru air bag module has been installed in the vehicle.** Follow the instructions described in the “Counterfeit Air Bag Information” Dealer Advisory Bulletin and contact the SOA Warranty Helpline to close out the recall coverage on the vehicle.

- Document the presence of the aftermarket or counterfeit device on the repair order and with photos. Report this information immediately on a Quality Monitoring Report (QMR).

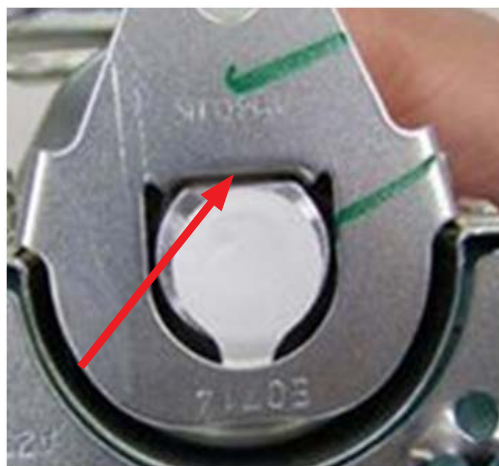
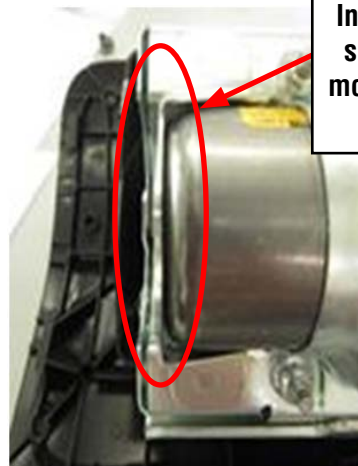
Inflator properly seated against mounting bracket (NO GAP)

STEP 9- Install the new inflator into the mounting bracket so the yellow taped end aligns with the removed stopper plate. Make sure the “D-shaped” portion of the inflator harness connector boss aligns with the “D-shaped” portion of the hole in the end of the mounting bracket as shown below. When properly installed, the end of the inflator will be seated tight against the mounting bracket. Do not peel the white harness connection dust cover at this time.

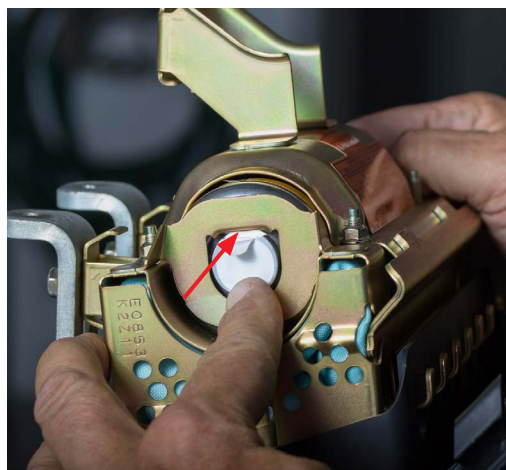
Inflator properly seated against mounting bracket (NO GAP)

STEP 9- Install the new inflator into the mounting bracket with the harness connector end going in first toward the mounting bracket. Make sure the “D-shaped” portion of the inflator harness connector boss aligns with the “D-shaped” portion of the hole in the end of the mounting bracket as shown below. When properly installed, the end of the inflator will be seated tight against the mounting bracket. Do not peel the white harness connection dust cover at this time.
