PRODUCT CAMPAIGN BULLETIN

APPLICABILITY: 2003-2005 Subaru Legacy and Outback**
 2003-2005 Subaru Baja
 2004-2005 Subaru Impreza**
 (including WRX and STI)

NUMBER: WQP-51R
DATE: January 2015
NHTSA ID: 14V-763
REVISED: December 21, 2022

SUBJECT: Regional Front Passenger Air Bag Inflator Replacement

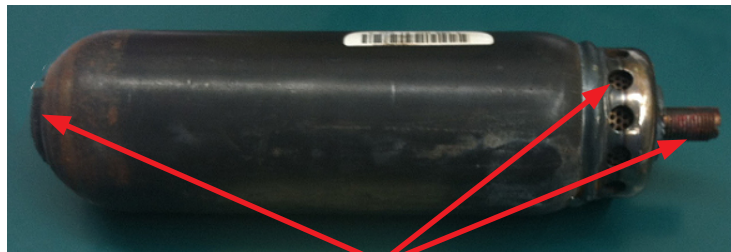
The shape, holes, and copper-colored stud indicate this not a Genuine Subaru inflator.

- Document the presence of the aftermarket or counterfeit device on the repair order and with photos. Report this information immediately on a Quality Monitoring Report (QMR).

- Once the QMR has been submitted, contact the Subaru Claims Helpline to discuss the details. They will advise you on how to proceed with treatment of the open campaign.

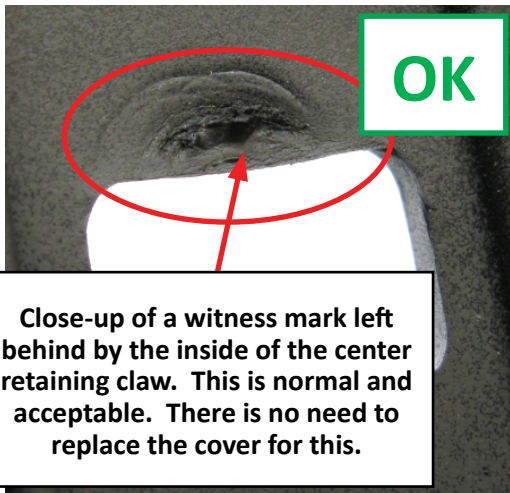
Close-up of a witness mark left behind by the inside of the center retaining claw. This is normal and acceptable. There is no need to replace the cover for this.

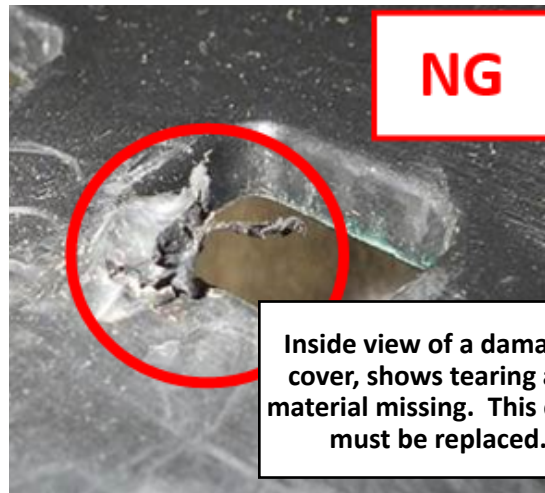
Inside view of a damaged cover, shows tearing and material missing. This cover must be replaced.

Step 3- Confirm the orientation is correct as outlined earlier in this bulletin. Refit the original cover, if reusable, onto the replacement module assembly. Make sure all the claws are fully engaged (see Figure 1 above). When properly installed, the cover should feel loose with a small amount of freeplay. If the cover is tight (no freeplay or looseness), it most likely is not fully engaged onto the claws.
