**PRODUCT CAMPAIGN BULLETIN**

**APPLICABILITY:** 2003-2005 Subaru Legacy and Outback\*\*  
 2003-2005 Subaru Baja  
 2004-2005 Subaru Impreza\*\*  
 (including WRX and STI)

**NUMBER:** WQP-51R  
**DATE:** January 2015  
**NHTSA ID:** 14V-763  
**REVISED:** December 7, 2017

**SUBJECT:** Regional Front Passenger Air Bag Inflator Replacement

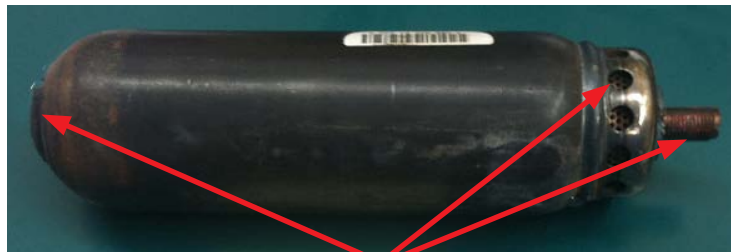
**The shape, holes, and copper-colored stud indicate this not a Genuine Subaru inflator.**

- Document the presence of the aftermarket or counterfeit device on the repair order and with photos. Report this information immediately on a Quality Monitoring Report (QMR).

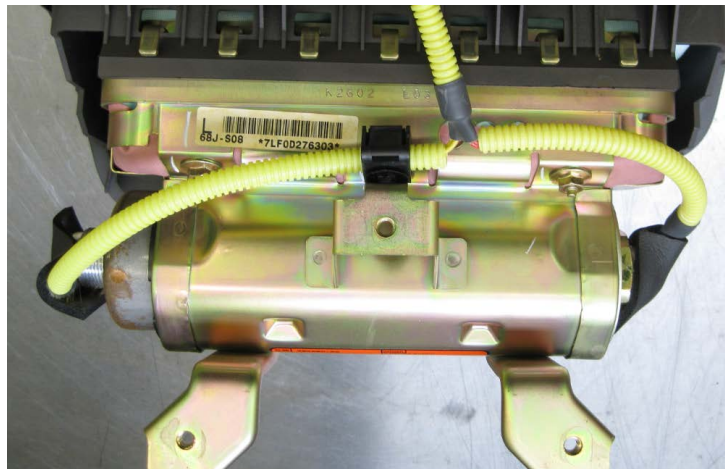
**Inflator WITHOUT Ammonium Nitrate- Serial Number Label Location (2003 Legacy, Outback and Baja models only): Record this 12-digit number for claims purposes.**

- These early production 2003 MY vehicles (77,000) were equipped with inflators which do not contain ammonium nitrate.
- These inflators which do not contain ammonium nitrate do not require replacement as part of any Subaru airbag recall.

See the Claim Reimbursement and Entry Procedures at the end of this announcement for instructions on how to submit a claim for “Inspection Only” when an inflator without ammonium nitrate is identified.

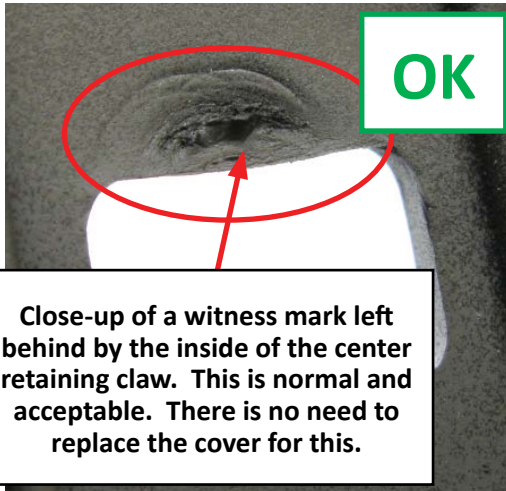
Close-up of a witness mark left behind by the inside of the center retaining claw. This is normal and acceptable. There is no need to replace the cover for this.

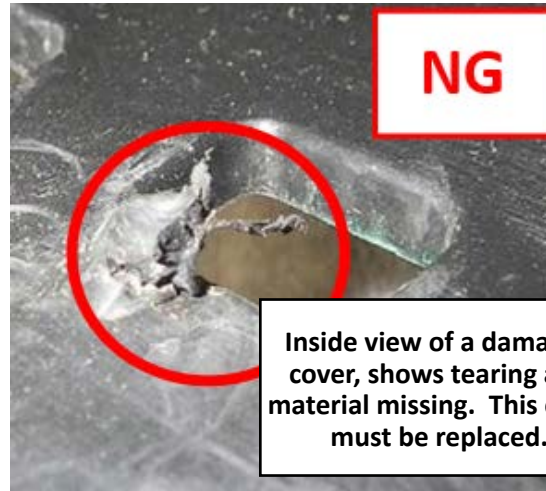
Inside view of a damaged cover, shows tearing and material missing. This cover must be replaced.
