**SERVICE INFORMATION BULLETIN**

**NUMBER:** 07-116-16R

**SUBJECT:** Supplemental Service Procedure Information to be Used in Conjunction with Campaigns WQP-51, WQR-53R and TKA, B, C-16R

**DATE:** 11/11/16

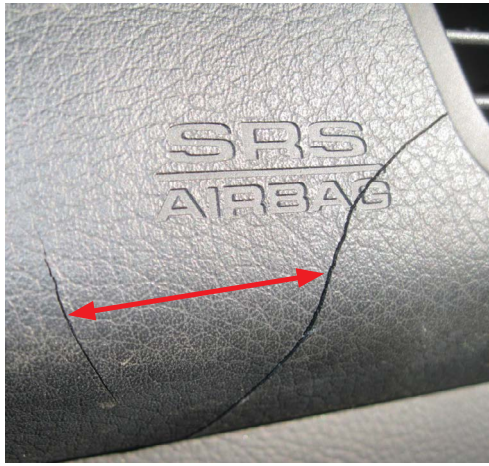
- On 2005-2009MY Legacy / Outback models, if any cracking is identified on either the outside “soft” padded surface of the IP as shown in the photo below or, if during disassembly, cracking of the internal “hard” plastic structure of the IP is found, **the IP blocking procedure outlined in this bulletin must NOT be followed as more damage will likely result.** In this case, the IP must be completely removed following the applicable Service Manual procedure before removing the airbag module.

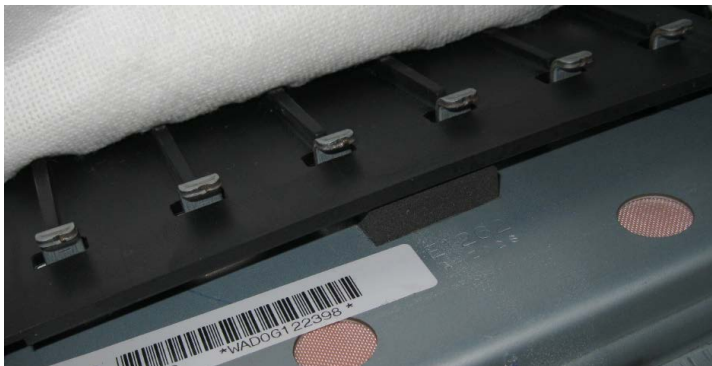
**Module in position, retaining claws engaged.**

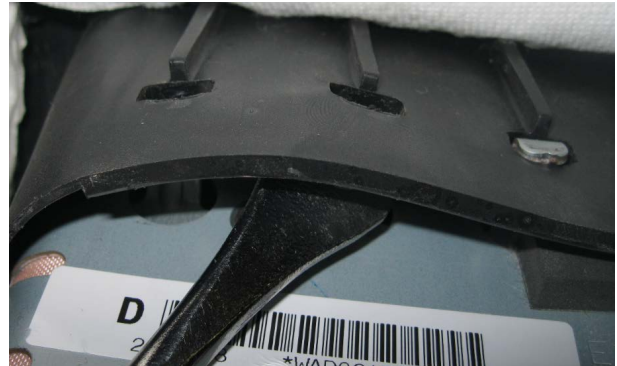
**Retaining claws being CAREFULLY disengaged.**

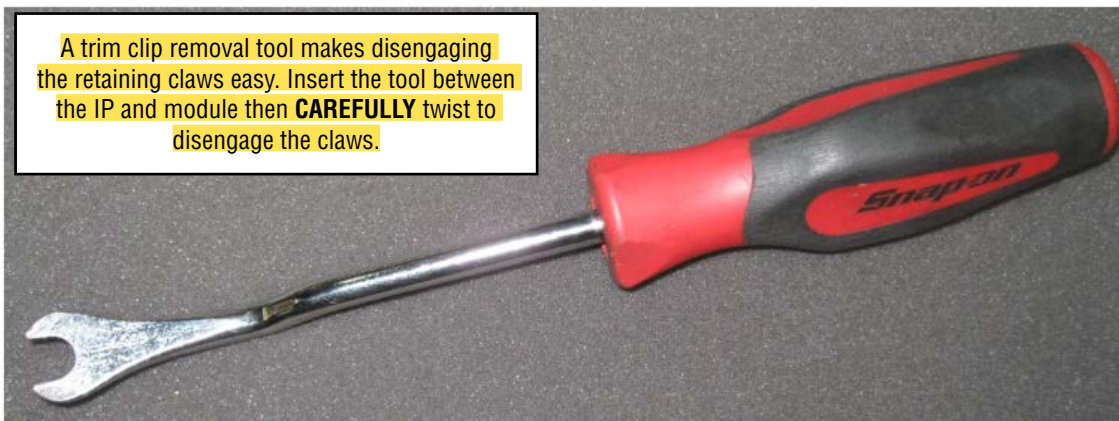
A trim clip removal tool makes disengaging the retaining claws easy. Insert the tool between the IP and module then **CAREFULLY** twist to disengage the claws.

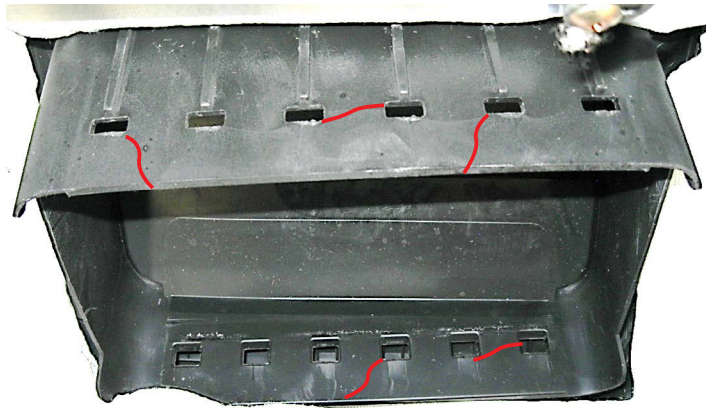
This photo shows the IP with the airbag module removed. If any cracks (examples shown as the red lines) are identified between retaining claw holes or between holes and the outside edge, the IP **MUST BE REPLACED.**

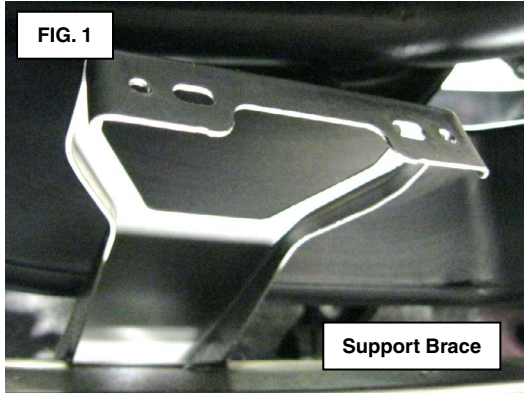
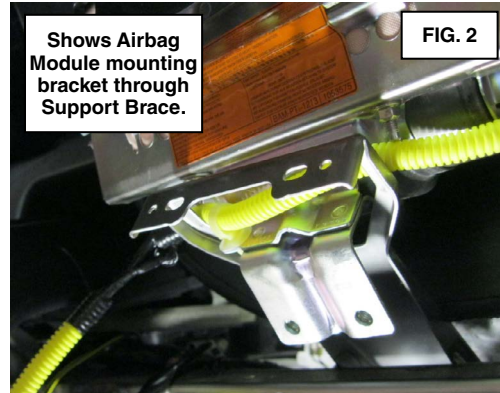
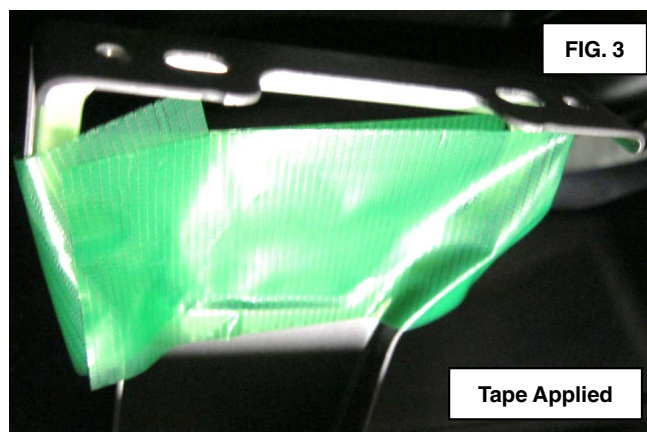
- On these models, there is an additional support brace for the IP attached to the steering column support bar (Fig. 1 below). The bracket has an opening in it which the mounting bracket for the airbag module fits through easily. The airbag module cannot be removed if its mounting bracket becomes caught in this brace (Fig. 2). **BEFORE** attempting to remove the airbag module, apply a piece of duct tape (or equivalent) to the brace (Fig. 3) to prevent this.
