SUBJECT: **DELIVERY HOLD - Customer Satisfaction Program 15B21 – Supplement #2**
Certain 2015 Model Year Edge Vehicles
A-Pillar Water Leak Inspection and Repair

In some of the affected vehicles, water may leak into the cabin through the sheet metal joint in the A-pillar area directly behind the hood hinge on both sides of the vehicle. The water enters the cabin at the lower A-pillar areas behind the lower dash panel trim panels.

CERTAIN 2015 MODEL YEAR EDGE VEHICLES — A-PILLAR WATER LEAK INSPECTION AND REPAIR PROCEDURE

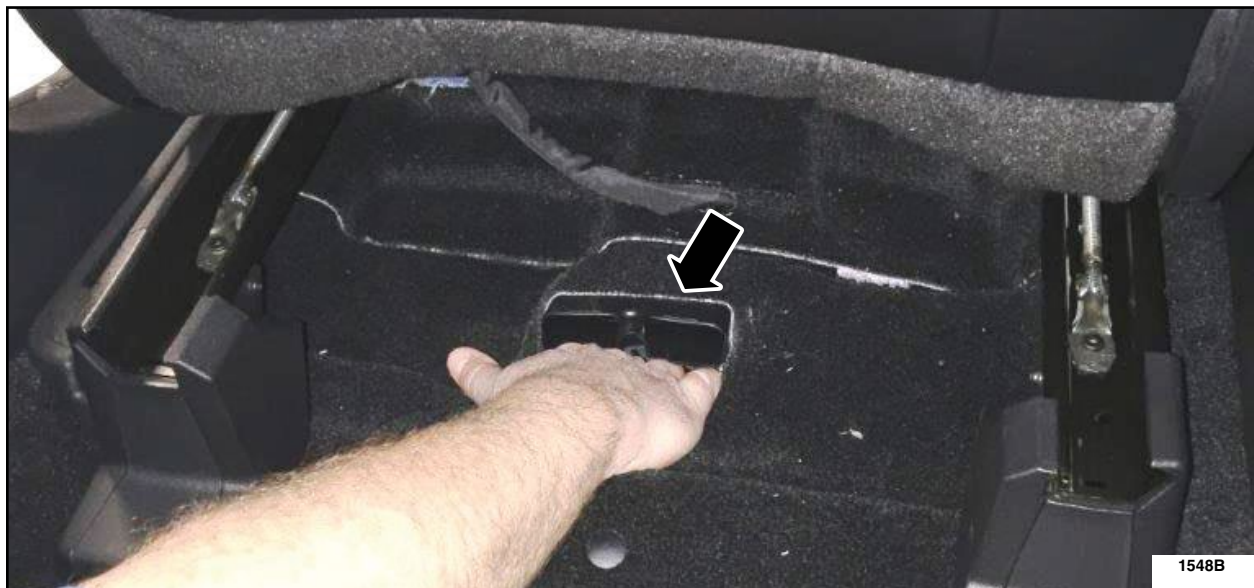
FIGURE 1

- c. Move both front seats to full forward position. From rear seat area, reach in through the holes in the carpet below the rear seat climate control ducts on the floor and feel for water or evidence of moisture on the floor pan sheet metal. See Figure 1.

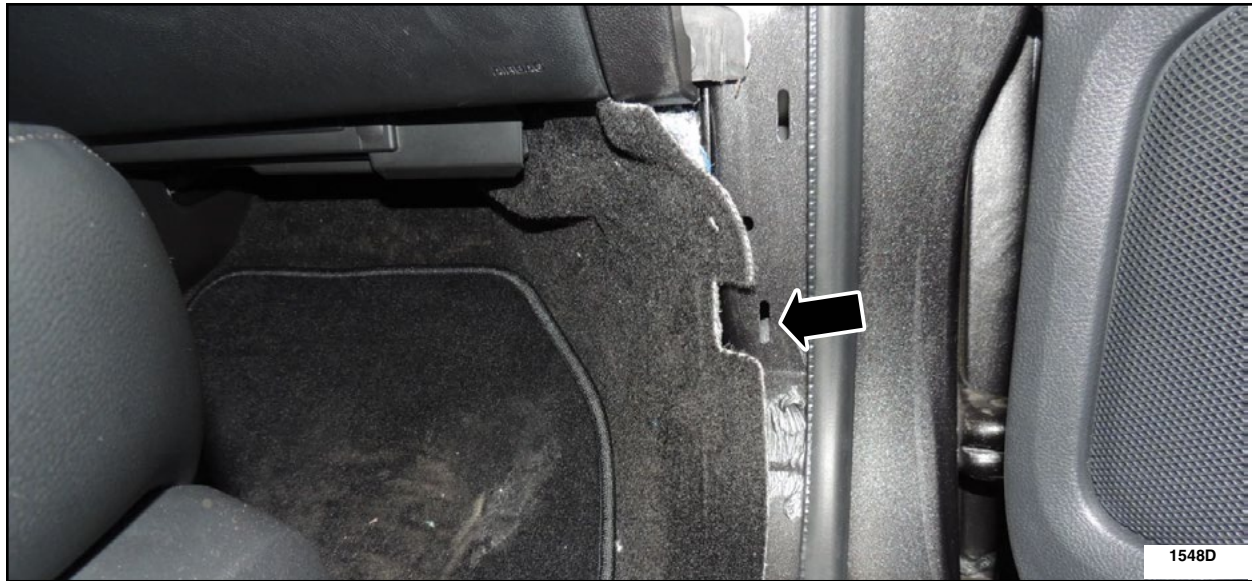
FIGURE 6

7. Using a cotton swab or a piece of paper/cardboard, check for the presence of standing water and visually check for the evidence of water/dampness in the lower A-pillar on both the LH and RH sides of the vehicle through the interior cowl trim panel lower attaching clip retainer opening. See Figure 6.
8. Pull back the carpet and padding on the floor next to the LH and RH A-pillar areas and check for water/dampness.

- Is standing water, moisture or a mildew/musty odor present?

YES – Proceed to Wet Vehicle Repair Procedure (Attachment V).

NO – The vehicle did not experience a water leak. Continue to Upper A-pillar Sheet Metal Seam Sealing Procedure to complete repairs.

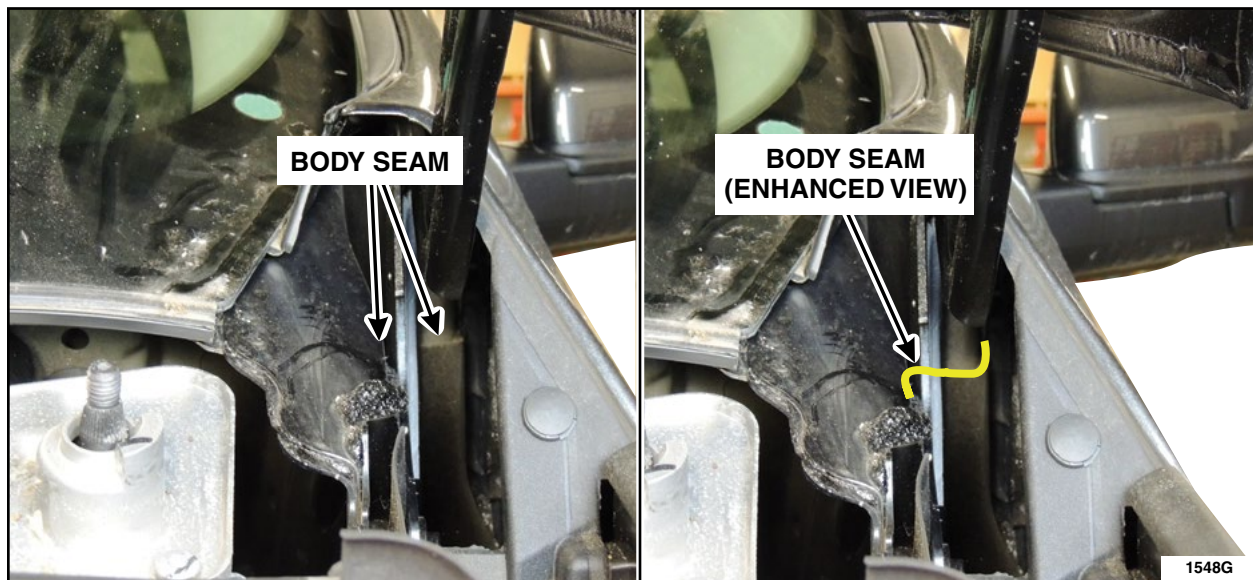
FIGURE 9

In some of the affected vehicles, water may leak into the cabin through the sheet metal joint in the A-pillar area directly behind the hood hinge on both sides of the vehicle. The water enters the cabin at the lower A-pillar areas behind the lower dash panel trim panels.

3. Open the hood and locate the body seam that runs behind the hood hinge at the base of the exterior A-pillar on both the RH and LH sides of the vehicle. See Figures 9 and 10.

4. Use a flashlight to locate the body seam that runs behind and along the side of the LH and RH hood hinges. Apply a bead of sealer to the body seam. See Figures 9, 10 and 11.

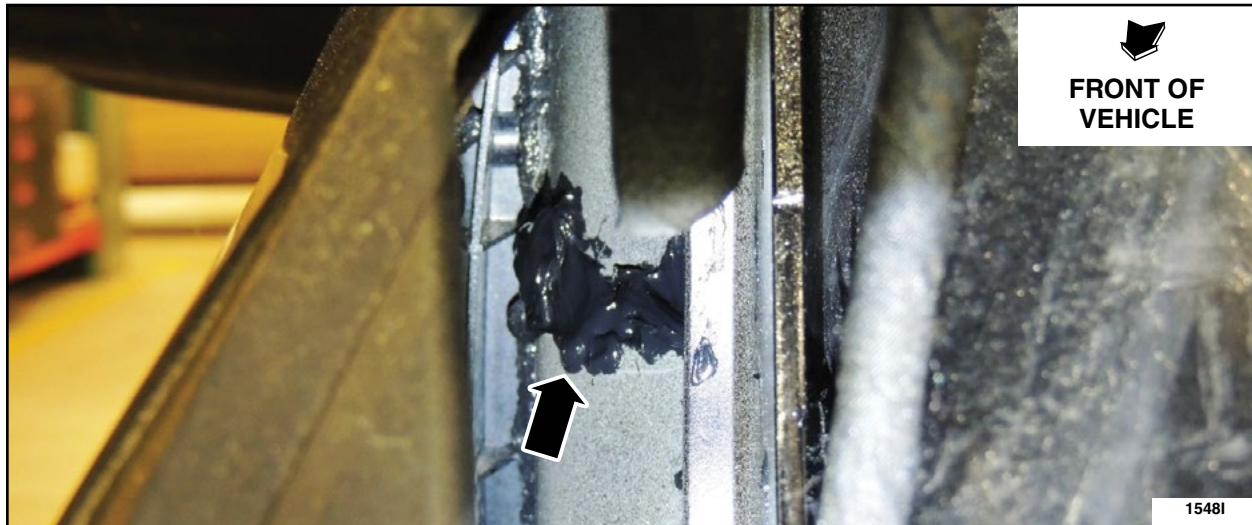
FIGURE 12

5. Carefully inspect the bead of seam sealer to ensure it completely fills the gap in the sheet metal panels. Apply additional seam sealer if required to ensure a leak free joint is attained. See Figure 12.

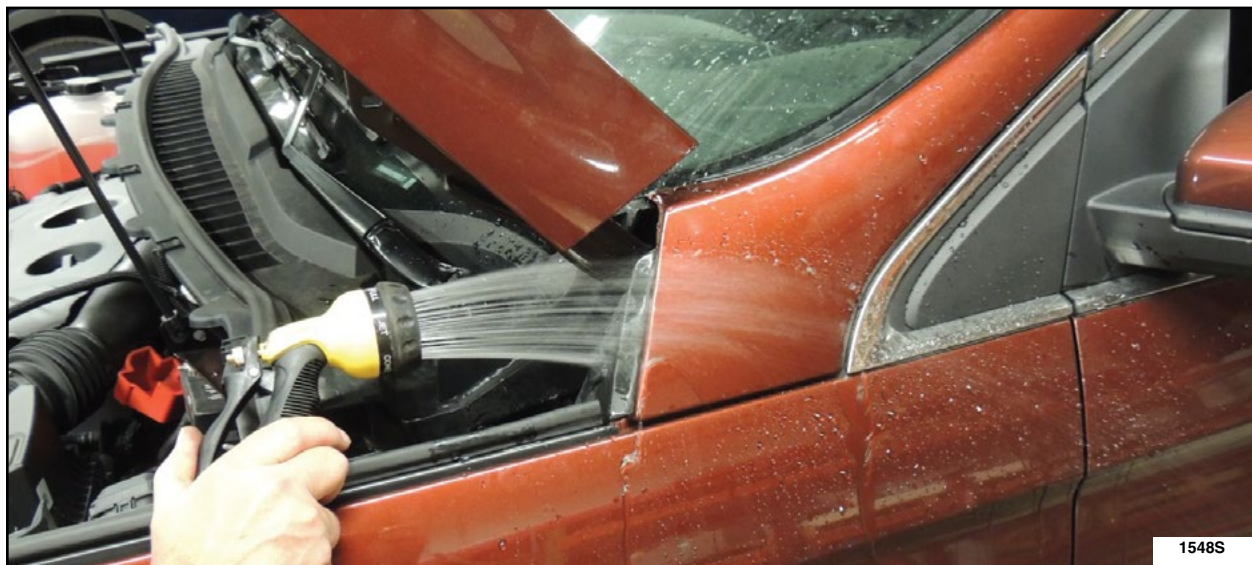
FIGURE 13

6. **NOTE:** Observe the LH and RH lower A-pillar area while water testing the vehicle.

- If water is leaking into the A-pillar(s) dry with compressed air and apply additional seam sealer to repair area. Repeat step to verify repair as needed.

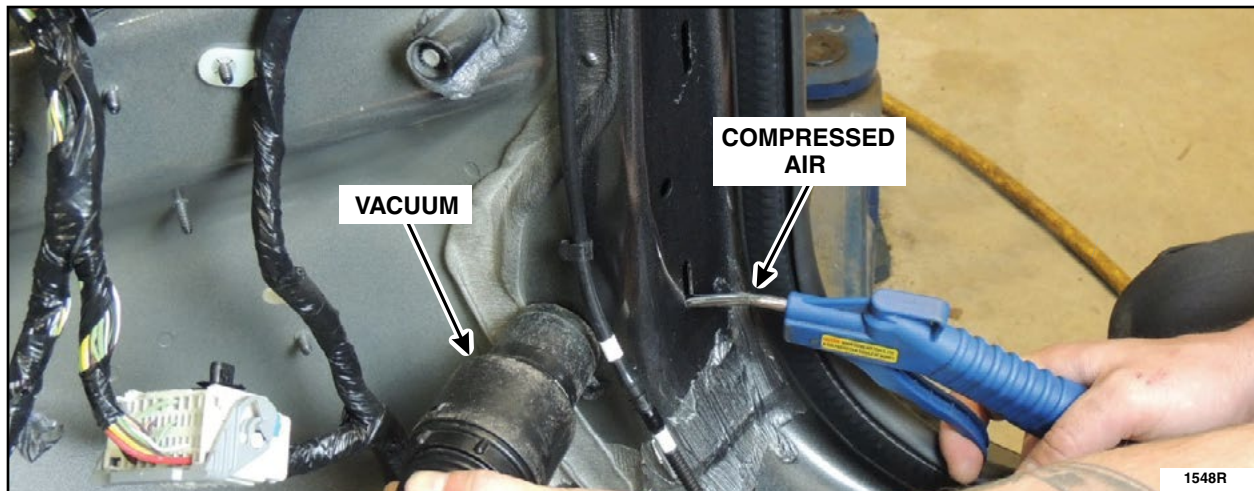
FIGURE 6

8. Using an air hose nozzle and shop vacuum, remove any residual water from the lower A-pillars as shown. See Figure 6.

- Manipulation of air hose nozzle around the cavity is required for minimum of five minutes per side.

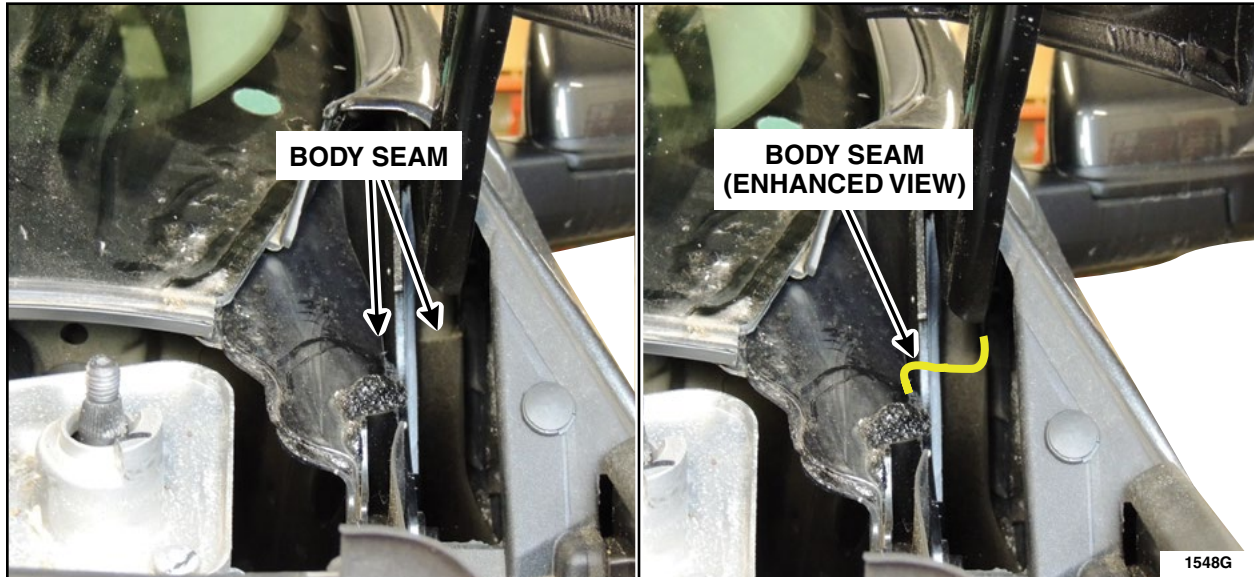
FIGURE 9

11. Open the hood and locate the body seam that runs behind the hood hinge at the base of the exterior A-pillar on both the LH and RH sides of the vehicle. See Figures 9 and 10.

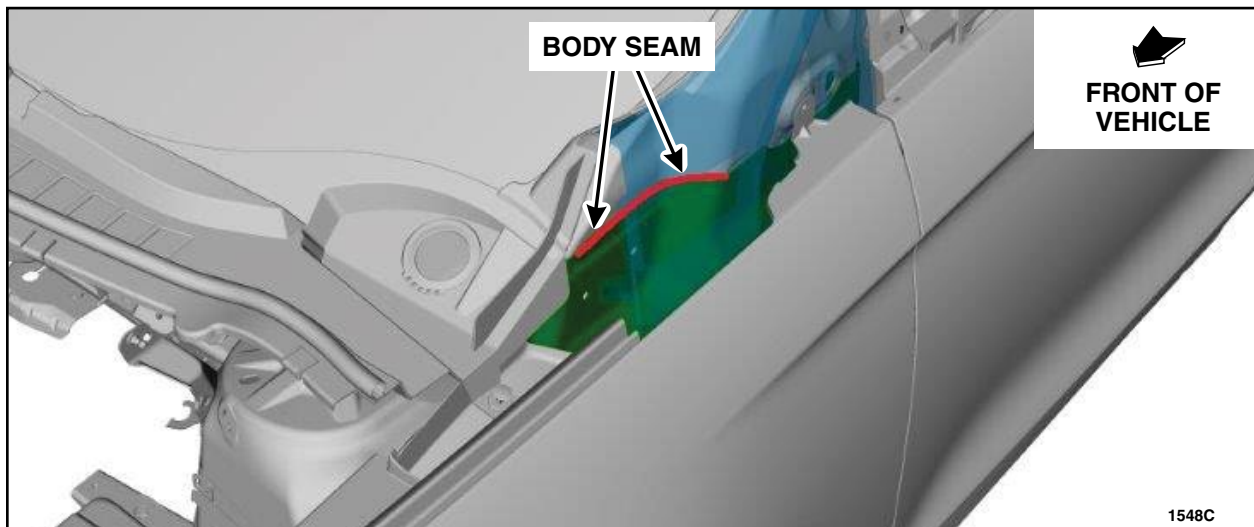
FIGURE 10

12. Use a flashlight to locate the body seam that runs behind and along the side of the LH and RH hood hinges. Apply a bead of sealer to the body seam. See Figures 10, 11 and 12.

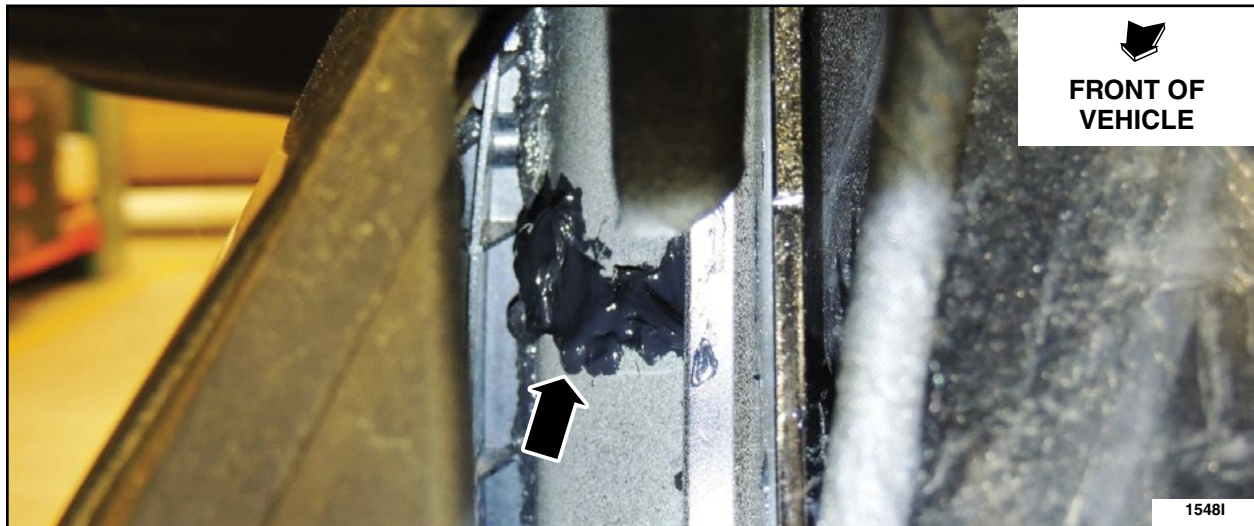
FIGURE 12

13. Carefully inspect the bead of seam sealer to ensure it completely fills the gap in the sheet metal panels. Apply additional seam sealer if required to ensure a leak free joint is attained. See Figure 12.

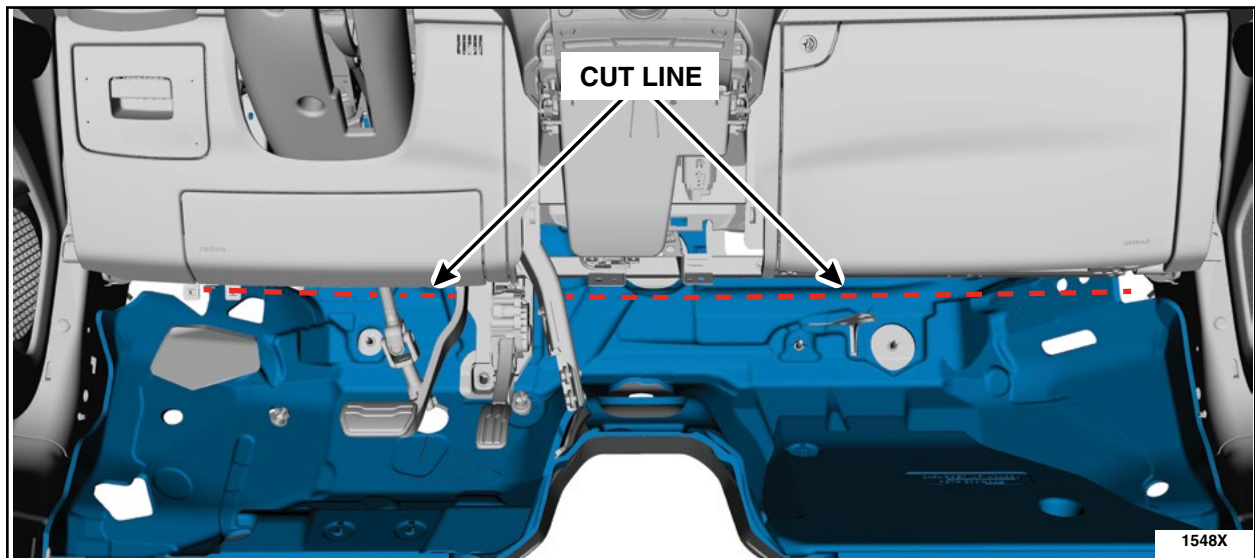
FIGURE 15

22. If possible, the affected wet portion of the instrument panel insulator pad should be cut out of the vehicle without removing the instrument panel at this time, so that the vehicle can be moved within the dealership until final repairs can be performed. Discard the removed portion of the instrument panel insulator pad. See Figure 15.

- If all affected (wet) areas of the insulator pad cannot be removed, follow WSM Section 501-12 to remove the instrument panel and completely remove and discard the instrument panel insulator pad.
