CERTAIN 2012 THROUGH 2014 MODEL YEAR FOCUS ELECTRIC VEHICLES — HIGH VOLTAGE WIRE HARNESS INSPECTION AND POWERTRAIN CONTROL MODULE REPROGRAMMING

OVERVIEW

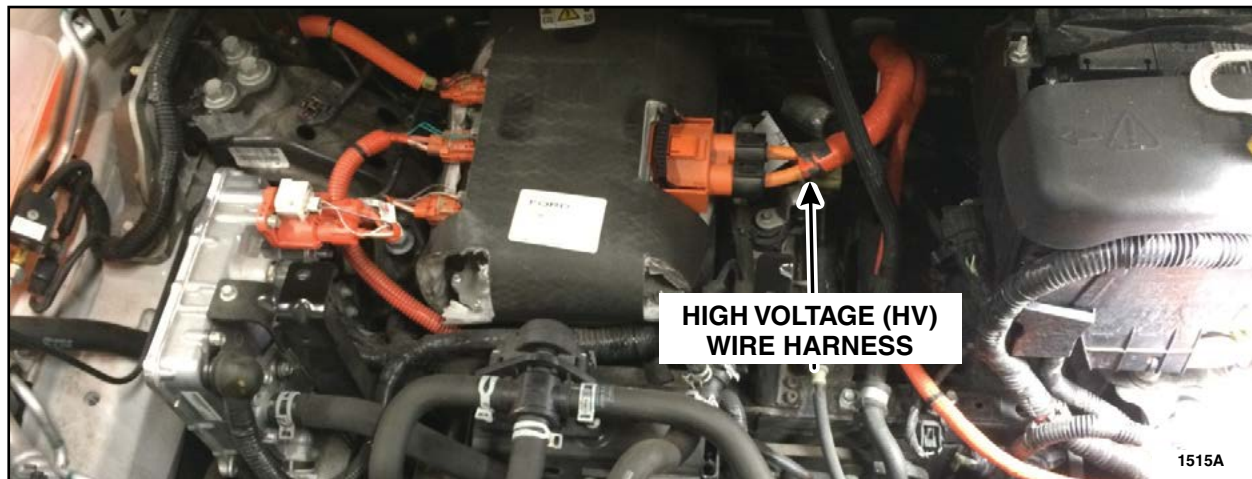
FIGURE 1a

1. Remove the two engine cover retainer pins, then remove the engine cover.
2. Inspect the HV wire harness. See Figure 1a.

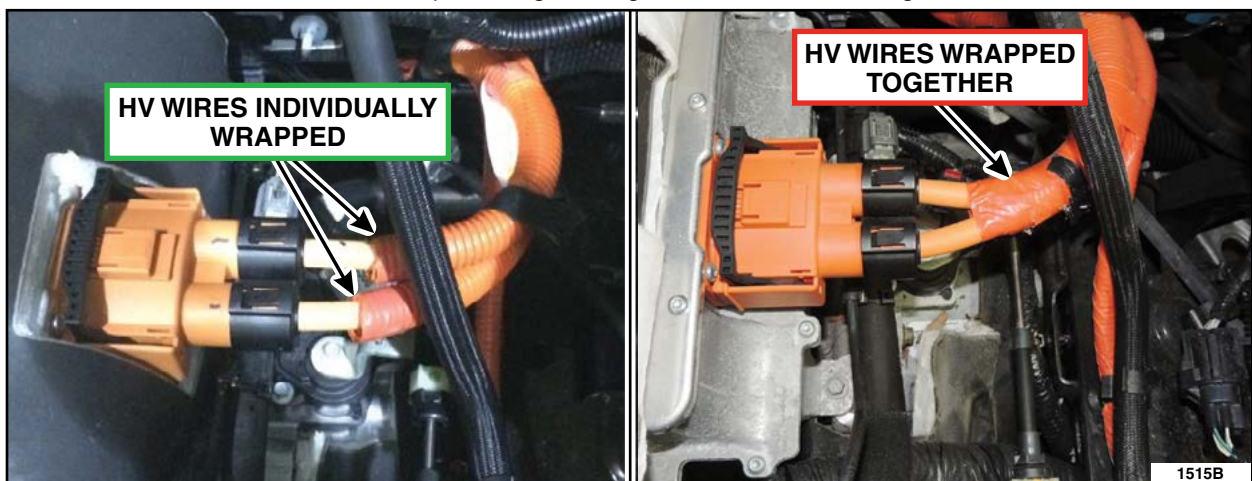
FIGURE 1b

3. Are the HV wires individually wrapped in convolute? See Figures 1b and 1c.
 - Yes - HV wire harness update is not required. Proceed to Module Reprogramming on Page 11.
 - No - Proceed to Update High Voltage Wire Harness on Page 3.
