CERTAIN 2012 - 2014 MODEL YEAR FOCUS ELECTRIC VEHICLES — HIGH **VOLTAGE WIRE HARNESS EXTENDED COVERAGE**

OVERVIEW

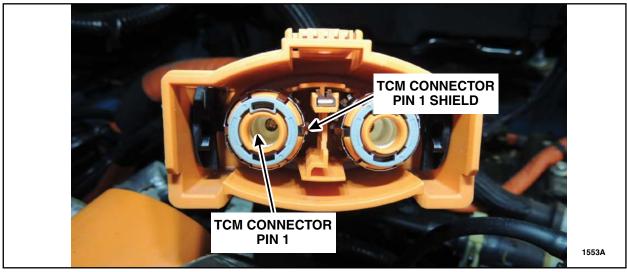
FIGURE 11

- 13. Measure electrical resistance (ohms) at the following TCM connector locations while wiggle testing the high voltage wire harness at each connector that was previously disconnected in this procedure.
 - a. TCM C1822B Pin 1 to C1822 Pin 1 shield. See Figure 11.
 - b. TCM C1822B Pin 2 to C1822 Pin 2 shield. See Figure 12.

- 14. Are the measured resistances greater than 173,000 ohms?
 - Yes This concern is not caused by the high voltage wire harness and therefore this program does not apply. Continue with normal diagnostic and repair procedures.
 - No Replace the high voltage wire harness. Please follow the WSM procedures in Section 414-03A.
