Michael A. Berardi  
Director  
Service Engineering Operations  
Ford Customer Service Division

**SUBJECT:** **Regional Program 15R01 – Supplement #1**  
Certain 2013-2015 Model Year Fusion and MKZ and 2015 Model Year Edge Vehicles  
Not Covered Under Safety Recall 15S14  
Steering Gear Motor Bolt Corrosion

**Regional Program 15R01 – Supplement #1**  
Certain 2013-2015 Model Year Fusion and MKZ and 2015 Model Year Edge Vehicles  
Not Covered Under Safety Recall 15S14  
Steering Gear Motor Bolt Corrosion

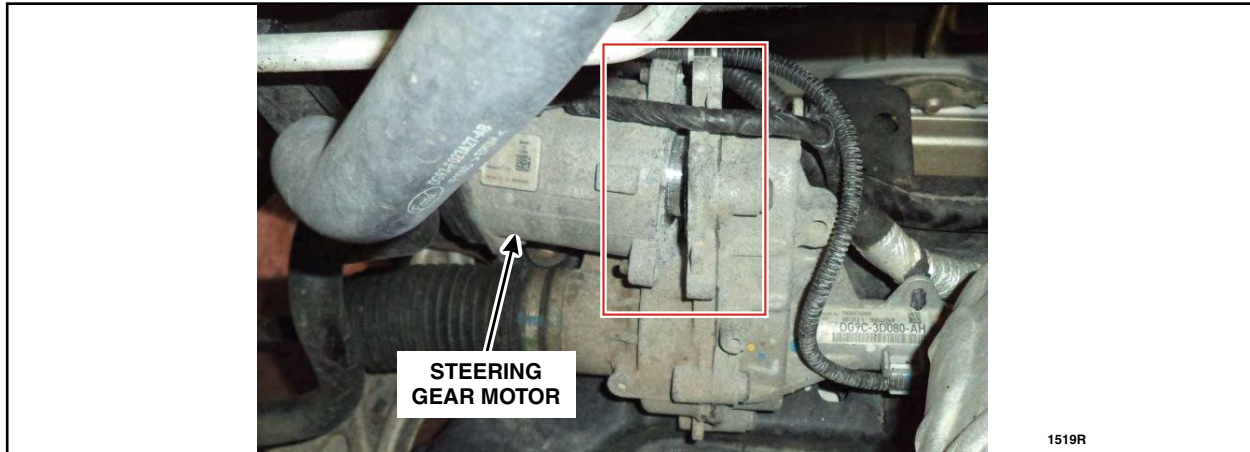
FIGURE 8

1. Inspect the steering gear motor for signs of separation, broken or missing bolts. See Figure 8.
2. Are any of the bolts broken or missing, or is a gap present between the motor and motor housing?

Yes – replace the steering gear. Please follow the WSM procedures in Section 211-02.  
Proceed to "Apply Corrosion Protection" on Page 7.  
No – proceed to "Replace Steering Gear Motor Bolts".
