PRODUCT CAMPAIGN BULLETIN

APPLICABILITY: 2003-2004 Baja
 2003-2008 Legacy and Outback
 2004-2005 Impreza, WRX, STI

SUBJECT: Takata Front Passenger Air Bag Inflator Replacement

NUMBER: WQR-53R
DATE: June 2, 2015
REVISED: April 12, 2016
NHTSA ID: 15V-323

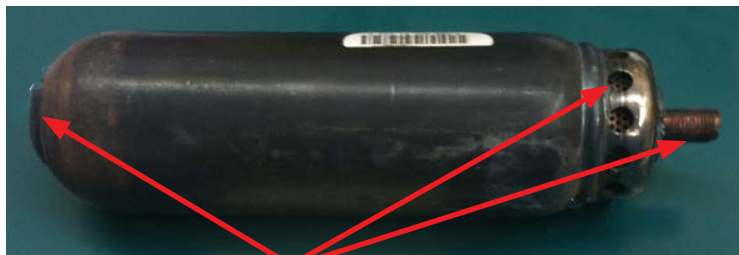
No visible stopper plates, a 6-nut configuration and rubber harness boots are other examples to indicate this is not a Genuine Subaru airbag module.

- **Do not proceed with this repair if your inspection reveals a non-Genuine Subaru air bag module has been installed in the vehicle.** Follow the instructions described in the “Counterfeit Air Bag Information” Dealer Advisory Bulletin and contact the SOA Warranty Helpline to close out the WQL-48 recall coverage on the vehicle.
