PRODUCT CAMPAIGN BULLETIN

APPLICABILITY: 2003-2004 Baja
 2003-2008 Legacy and Outback
 2004-2005 Impreza, WRX, STI

NUMBER: WQR-53R
DATE: June 2, 2015
REVISED: December 7, 2017
NHTSA ID: 15V-323

SUBJECT: Takata Front Passenger Air Bag
 Inflator Replacement

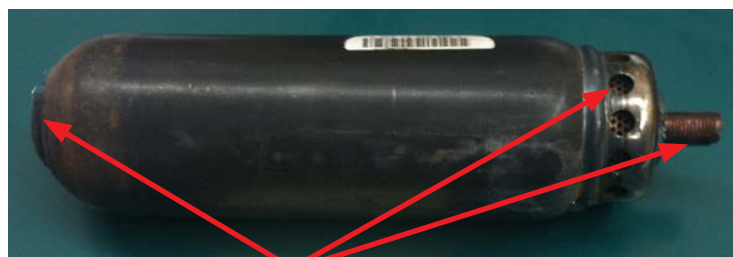
The shape, holes, and copper-colored stud indicate this not a Genuine Subaru inflator.

- Document the presence of the aftermarket or counterfeit device on the repair order and with photos. Report this information immediately on a Quality Monitoring Report (QMR).

- Once the QMR has been submitted, contact the Subaru Claims Helpline to discuss the details. They will advise you on how to proceed with treatment of the open campaign.

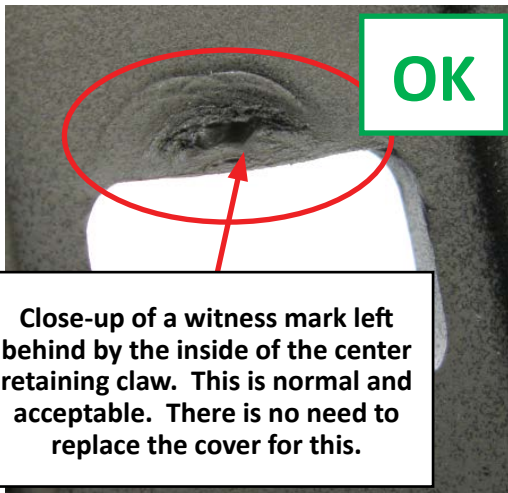
OK

Close-up of a witness mark left behind by the inside of the center retaining claw. This is normal and acceptable. There is no need to replace the cover for this.
