**PRODUCT CAMPAIGN BULLETIN**

**APPLICABILITY:** 2003-2004 Baja  
 2003-2008 Legacy and Outback  
 2004-2005 Impreza, WRX, STI

**SUBJECT:** Takata Front Passenger Air Bag Inflator Replacement

**NUMBER:** WQR-53R  
**DATE:** June 2, 2015  
**REVISED:** January 07, 2016  
**NHTSA ID:** 15V-323

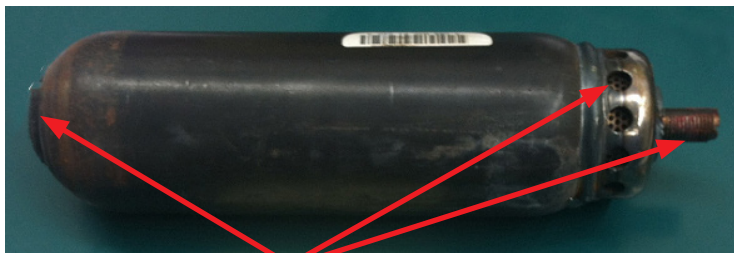
The shape, holes, and copper-colored stud indicate this not a Genuine Subaru inflator.

- Document the presence of the aftermarket or counterfeit device on the repair order and with photos. Report this information immediately on a Quality Monitoring Report (QMR).

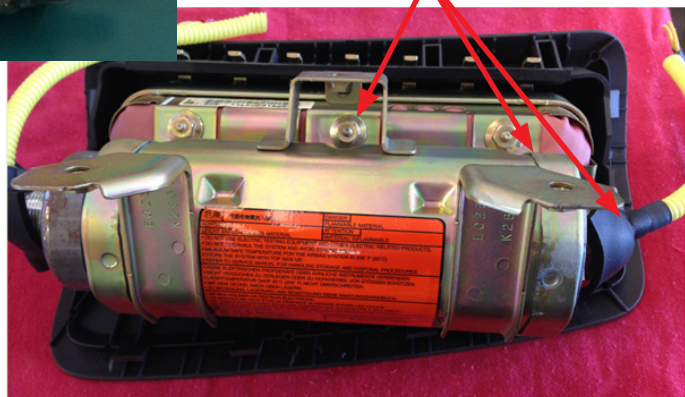
No visible stopper plates, a 6-nut configuration and rubber harness boots are other examples to indicate this is not a Genuine Subaru airbag module.
