PRODUCT CAMPAIGN BULLETIN

APPLICABILITY: 2003-2004 Baja
 2003-2008 Legacy and Outback
 2004-2005 Impreza, WRX, STI
SUBJECT: Takata Front Passenger Air Bag
 Inflator Replacement

NUMBER: WQR-53R
DATE: 06/02/15
REVISED: 05/14/21
NHTSA ID: 15V-323

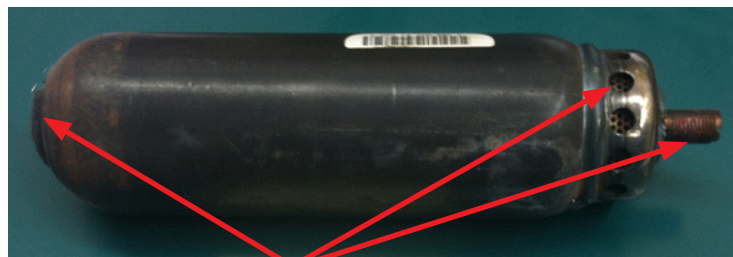
The shape, holes, and copper-colored stud indicate this not a Genuine Subaru inflator.

- Document the presence of the aftermarket or counterfeit device on the repair order and with photos. Report this information immediately on a Quality Monitoring Report (QMR).

- Once the QMR has been submitted, contact the Subaru Claims Helpline to discuss the details. They will advise you on how to proceed with treatment of the open campaign.
