PRODUCT CAMPAIGN BULLETIN

APPLICABILITY: 2004-2005 Subaru Impreza, WRX, STI

SUBJECT: Takata Front Passenger Air Bag Inflator Replacement

NUMBER: WQR-53R

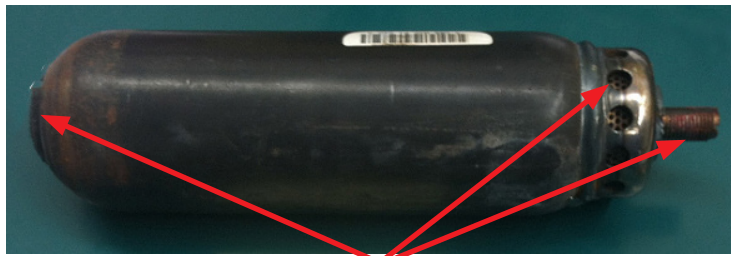
The shape, holes, and copper-colored stud indicate this not a Genuine Subaru inflator.

- If an aftermarket or counterfeit passenger airbag or inflator is identified at any point during the campaign service procedure, **STOP IMMEDIATELY. NEVER attempt to remove or otherwise disable any aftermarket or counterfeit device.**

- Document the presence of the aftermarket or counterfeit device on the repair order and with photos. Report this information immediately on a Quality Monitoring Report (QMR).

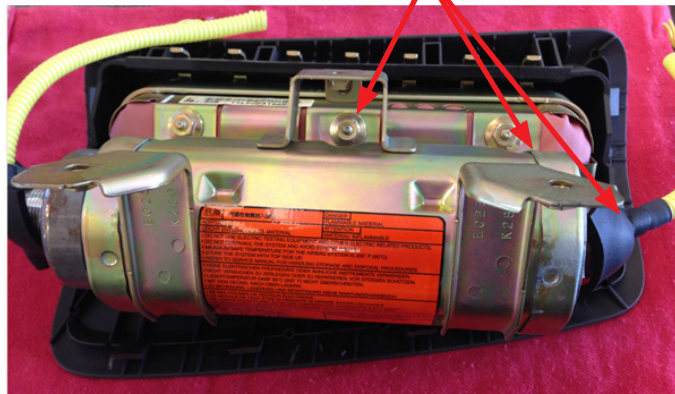
No visible stopper plates, a 6-nut configuration and rubber harness boots are other examples to indicate this is not a Genuine Subaru airbag module.
