PRODUCT CAMPAIGN BULLETIN

APPLICABILITY: 2003-2004 Baja
 2003-2008 Legacy and Outback
 2004-2005 Impreza, WRX, STI

SUBJECT: Takata Front Passenger Air Bag Inflator Replacement

NUMBER: WQR-53R
DATE: June 2, 2015
REVISED: September 7, 2016
NHTSA ID: 15V-323

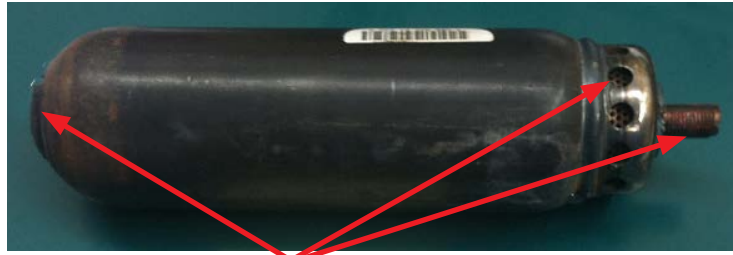
The shape, holes, and copper-colored stud indicate this not a Genuine Subaru inflator.

- Document the presence of the aftermarket or counterfeit device on the repair order and with photos. Report this information immediately on a Quality Monitoring Report (QMR).
- Once the QMR has been submitted, contact the Subaru Claims Helpline to discuss the details. They will advise you on how to proceed with treatment of the open campaign.

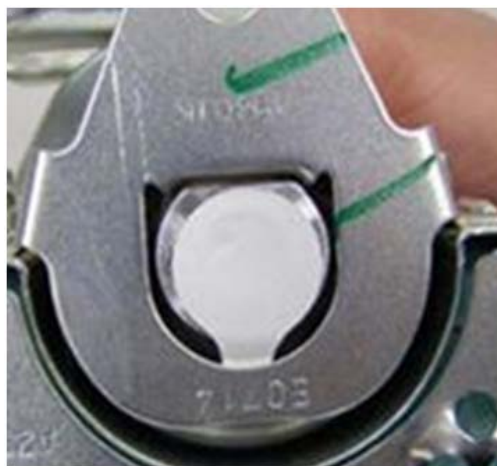
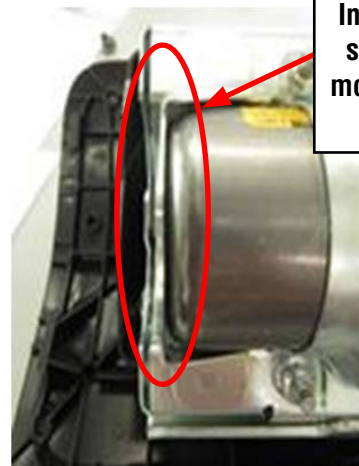
Inflator properly seated against mounting bracket (NO GAP)

STEP 9- Install the new inflator into the mounting bracket so the yellow taped end aligns with the removed stopper plate. Make sure the “D-shaped” portion of the inflator harness connector boss aligns with the “D-shaped” portion of the hole in the end of the mounting bracket as shown below. When properly installed, the end of the inflator will be seated tight against the mounting bracket. Do not peel the white harness connection dust cover at this time.
