Recall Bulletin

SUBJECT: Power Lift Gate Prop Rod Recovery

MODELS: 2008-2012 Buick Enclave
2009-2012 Chevrolet Traverse
2007-2012 GMC Acadia
2007-2010 Saturn Outlook
Built Prior to March 1, 2012 and Equipped with Power Lift Gate (TB5 or E61)

Enclosure
GM Recall #15240

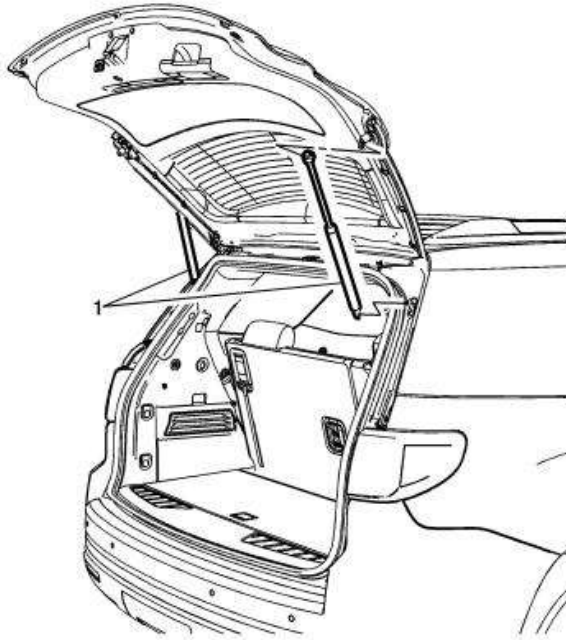
2878222

Note: GM engineering has determined that improved durability of the lift gate strut can be realized by installing the strut assembly with the rod end facing downward (attached to the lift gate) when the lift gate is in the closed position. In this orientation, dust and dirt does not collect on the strut housing to rod seal, which can cause wear on the seal.

Note: When replacing or repositioning the lift gate struts, install the strut assembly with the strut body end attached to the vehicle body and the rod side attached to the lift gate (1).
