Recall Bulletin

SUBJECT: Power Lift Gate Prop Rod Recovery

MODELS: 2008-2012 Buick Enclave
2009-2012 Chevrolet Traverse
2007-2012 GMC Acadia
2007-2010 Saturn Outlook
Built Prior to March 10, 2012 Equipped with Power Lift Gate (TB5 or E61)

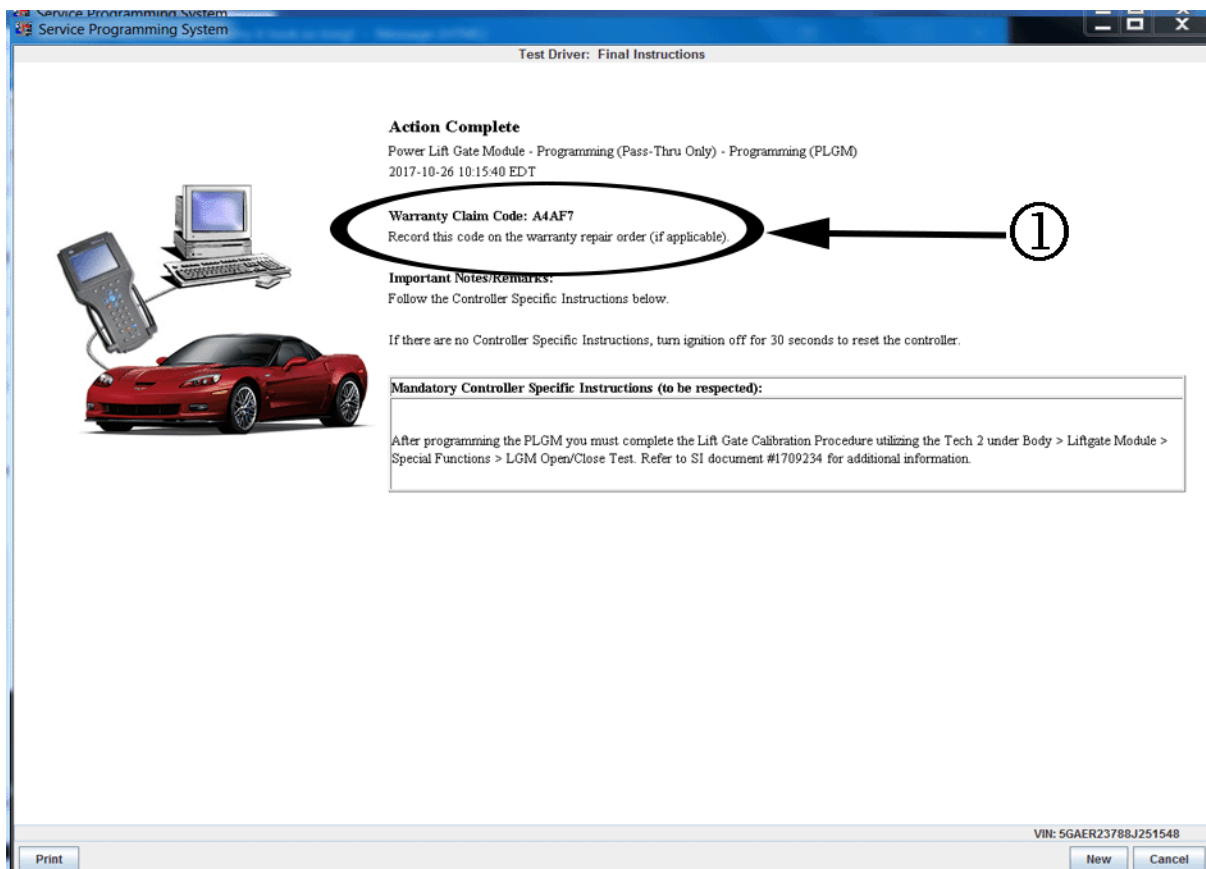
Note: If the Same Calibration/Software Warning is noted on the SPS Controller screen, continue with the programming event using SPS to ensure a Warranty Claim Code is displayed on screen. Technicians **MUST** record the Warranty Claim Code (1) on the Job Card. To avoid warranty transaction rejection, this information must be entered when submitting the transaction.

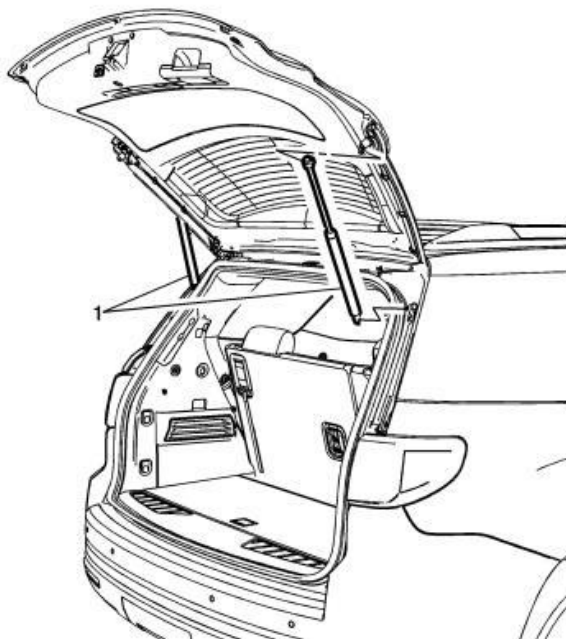
2878222

Note: GM engineering has determined that improved durability of the lift gate strut can be realized by installing the strut assembly with the rod end facing downward (attached to the lift gate) when the lift gate is in the closed position. In this orientation, dust and dirt does not collect on the strut housing to rod seal, which can cause wear on the seal.

Note: When replacing or repositioning the lift gate struts, install the strut assembly with the strut body end attached to the vehicle body and the rod side attached to the lift gate (1).
