Recall Bulletin

SUBJECT: HVAC Connector Wire Failure

MODELS: 2006–2010 HUMMER H3
2009–2010 HUMMER H3T

GM Recall #15042

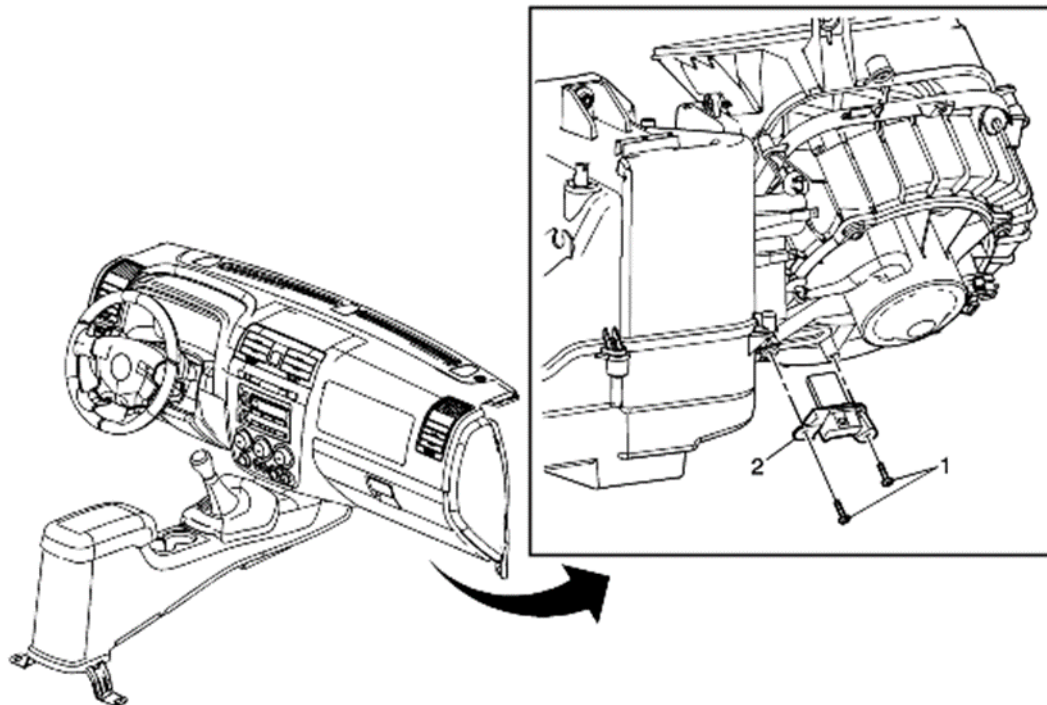
1560040

LH drive vehicle shown, RH drive similar.

5. Disconnect the electrical connector from the blower motor resistor assembly (2).
6. Remove the blower motor resistor assembly. Refer to *Blower Motor Resistor Assembly Replacement (Left Hand Drive)* or *Blower Motor Resistor Assembly Replacement (Right Hand Drive)* in SI.
