2017 CX-5 - GENUINE MAZDA ACCESSORY TRAILER HITCH HARNESS RECALL 1617K

A. VEHICLE INSPECTION PROCEDURE

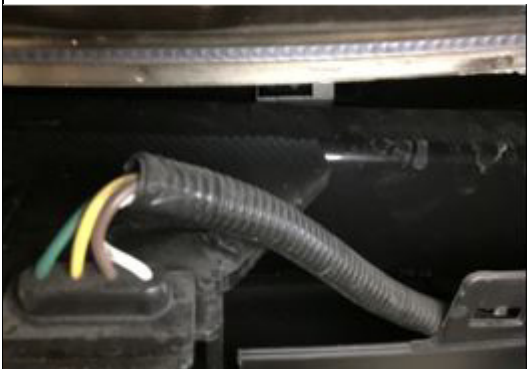
On vehicles with a Genuine Mazda Accessory Trailer Hitch Harness installed, due to inappropriate routing of the harness, there may be an insufficient clearance between the harness and the main exhaust silencer. If the exhaust silencer makes contact with the harness while driving, harness damage may eventually occur causing harness wires to become short-circuited. Other than loss of trailer lighting, no other vehicle systems are affected.

No Damage / Re-Route Harness	Melted / Replace Harness

1. Raise the vehicle on a hoist.
2. Visually inspect the accessory trailer hitch wire harness for signs of heat damage / melting.
 - If there are no signs of heat damage / melted wire harness, proceed to the “CX-5 Trailer Hitch Harness Re-Routing Procedure”.
 - If there are signs of heat damage / melted wire harness, proceed to the “CX-5 Trailer Hitch Harness Replacement Procedure”.
