Michael A. Berardi
Director
Service Engineering Operations
Ford Customer Service Division

**SUBJECT: NEW VEHICLE DEMONSTRATION / DELIVERY HOLD
Compliance Recall 16C14**

Certain 2015-2016 Model Year Edge Vehicles Serviced with an Anti-Lock Brake System Repair
Anti-Lock Brake System Module Repair

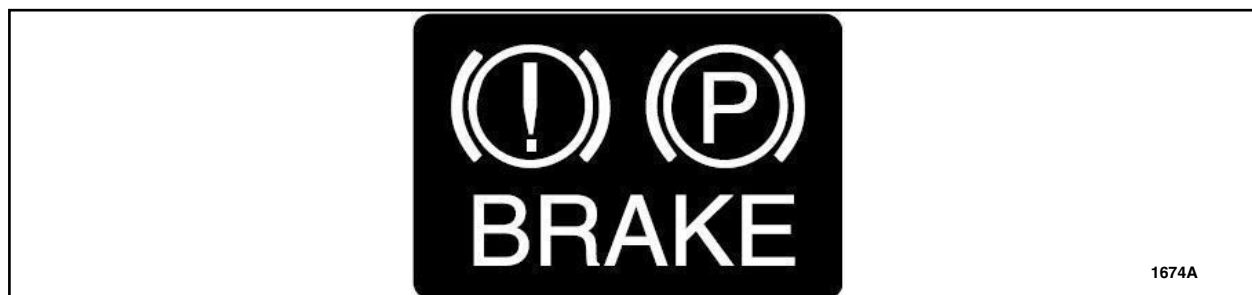
FIGURE 1

1. Apply the EPB and check the operation of the brake system warning lamp. See Figure 1.
 - If the brake system warning lamp **is** illuminated, the recall is complete, no further action is needed.
 - If the brake system warning lamp **is not** illuminated, proceed to ABS Module Replacement.

1. Prior to ABS Module replacement, ensure that the Integrated Diagnostic Software (IDS) is updated to release 102.02 or higher.
2. Replace the ABS Module. Please follow the Workshop Manual (WSM) procedures in Section 206-09.
3. Apply the EPB and recheck to verify brake system warning lamp illumination.
